Fukushima Daiichi Accident: Why it happened, What happened and the Challenge of nuclear safety in Japan

Hidekazu Yoshikawa, HEU

HEU-TAMU Summer School on Nuclear
Reactor System Engineering

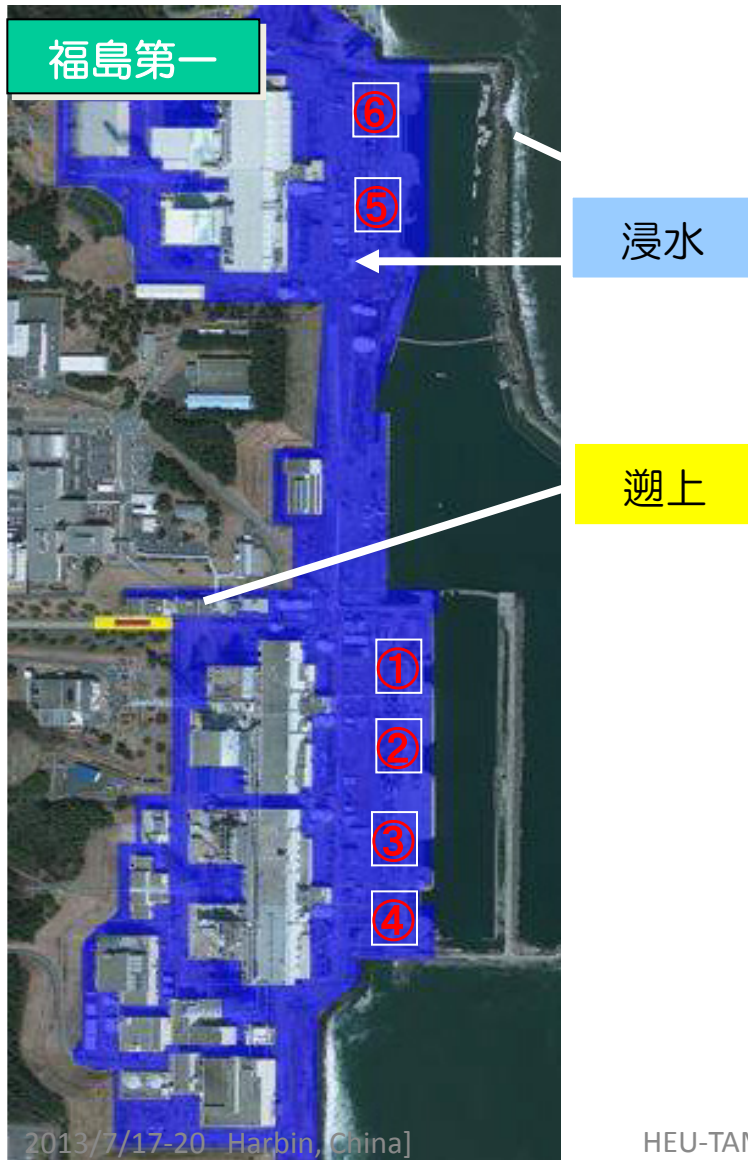
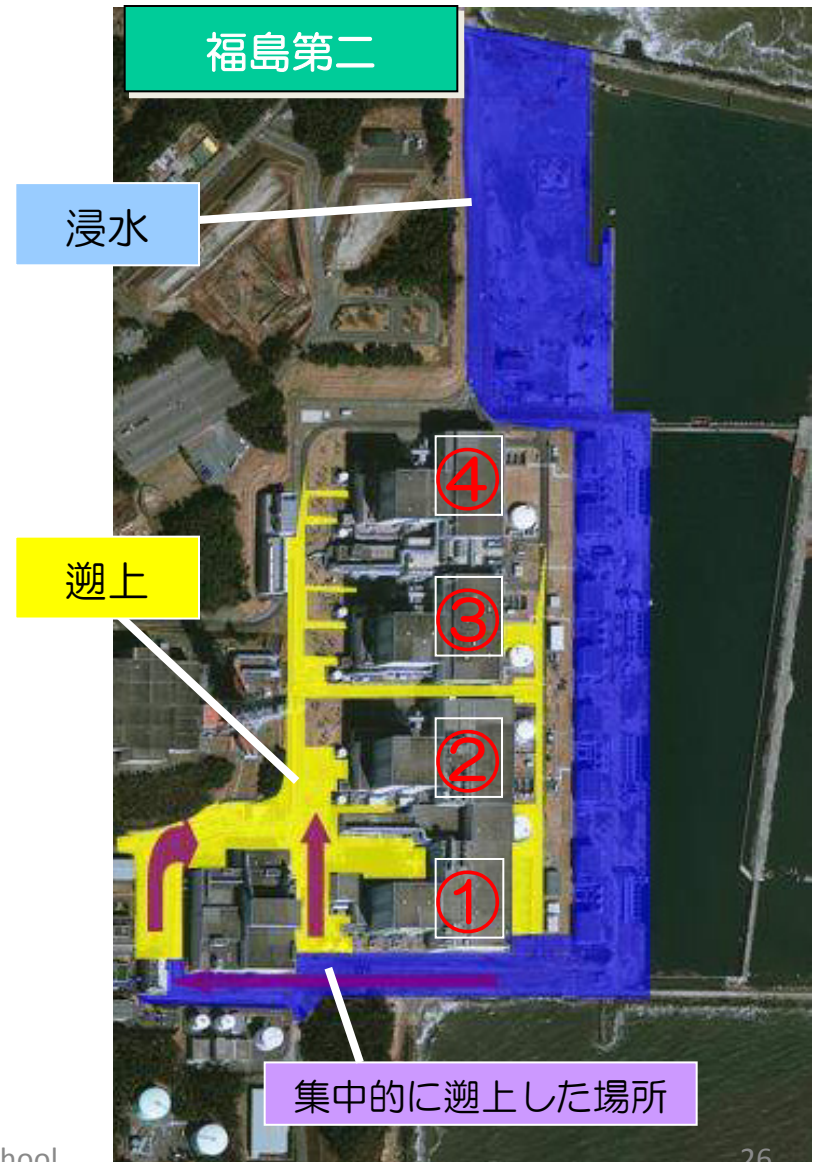
Fukushima Daiichi NPS

- About one hour after the earthquake, big tsunami arrived the plant site.
- At Fukushima Daiichi NPS, the tsunami run-up reached the ground level of major buildings (O.P.+10 m on Units 1 to 4, while O.P.+13 m on the Units 5 & 6.
- The flooded areas covered the entire area of major building.
- The flood height on Units 1 to 4 was approximately O.P. +11.5 m to 15.5 m, and flood depth approximately 1.5 to 5.5 m.
- On the side of Units 5 and 6, the flood height was approximately O.P. +13 m to +14.5 m, and flood depth approximately 1.5 m or less.

Submergence of Fukushima NPPs by tsunami

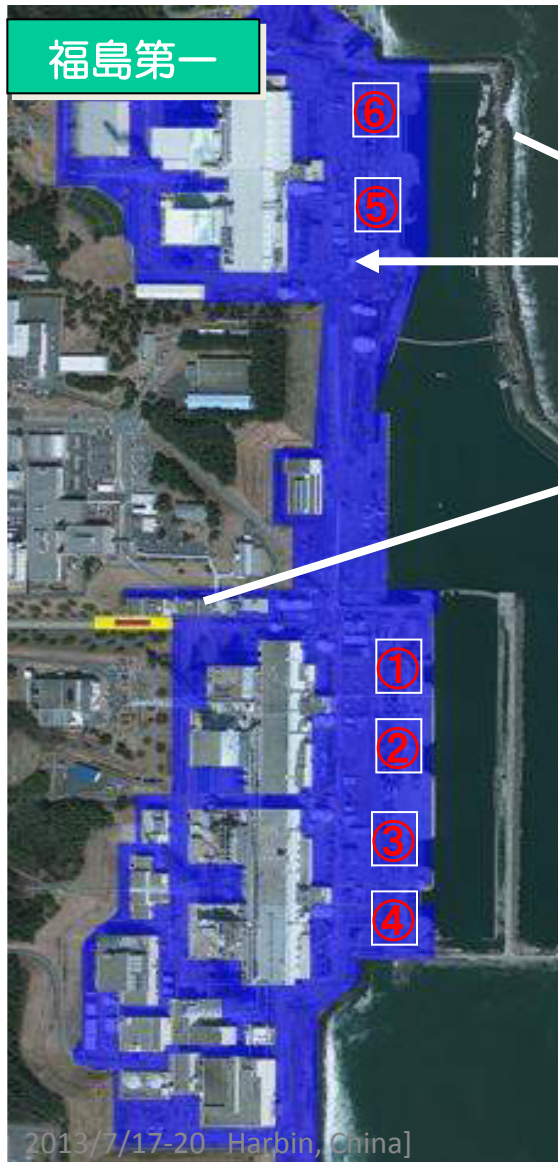
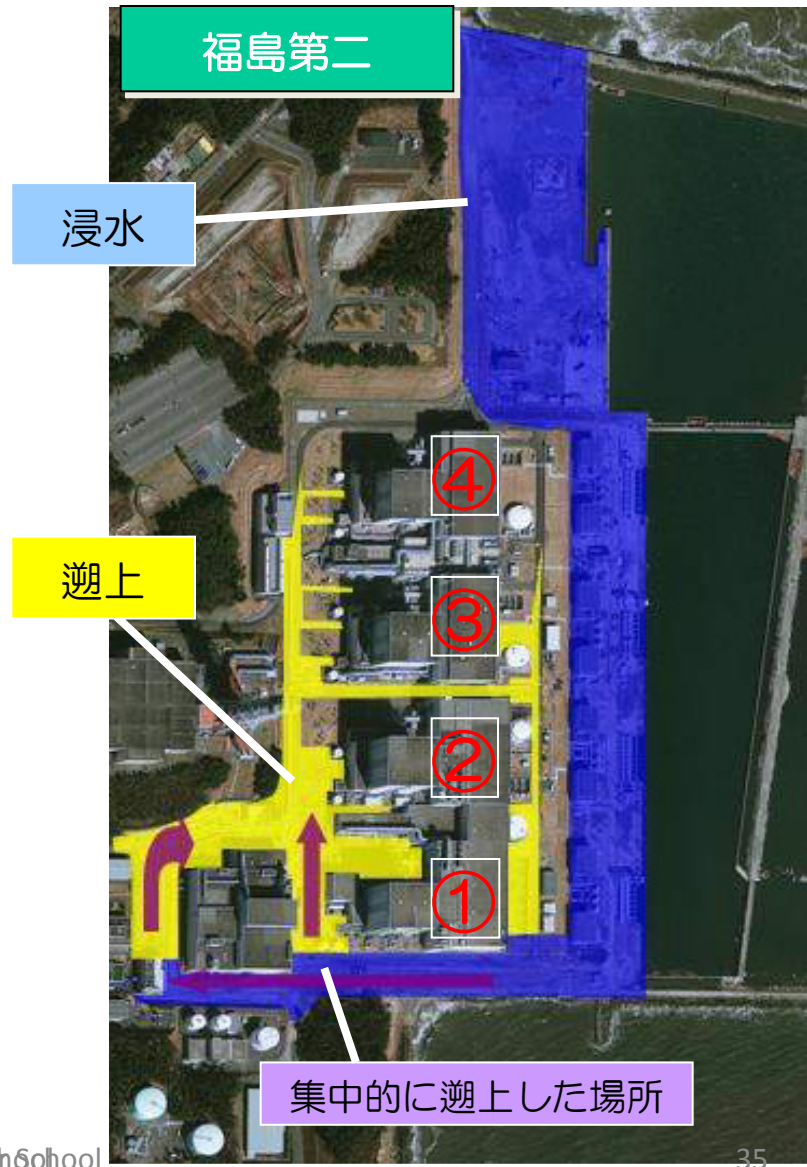
Fukushima Daini NPS

- At Fukushima Daini NPS, although the entire seaside area of O.P. +4 m was flooded (flood height approximately O.P. +7 m), there were no watermarks of the tsunami run-up breaching the slope to the O.P. +12 m major buildings area.
- Since the damage was less than that of Fukushima Daiichi NPS, the accident response were entirely different

Submergence of Fukushima NPPs by tsunami

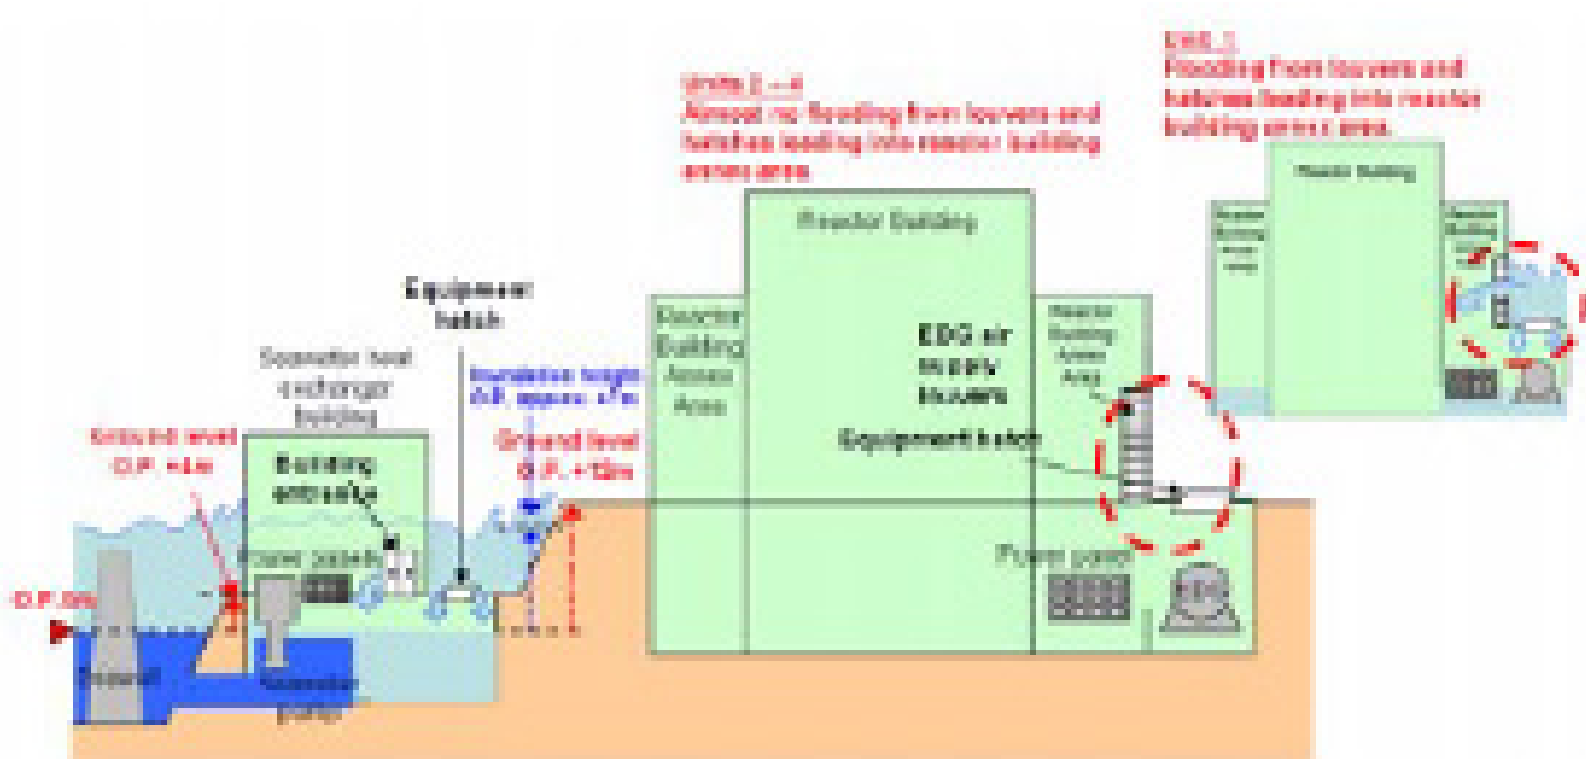
Path of inundation into major buildings (Fukushima Daini NPS).

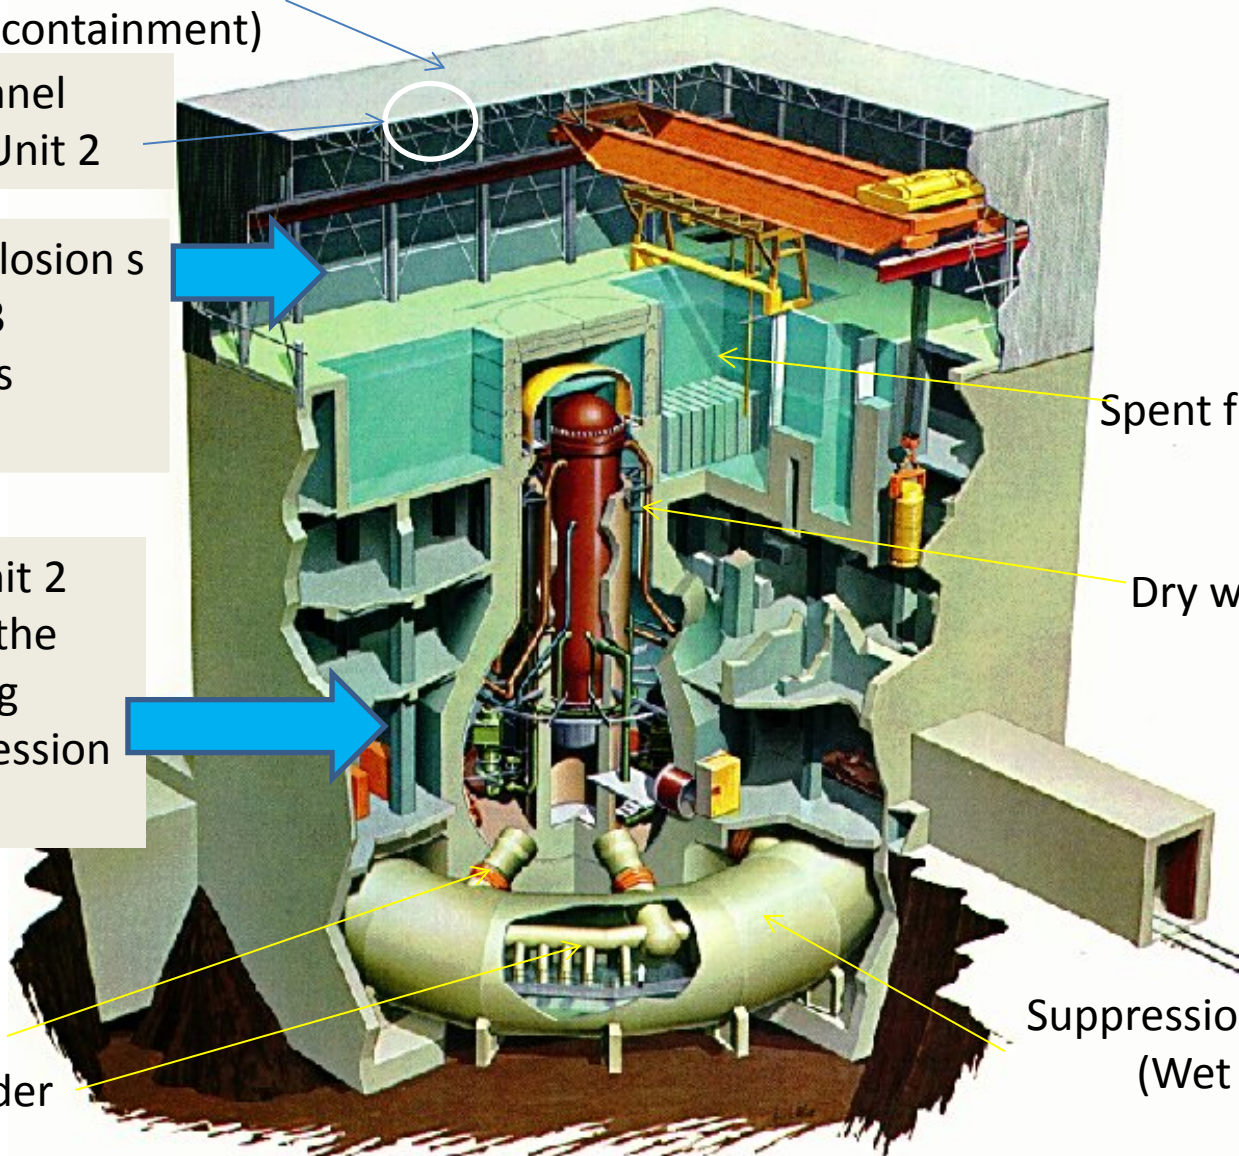
Blow-out panel
Opened in Unit 2

Location of explosions
In Units 1 and 3
Location of fires
In Unit 4

Explosion of Unit 2
Somewhere in the
Reactor building
near the suppression
Chamber?

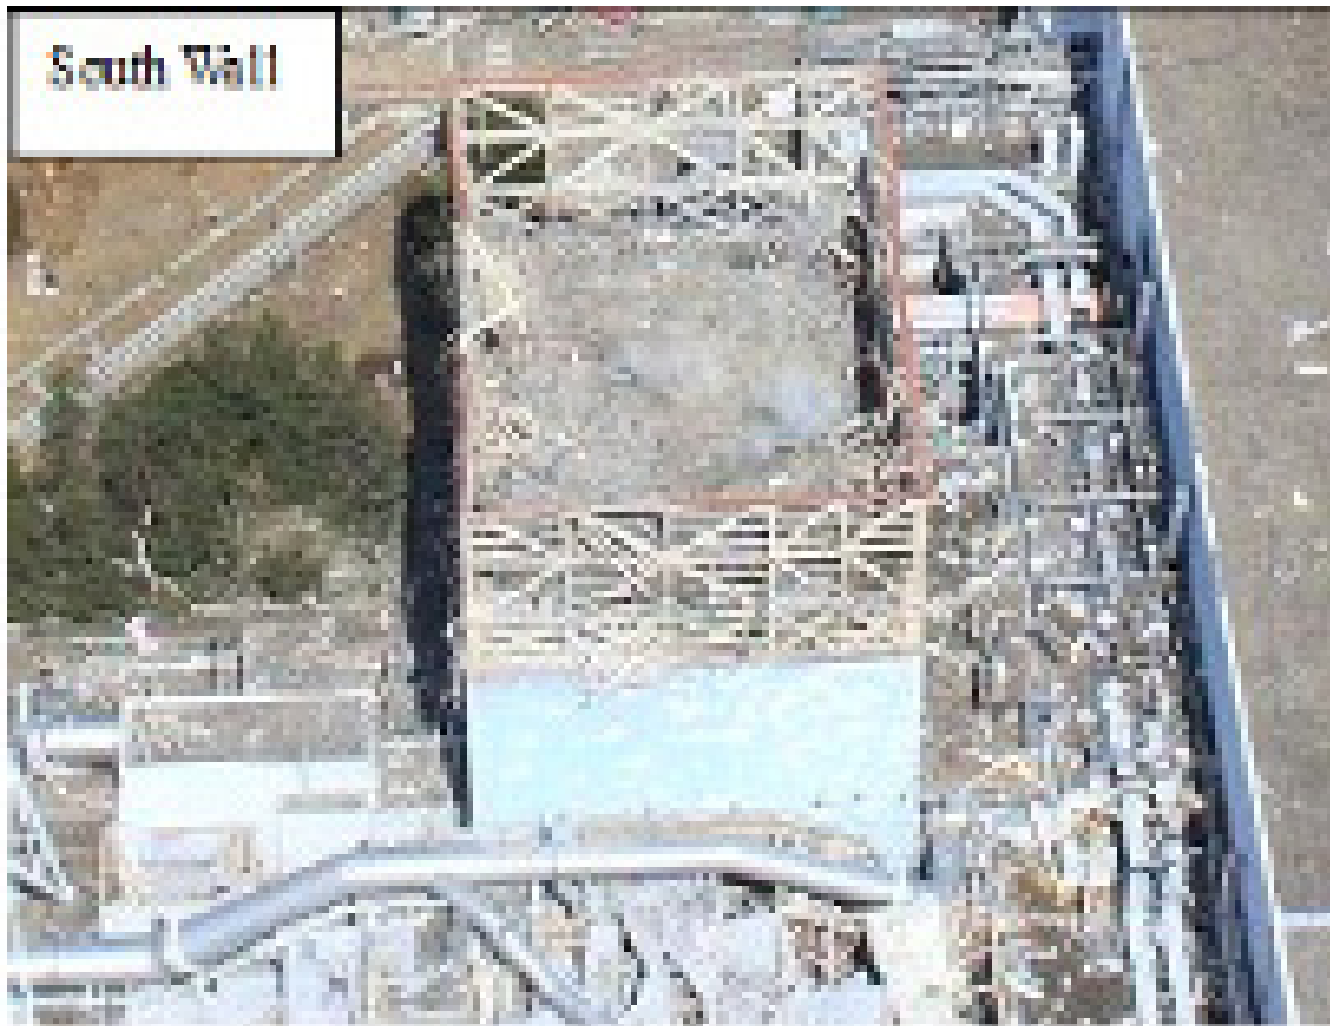
Appearance of Unit 1 R/B after explosion.

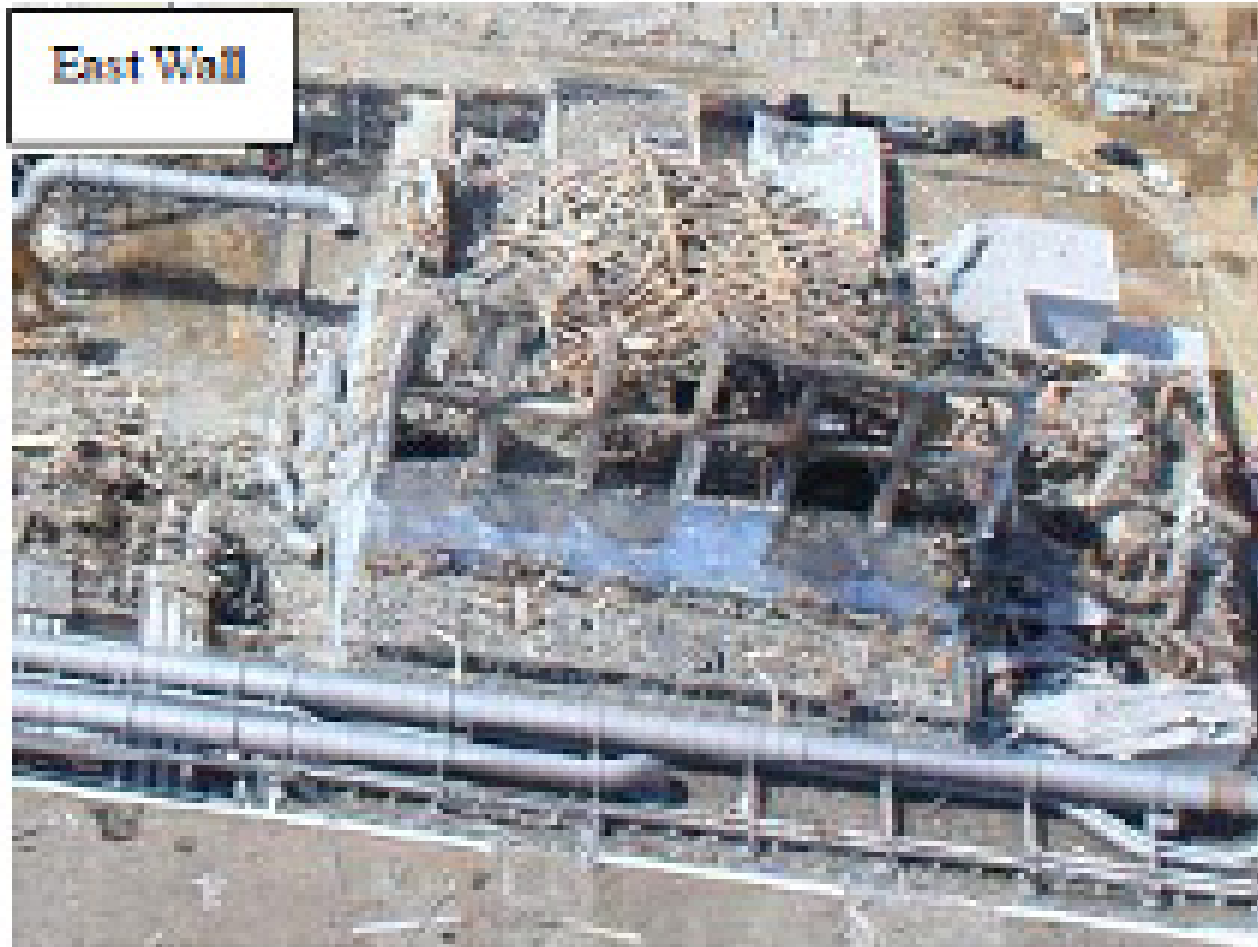
Appearance of Unit 3 R/B after explosion.

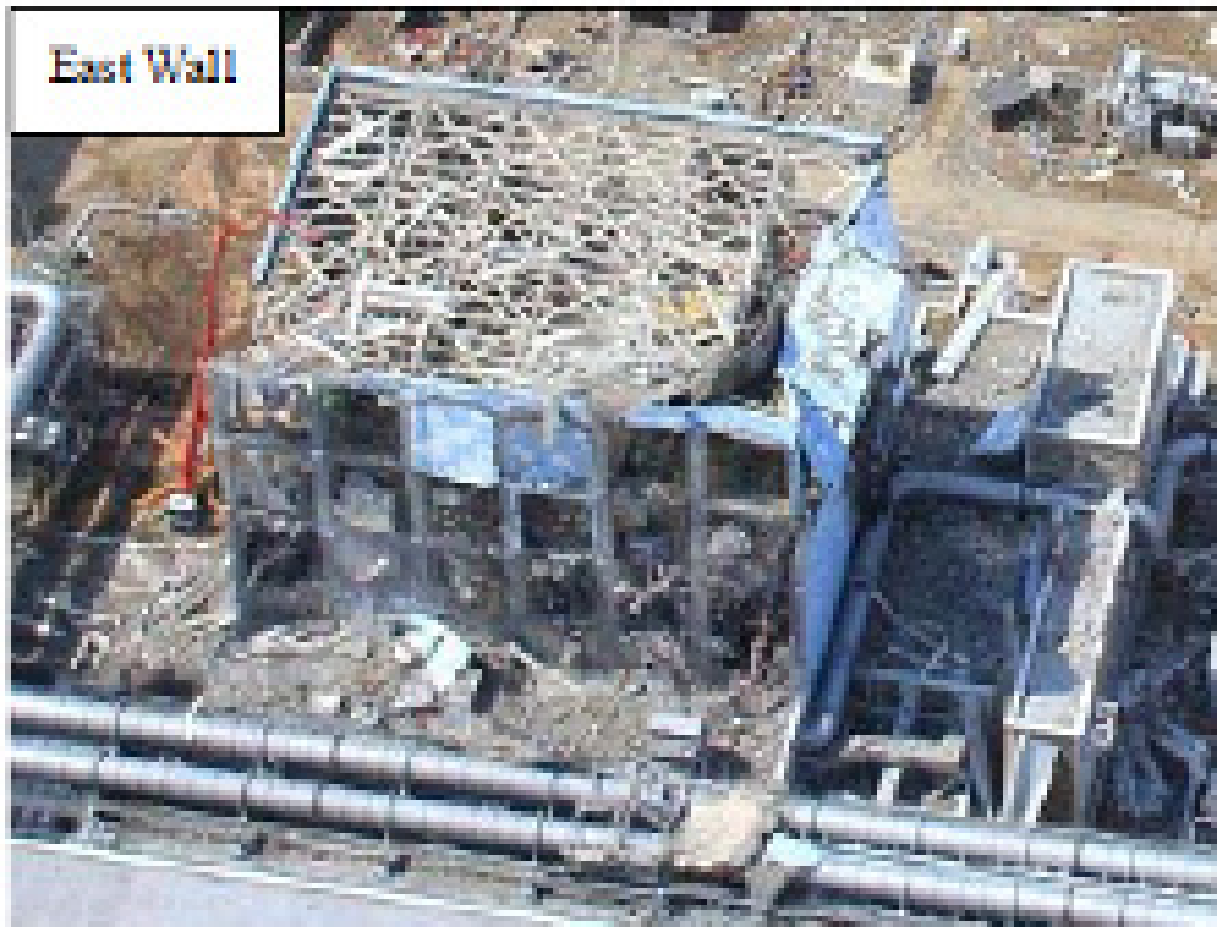
Appearance of Unit 4 R/B after explosion.

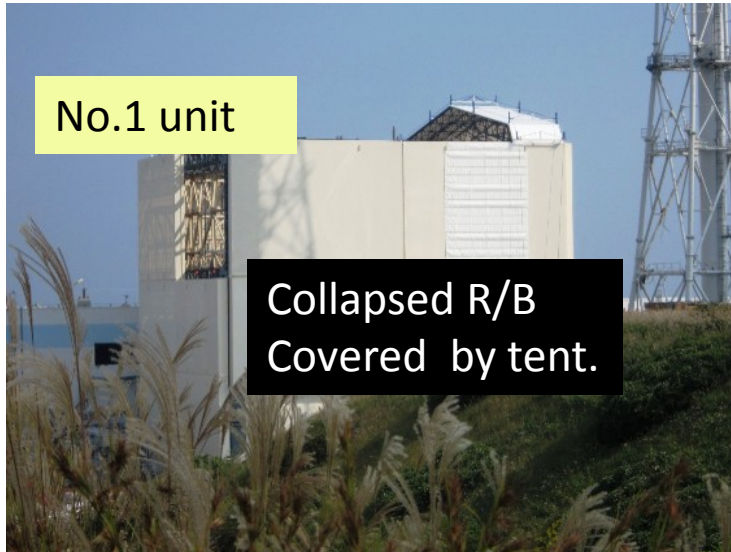
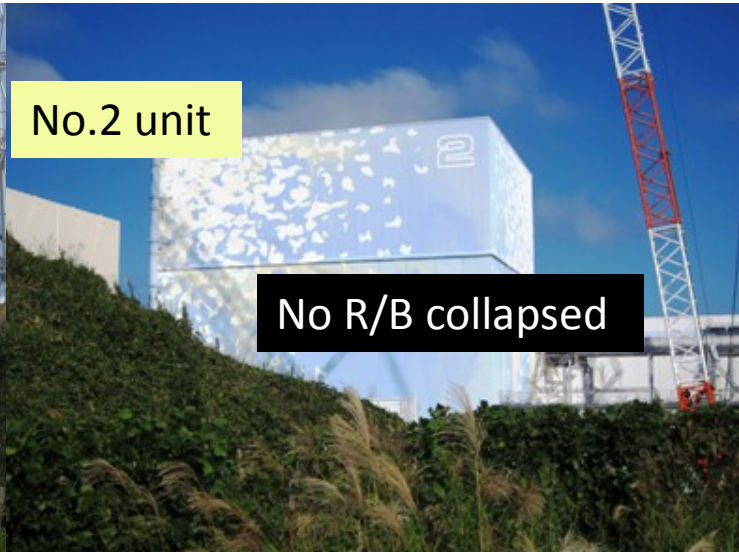
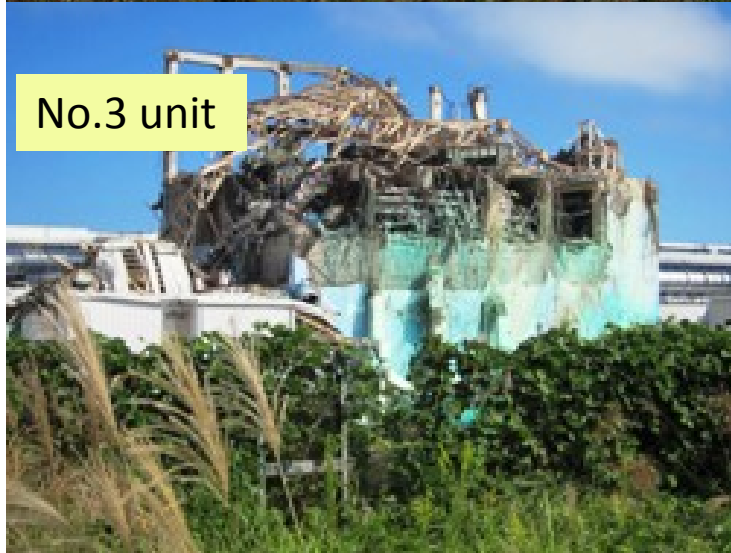
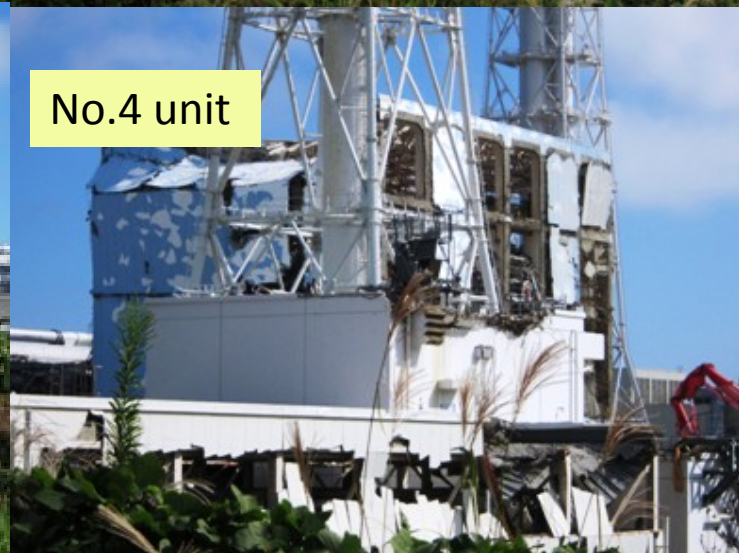
Appearance of damaged units of Fukushima Daiichi NPS (Around October 2011)

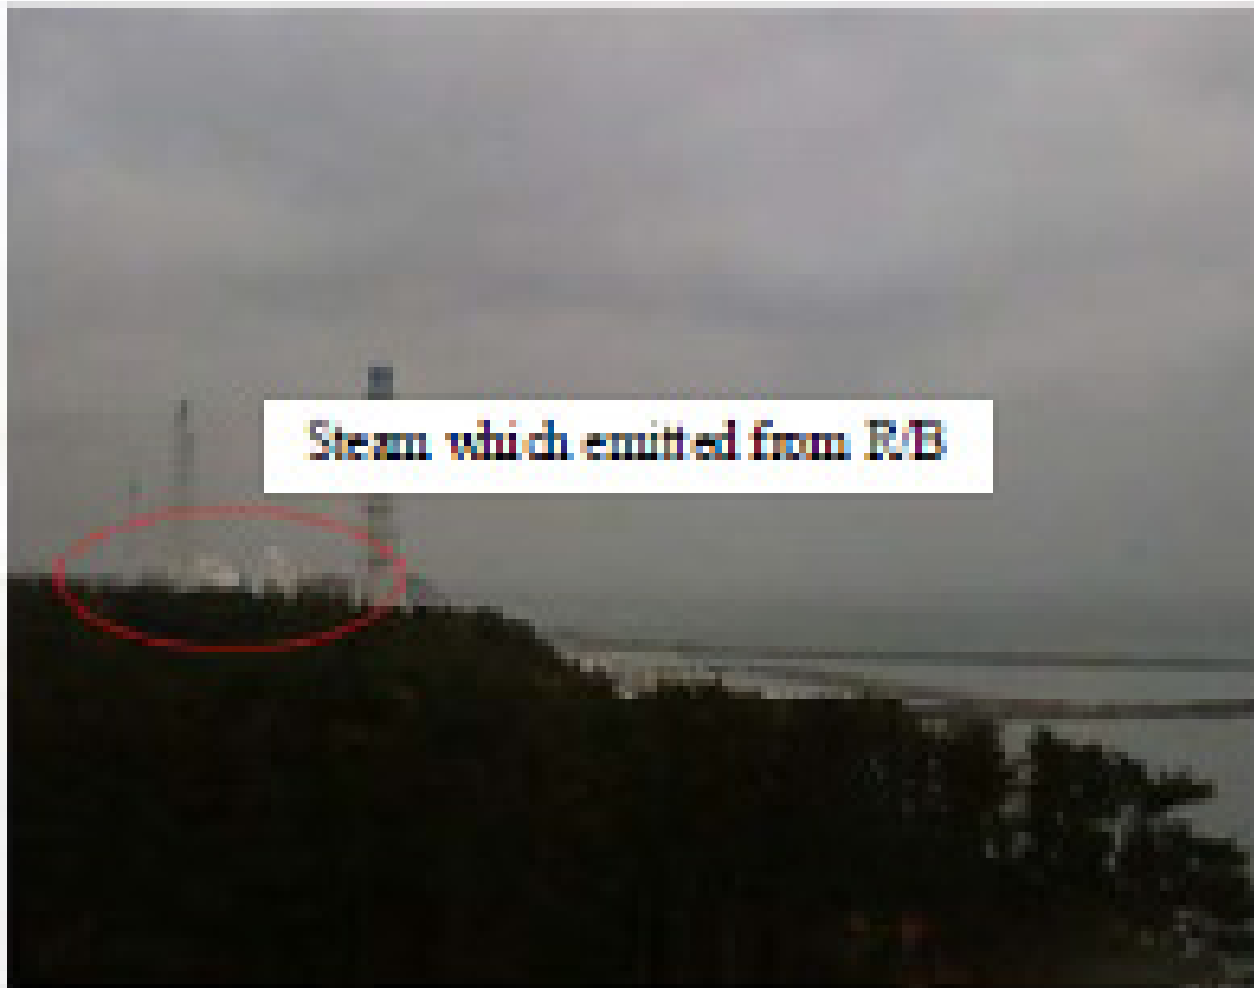
- Since Unit 2 PCV pressure decreased substantially between 07:00 and 11:00 on the same day , and white smoke was seen coming from Unit 2 R/B (the next figure)
- It is highly likely that Unit 2 was the source of the release.

Fukuichi live camera (around 19:00 on March 15).
