# Lessons learned from the Fukushima Daiichi Nuclear Power Plant Accident

NARABAYASHI Tadashi<sup>1</sup>

1. Division of Energy and Environmental Systems, Hokkaido University  
Kita 13, Nishi 8, Kita-ku, Sapporo 060-8628, Japan. (E-mail: [tnaraba@eng.hokudai.ac.jp](mailto:tnaraba@eng.hokudai.ac.jp))

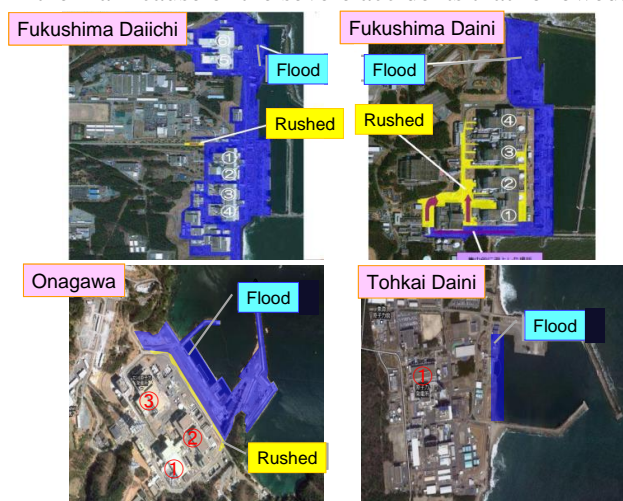
The Fukushima Daiichi NPP was hit by a tsunami caused by the Tohoku-Pacific Ocean Earthquake, resulting in nuclear accidents in Units No.1 to No.4. As shown in Fig. 1, although the other NPPs such as Fukushima Daini, Onagawa and Tokai Daini were also

hit by the tsunami, they all were able to terminate operation and safely, until cool down condition. The Fukushima Daini NPP succeeded in shutdown safely even though Unit No.1 was affected by water flooding through hatches and an emergency Diesel generator (EDG) air intake. The AC power was restored by changing the power cable and the seawater pump motors were replaced by bringing in new motors from the Toshiba Mie Works and Kashiwazaki-Kariwa NPP by helicopter. In the case of the Fukushima Daiichi NPP, Unit No.5 was brought under control by using EDG power from Unit No.6.

Fig. 1 Comparison of flooded area for each NPP<sup>[2]</sup>.

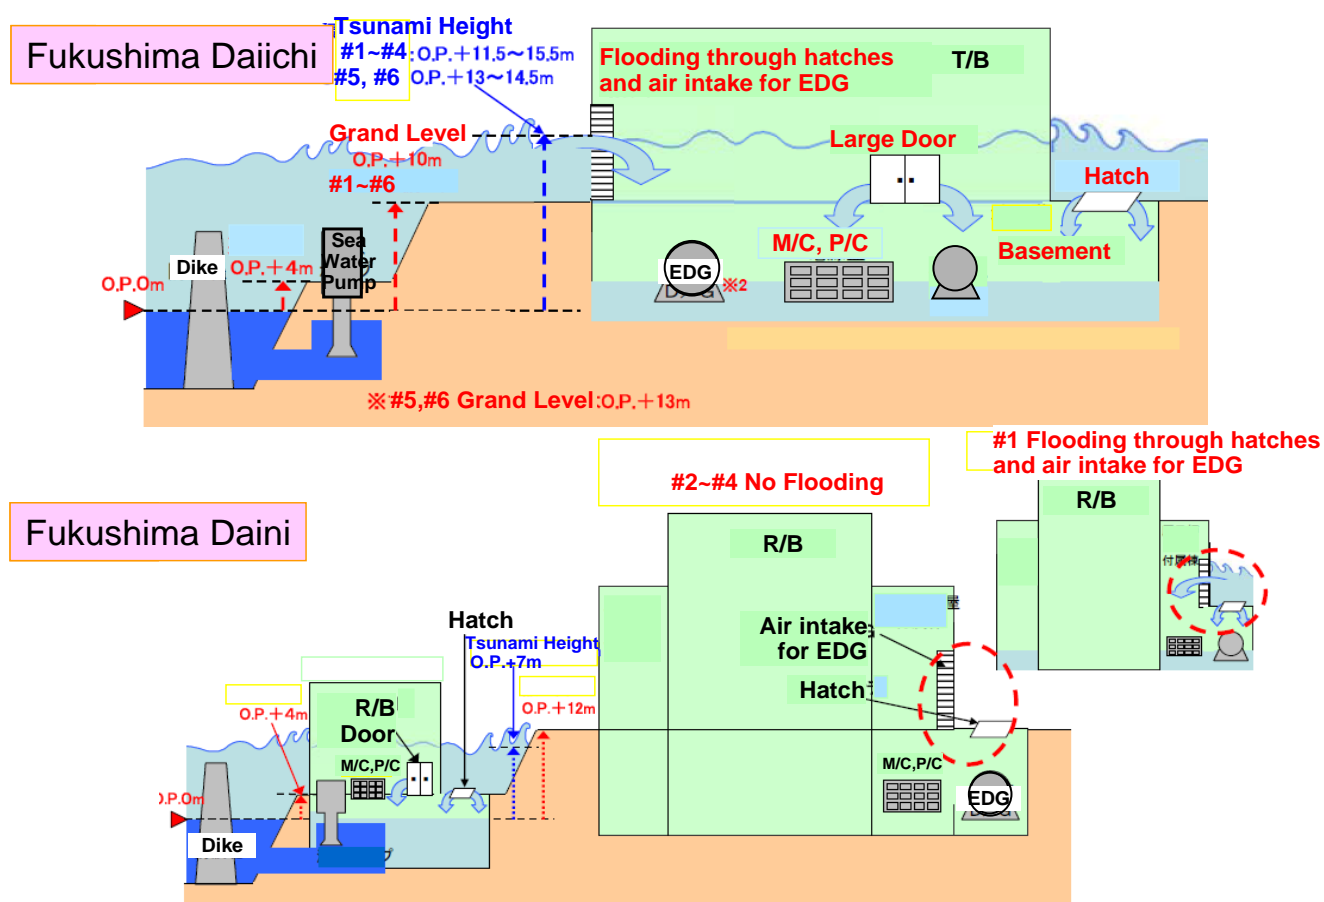
Figure 2 shows a comparison of the flood damage to emergency diesel generators (EDGs). However, for Units No.1 to No.4, there was a complete loss of both AC power by the EDGs and DC power, and this was the main cause of the severe accidents that followed.

Fig. 2 Comparison of flood damage to emergency diesel generators for Fukushima Daiichi and Daini NPPs <sup>[2]</sup>.

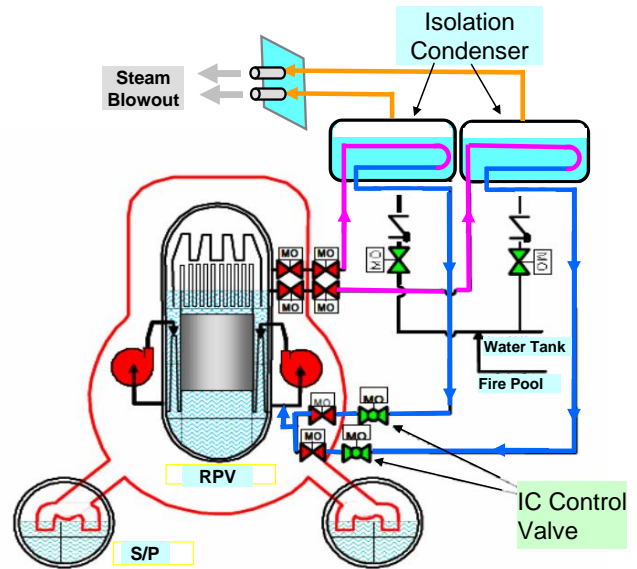
In the case of Unit No.1, DC battery power was lost in the main control room. This caused the motor operated (MO) isolation valves to undergo fail-close action, thereby cutting off the isolation condenser (IC), as shown in Fig. 3. It was a fail-dangerous system. If the IC had continued to operate, the situation would have soon been brought under control.

Fig. 3 Isolation condensers in Fukushima Daiichi Unit No.1.

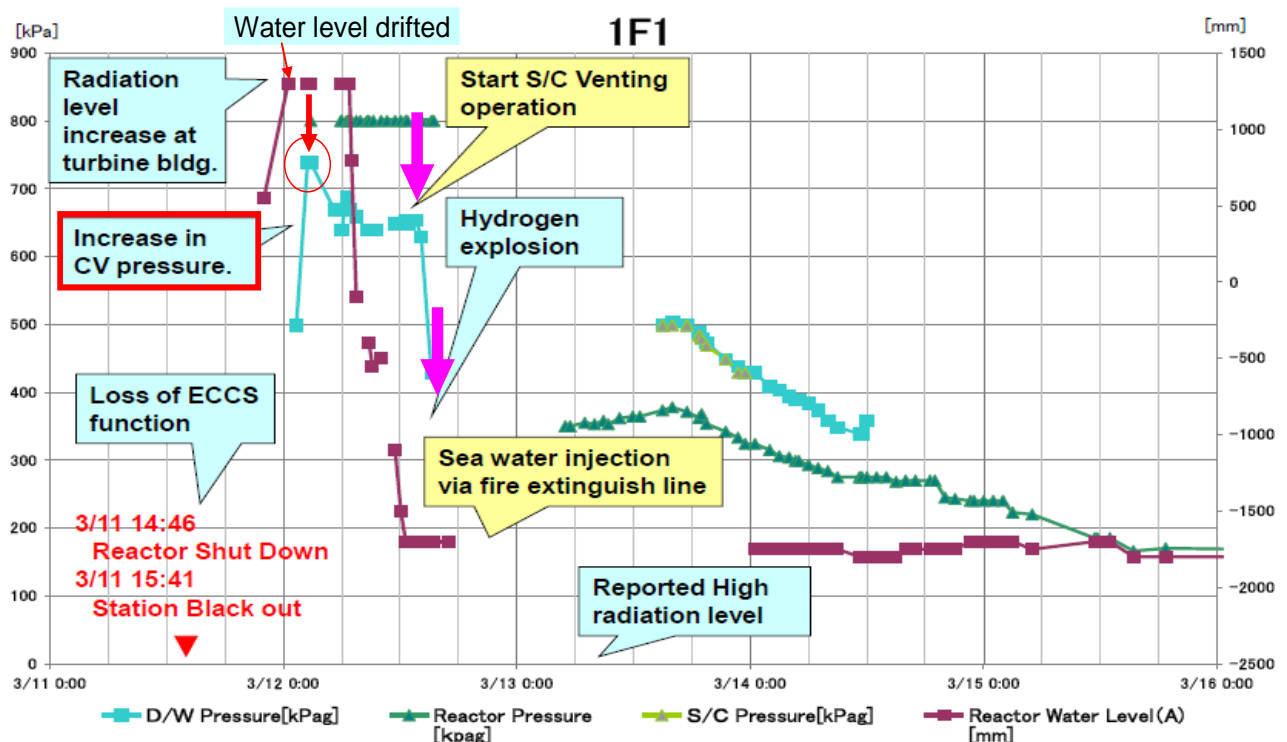
After the loss of both the emergency core cooling system and the IC core cooling, the containment vessel (CV) pressure increased. The water level measurement drifted due to evaporation of water in the reference leg, as shown in Fig. 4. The radiation level increased at a turbine building (T/B). A hydrogen explosion occurred after suppression chamber (S/C) wet venting.

Fig. 4 Measured pressure in RPV and CV of Unit No.1, and water level in RPV [3].

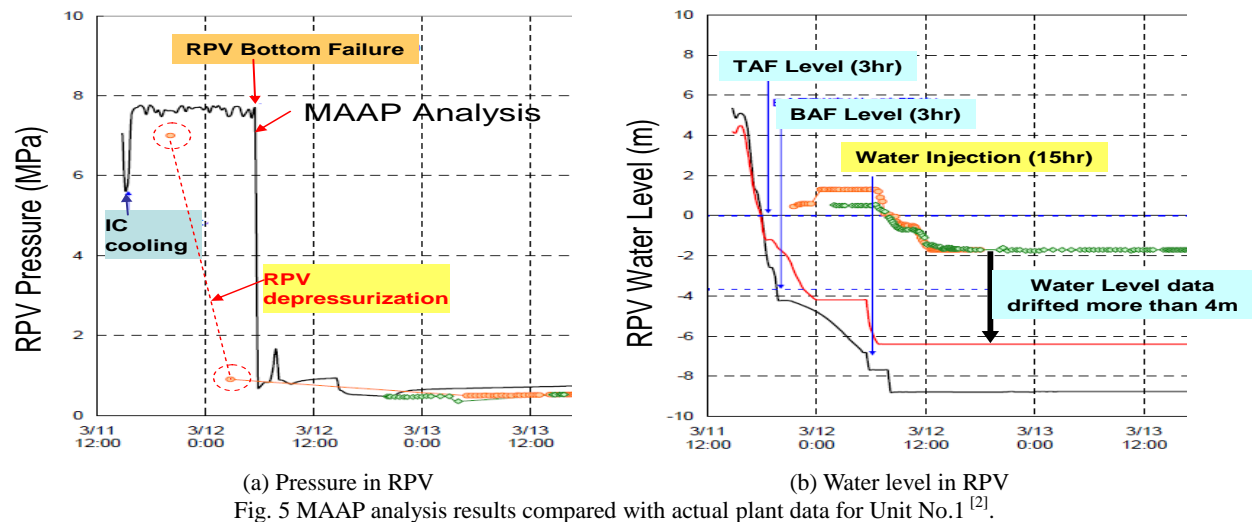
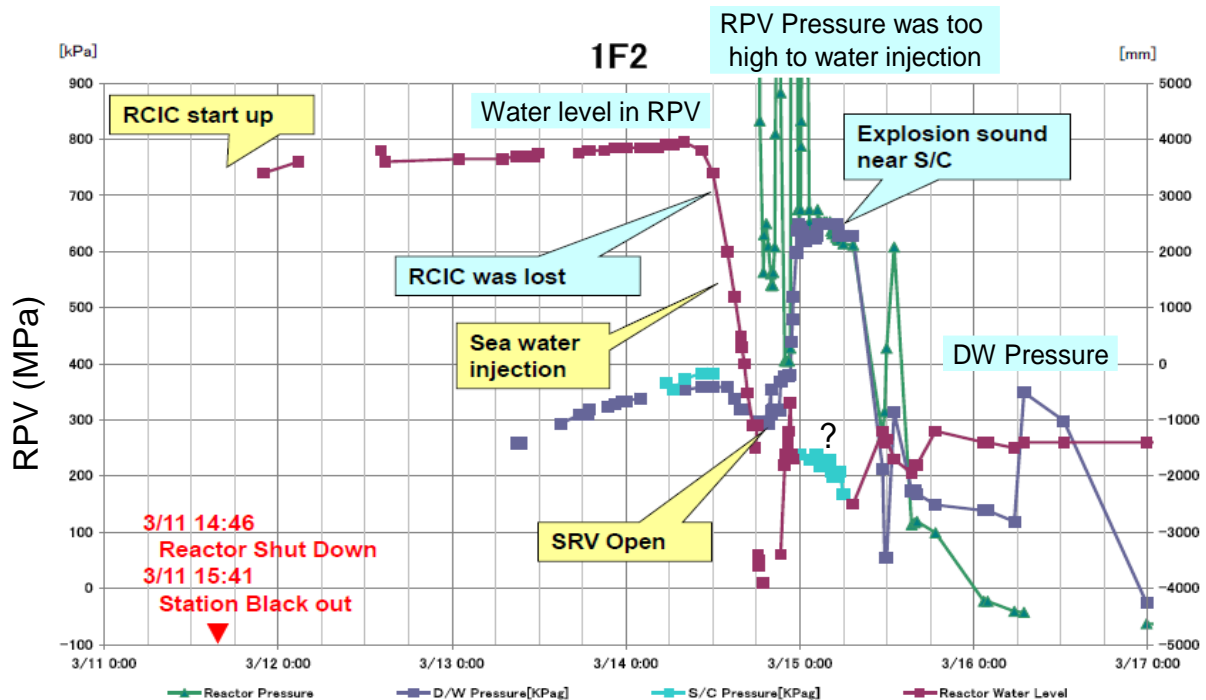
As shown in Fig. 5(a), both the MAAP code analysis results and actual data suggest that depressurization of the RPV started before its bottom failed. This might have been caused by the melting of TIP tubes in the core or control rod drive (CRD) tubes. As shown in Fig. 5(b), the measured water level measurement drifted by more than 4 m due to water loss in the reference leg. This is likely to have been caused by the high-temperature superheated core.

Water should have been supplied to the water level reference leg through the instrumentation piping. Water should have been supplied to the water level reference leg through the instrumentation piping. In the case of Unit No.2, reactor core isolation cooling (RCIC) continued to work for about 3 days. As shown in Fig. 6, after the loss of RCIC water injection, the water level in the RPV soon decreased. The safety relief valve (SRV) was opened and the drywell (DW) pressure increased to 650 kPa.

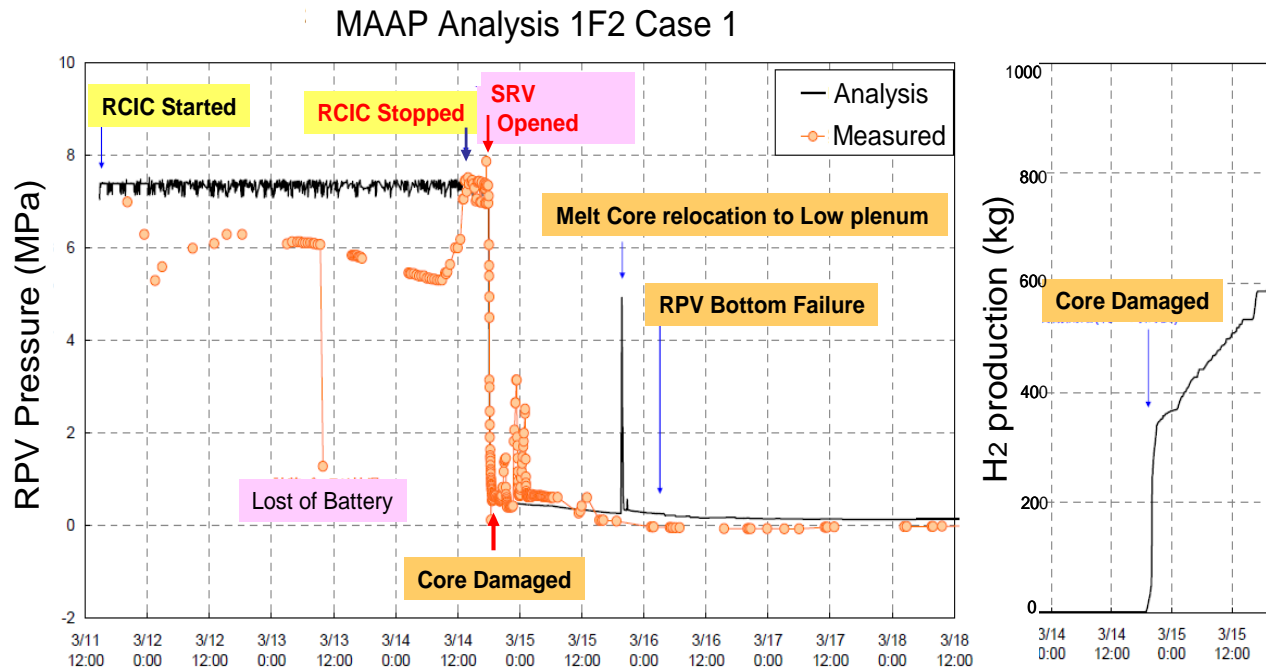
The RPV pressure was too high to allow water injection by using a fire engine pump. This failure to inject water soon after the stop of RCIC in Unit No.2 promptly lead to core damage and the generation of  $H_2$  gas as shown in Fig. 7. A high-pressure discharge pump driven by a diesel engine or motor should have been used for the backup of RCIC trip.

Fig.7 MAAP analysis results compared with actual plant data for Unit No.2 <sup>[2]</sup>.

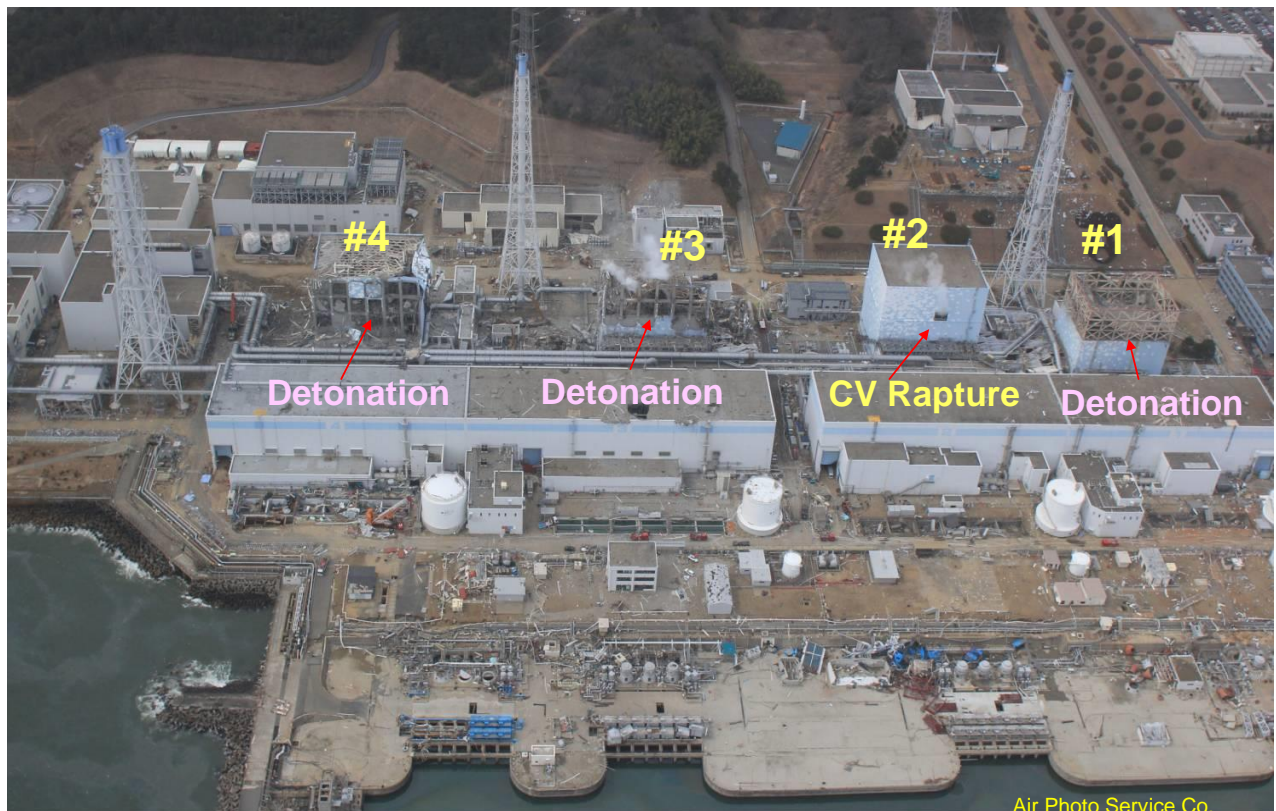
As shown in Fig. 8,  $H_2$  detonations occurred in Unit No.1, No.3 and No.4. When the Unit 1's detonation occurred the blowout panel of Unit No. 2 was opened. The hydrogen in Unit No.2 was released through the opened blowout panel and detonation didn't occurred in Unit 2.

Fig. 8 H<sub>2</sub> detonations occurred after vent operations (Units No.1, No.3 and No.4).

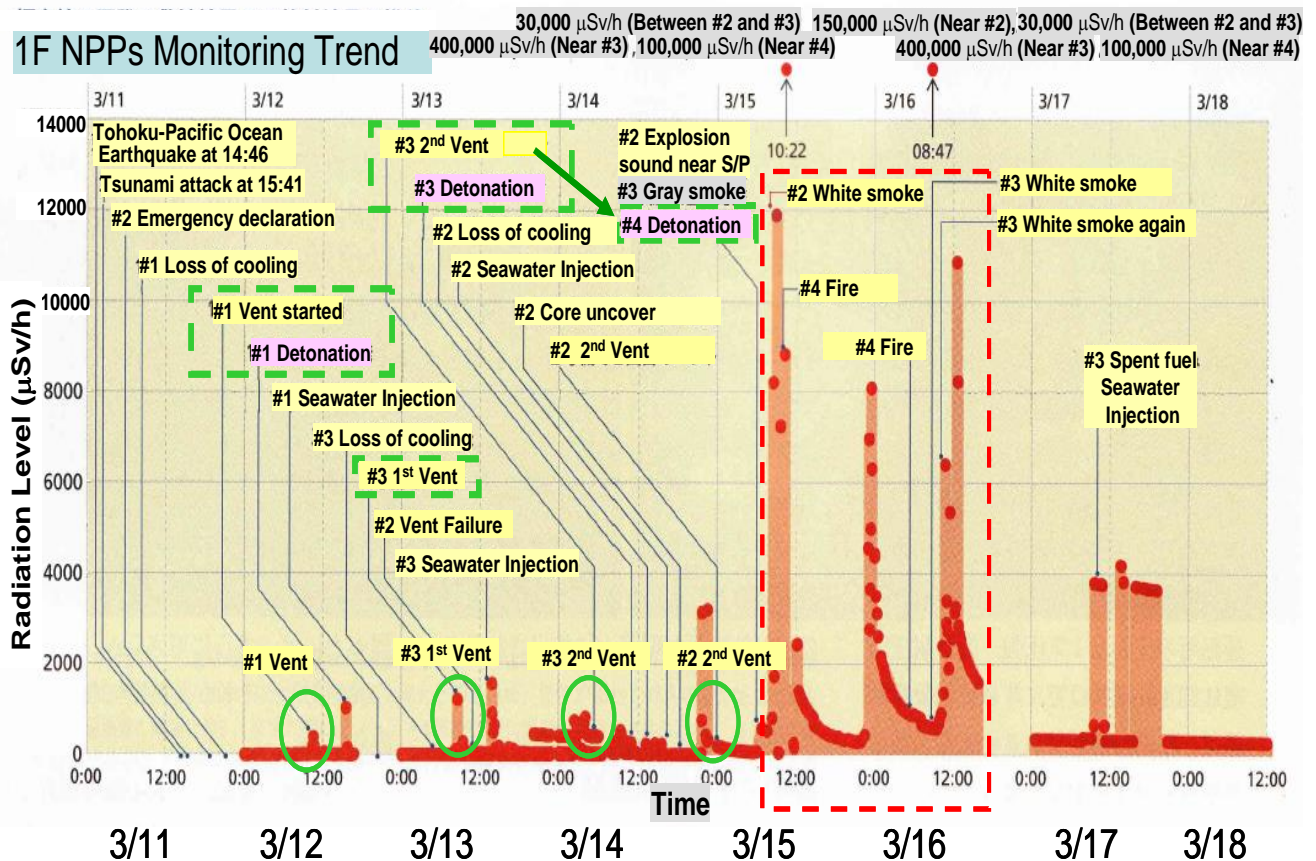
It was reported that an explosion sound was also heard near the S/C of Unit 2. However, examination of the data showed that it was due to a hydrogen detonation in the reactor building (R/B) of Unit No.4. Soon after the detonation, the Unit No.2 DW pressure decreased, as seen in Fig. 6. Figure 9 shows the trend in monitored radiation levels for Fukushima Daiichi Units No.1, No.2, No.3 and No.4, which can be compared with the events as illustrated in Fig. 10.

It seemed that the detonation occurred after venting operations. The radiation level increased soon after the Unit No.2 CV rupture on March 15.

Fig. 9 Monitored radiation levels for Fukushima Daiichi Units No.1, No.2, No.3 and No.4 (Nikkei Science, 2011).

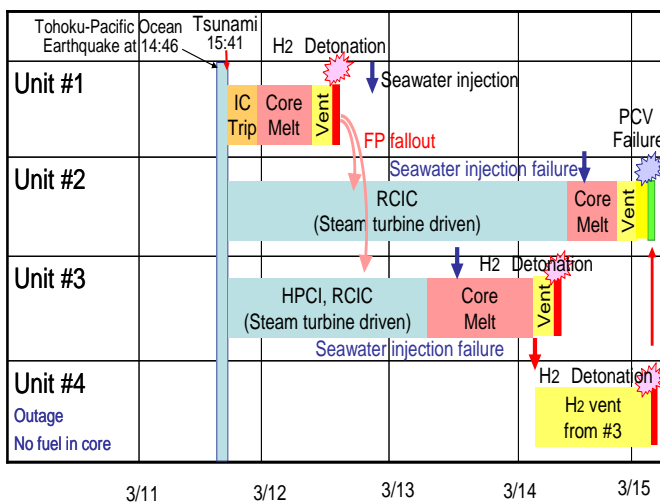
Fig. 10 Chain of major events in Units No.1 to No.4 to bring about severe accidents in the Fukushima Daiichi NPP.

A loss of core cooling occurred due to the IC trip in Unit No.1, and the RCIC steam turbine also tripped due to loss of battery power in Units No.2 and No.3. The suppression pool (S/P) temperature and pressure became so high that water injection actions for accident management took a long time.

This was the reason why the chain of severe accidents occurred in the four units of Fukushima Daiichi NPP, as shown in Fig. 10.

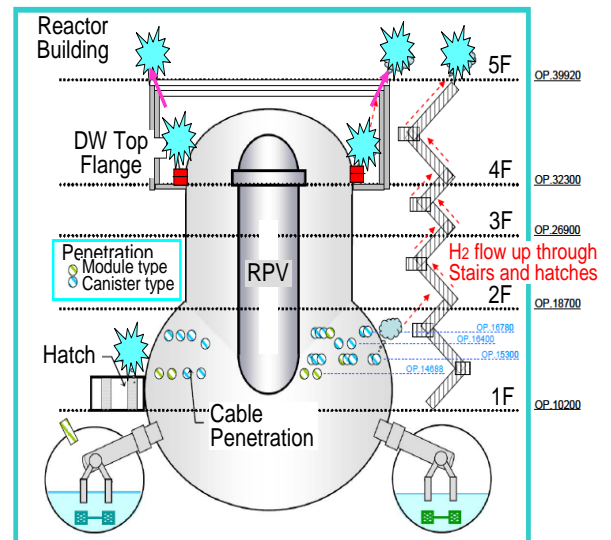
Fig.11 H<sub>2</sub> leak path from drywell in Unit No.1 to No.3.

Figure 11 shows that the CV top flange and hatches might act as leakage pathways. Hydrogen and FP flow upwards by way of stairways and hatches.

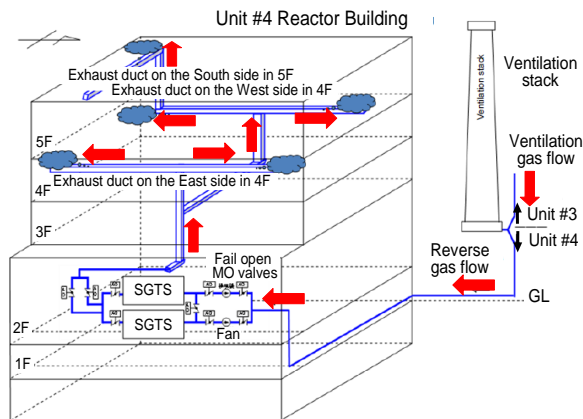
Fig. 12 H<sup>2</sup> gas flow into unit No.4 reactor building from unit No.3.

Although there was no nuclear fuels in the reactor core of Unit No.4, hydrogen flowed from Unit No.3 through the stack line into Unit No.4 and underwent reverse flow through the standby gas treatment system (SGTS) filters, as shown in Fig. 12.

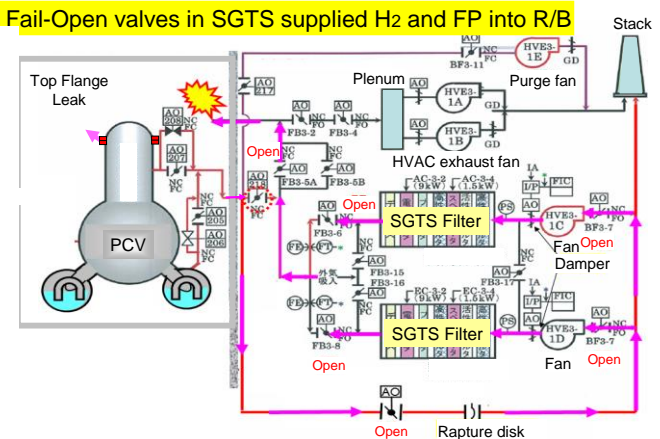
Fig. 14 Flow diagram of SGTS/HVAC and added hard vent system. [2]

The author pointed out to NISA that the added vent line might have acted as a means of hydrogen and fission products (FP) leaked through the SGTS and HVAC lines, as shown in Fig. 14. Because hydrogen and FP might flow back into each room through the exhaust gas ducts. The vent lines of each NPP should have been independent from the SGTS/ HVAC line. The NISA ordered to the licensees to make a new independent vent line for filtered vent system. This is the one of the point of lessons and learn. There were no accident reports about Fukushima-Daiichi which point out the vent system's fault and potential risk.

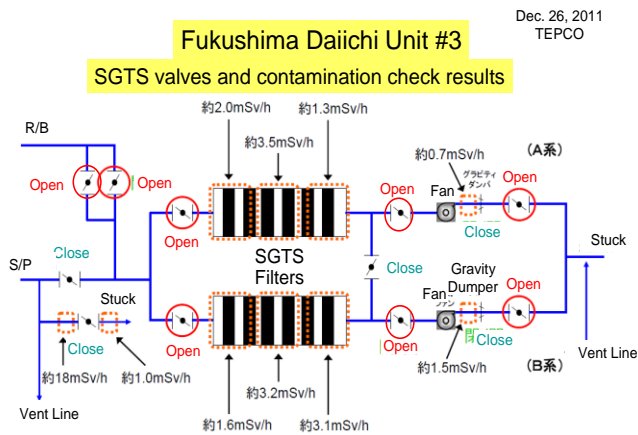
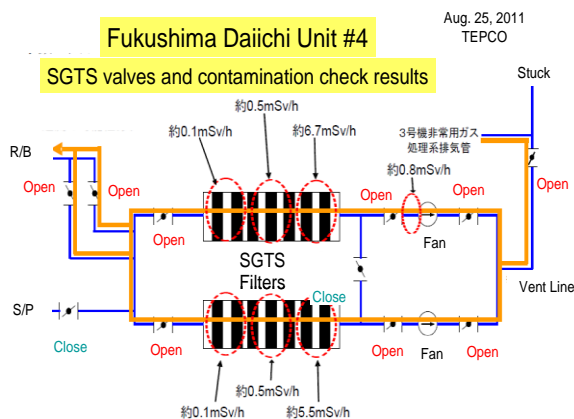
Fig. 13 Results of SGTS valves open/close check and SGTS filter contamination survey [2]

A strong hydrogen detonation occurred in the Unit No.4 reactor building on March 14. As shown in Fig. 13, it was confirmed that the SGTS filters were contaminated and all the MO valves were open due to the fail-open design in Units No.3 and No.4. This might be reason why hydrogen detonation in Unit 4, where these were no nuclear fuels in reactor core.
