Dry core degradation scenario and wet one in Fukushima Daiichi NPS core melt accident

TANABE Fumiya¹

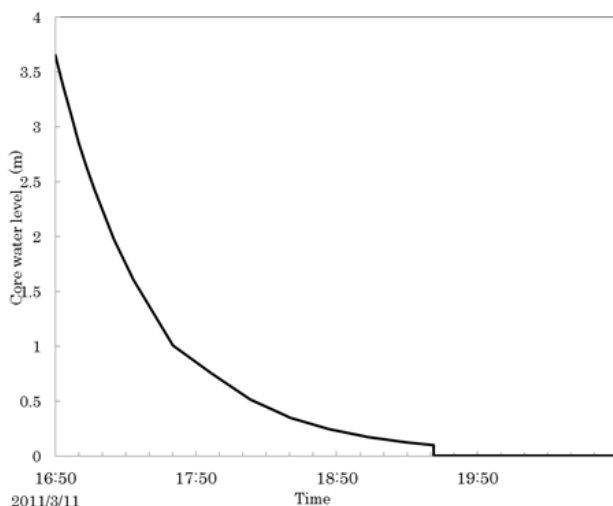
Fig.1 Core water level in the Unit 1 reactor calculated by the simple model.

It is assumed for simplicity in the calculation that all of the exposed core material moves down together and interact with water at the termination of UO_2 melting (19:31). Then the water level is calculated to drop abruptly to zero at this time (Fig.1) and accumulated hydrogen mass is calculated to jump up to 453.5 kg at this time because all residual water in the core is assumed to react with high temperature zirconium relocating. It is expected in the actual course of the accident, on the contrary, that each

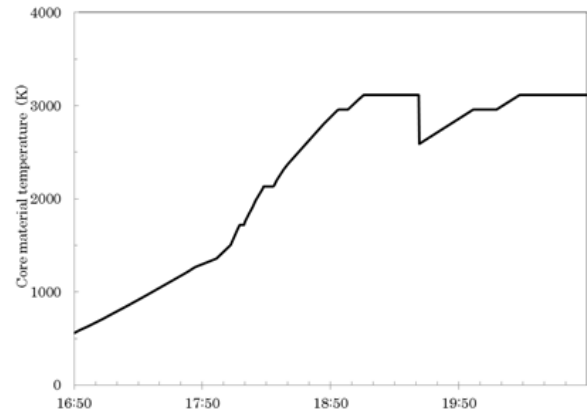
At 17:42 the average temperature of the exposed core material reaches 1200 K at which fuel rod cladding is expected to be ruptured due to inner pressure.

At 18:03 the temperature reaches 1500 K, when runaway zirconium-steam reaction starts on fuel rod cladding and channel box wall (fuel rod assembly canister), and it generates much heat and hydrogen.

Fig.2 Exposed core material temperature in the Unit 1 reactor calculated by the simple model.

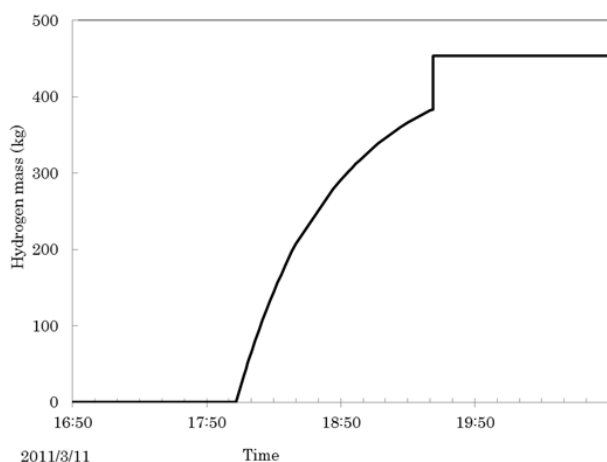
metal and ceramic would have moved down on melting and froze with vaporizing water in the lower core. Therefore, the actual water level should have decrease faster than one in Fig.1 after Fe melting, and the actual accumulated hydrogen mass would have increased faster than the curve in Fig.3 with the same final value.

Fig.3 Accumulated hydrogen mass in the Unit 1 reactor calculated by the simple model.

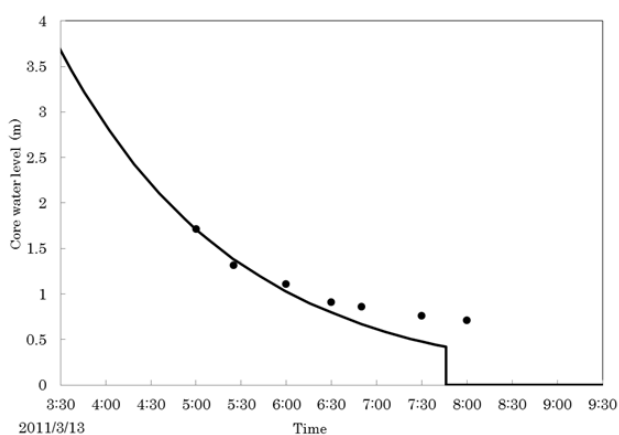
Fig.4 Core water level calculated in the Unit 3 reactor calculated by the simple model.

It is assumed for simplicity in the calculation that all of the exposed core material moves down together and interact with water at the termination of UO_2 melting (7:46). Then the water level is calculated to drop abruptly to zero at this time (Fig.4) and accumulated hydrogen mass is calculated to jump up to 1210 kg at this time because all residual water in the core is assumed to react with high temperature zirconium relocating. It is expected in the actual course of the accident, on the contrary, that each metal and ceramic would have moved down on melting and froze with vaporizing water in the lower core. Therefore, the actual water level should have decrease faster than one in Fig.4 after Fe melting, and the actual accumulated hydrogen mass increase faster than the curve in Fig.6 with the same final value.

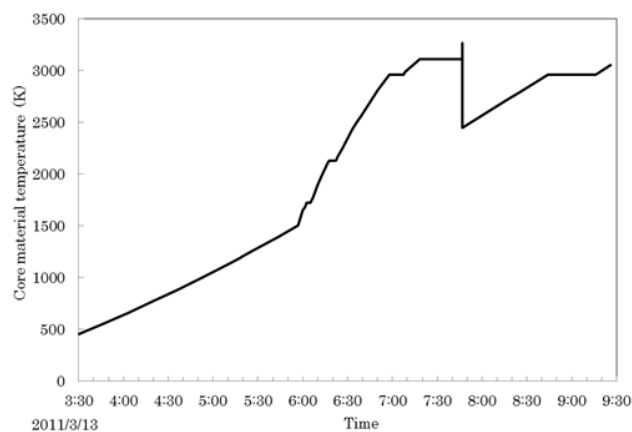
The calculated result of the average temperature of the exposed core material is shown in Figure 5. At 5:18 the average temperature of the exposed core

Fig.5 Exposed core material temperature in the Unit 3 reactor calculated by the simple model.

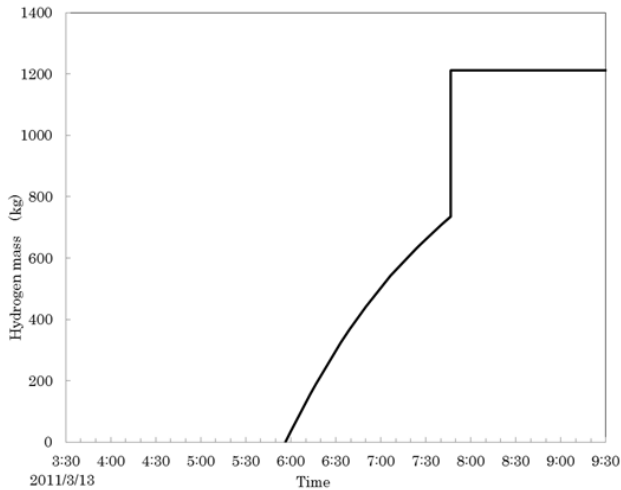
Fig.6 Accumulated hydrogen mass in the Unit 3 reactor calculated by the simple model.

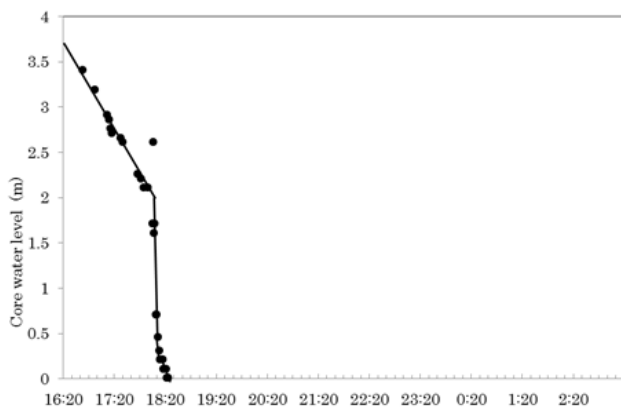
From the measurement the top of the active core was estimated to begin exposed to steam at 16:20 on 2011/03/14 and the core water level decreases gradually as shown in Fig.7. And then the bottom of the core was estimated to get completely dry out at 18.22 due to depressurization flashing. The estimated water level is well below the bottom of the core plate (namely in the lower plenum). The water level was assumed below the core plate hereafter because it was highly probable that the sea water injected using the fire pump on fire engine had not reached the reactor vessel due to high reactor pressure even after initiation of the injection at 19:54.

Fig.7 Core water level in the Unit 2 reactor interpolated with the measured values.

The core water level is shown in Figure 7, which is interpolation of the measured value.

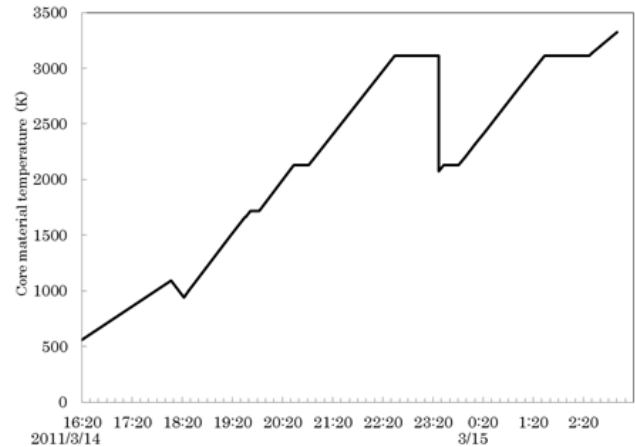
The calculated result of the average temperature of the exposed core material is shown in Figure 8. At 18:48 the average temperature of the exposed core material reaches 1200 K at which fuel rod cladding is expected to be ruptured due to inner pressure.

Fig.8 Exposed core material temperature in the Unit 2 reactor calculated by the simple model.

At 19:18 the temperature reaches 1500 K, when, if the water level was above the bottom of the active core, runaway zirconium-steam reaction should have started on fuel rod cladding and channel box wall (fuel rod assembly canister), and it should have generated much heat and hydrogen. Namely the completely dry core condition leads to no zirconium reaction because of absolute steam starvation.

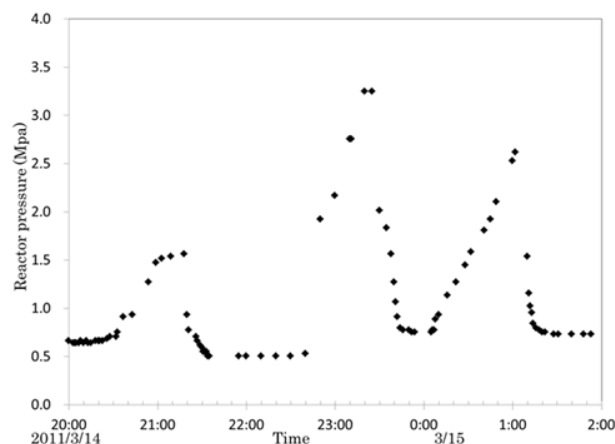
Hereafter, the metal liquid (Zr-Fe-B₄C) would have continuously drained into the lower plenum and interacting with water there to generate steam. The first distinguished but gradual pressure increase from 20:30 on March 14 in the observed reactor pressure as shown Fig.10 can be interpreted as due to this gradual relocation of the mixture metal liquid into the lower plenum.

metallic melt (Zr-U), ceramic (UO₂) melt and ceramic solid (UO₂) accumulate on the core plate. The core plate is heated by the molten mixture and stressed by the weight of the material, and finally abruptly gets failed. Then large amount of the very high temperature core material, most of which is fuel, would have fallen suddenly into the lower plenum. Then it interacts with water there and generates large amount of steam to result in abrupt reactor pressure increase. The second distinguished pressure peak increasing abruptly around 22:40 on March 14 in the observed reactor pressure (Fig.10) can be interpreted as due to this abrupt relocation of the fuel material (UO₂). In the pressure increase, the recorded value is 0.428MPa (gage) at 22:40 and 1.823MPa at 22:50. Therefore the pressure should have increased in a shorter time, probably within several minutes, which resembles to the pressure spikes in the Unit-3 and the TMI-2.

Fig.10 Measured reactor pressure in the Unit 2.
