# Evaluation of plant behavior during the accident at Fukushima Daiichi Nuclear Power Station

MIYATA Koichi<sup>1</sup>, and NISHINO Shoichiro<sup>2</sup>

1. Tokyo Electric Power Company, Chiyoda, Tokyo, 100-8560 Japan (Miyata.Koichi@tepcoco.jp)

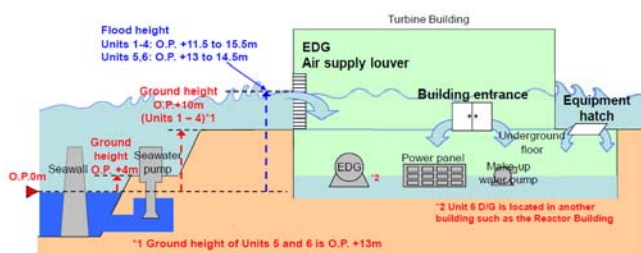
It was confirmed that flooding by the tsunami induced damage to building entranceways, EDG intake louvers and aboveground equipment hatches. Sea water also entered the EDG room and power panel room located on the underground floor. Since the tsunami was far higher than the ground level of the emergency seawater system pumps (O.P. +4 m), the tsunami caused these pumps (installed outdoors) to be submerged, resulting in loss of safety system function (Fig.2).

Fig.2 Path of inundation into major buildings (Fukushima Daiichi NPS).

Subsequently many power panels were inundated and all EDGs in operation were shut down except for Unit 6. This caused the loss of all AC power (station black out (SBO)) and resulted in the loss of all cooling functions using AC power. Furthermore, due to flooding of the cooling system seawater pumps, the heat removal function of transferring decay heat from the reactor to seawater was lost. In addition, Units 1 and 2 lost DC power concurrently with the tsunami’s impact. On the other hand, DC power at Unit 3 withstood the tsunami and the core cooling systems were able to deliver water to the reactor core, but subsequently these core cooling systems stopped - mostly due to the depletion of DC power.

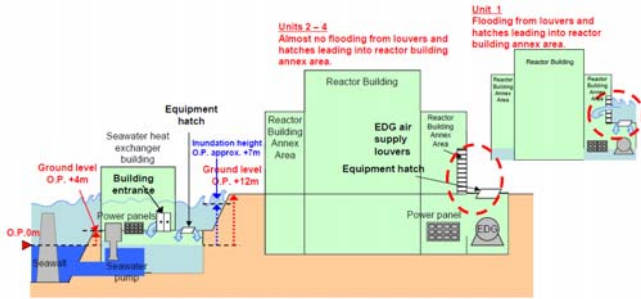
At Fukushima Daini NPS, although the entire seaside area of O.P. +4 m was flooded (flood height approximately O.P. +7 m), there were no watermarks of the tsunami run-up breaching the slope to the O.P. +12 m major buildings area. Since the damage was less than that of Fukushima Daiichi NPS, the difficulties of accident response were entirely different (Fig.3).

Fig.3 Path of inundation into major buildings (Fukushima Daini NPS).

At Fukushima Daini NPS, the tsunami caused the loss of emergency seawater system pump facilities at Units 1, 2 and 4. This prevented residual heat from being removed to the sea. However, since off-site power remained available for all units, it was possible to use alternate low pressure water injection systems such as the Make-up Water Condensate System (MUWC). MCRs' monitoring and operating functions were also maintained (Table 3).

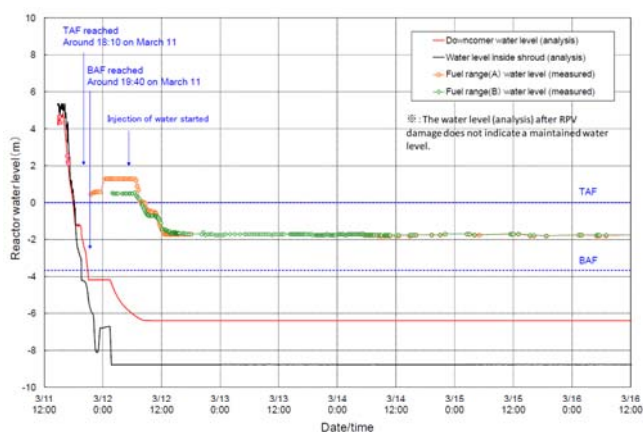
Although the procedures for maintaining reactor water level using the IC at the time of SBO had been prepared, the IC did not function because the valves were closed after the loss of DC power caused an isolation signal. Moreover reactor depressurization could not be performed, therefore reactor water injection using low-pressure pumps was impossible. As a result, reactor water level fell and the core was damaged (Fig.5). When DC power supply was temporarily restored after 18:00 on March 11, an attempt was made to open the IC valves, and according to the MAAP analysis, reactor water level was already lower than the top of active fuel (TAF). So, it is unlikely that the IC function was effective. After 21:00, although the reactor water level was indicated as higher than TAF, later investigation shows that the reactor water level gauge had already malfunctioned by this time.

Fig.5 Trend in reactor water level (Unit 1).

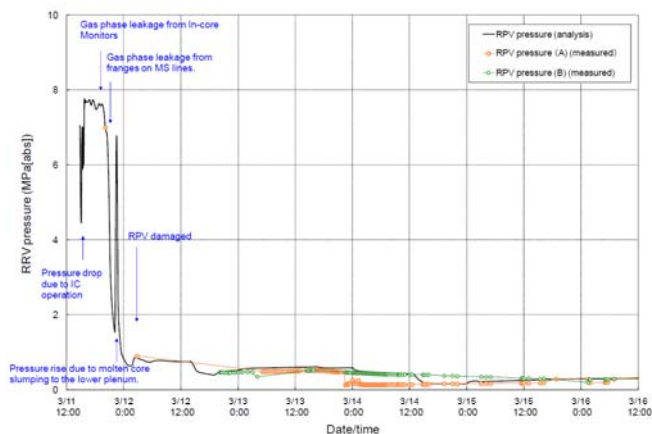
After 20:00 on March 11, it was confirmed that reactor pressure was about 6.9 MPa [gauge] and before 03:00 on March 12, it decreased to about 0.8 MPa [gauge] (Fig.6). According to the MAAP analysis, the RPV was damaged before 02:00 on

March 12 and almost all of the molten core had fallen onto the pedestal beneath the RPV.

Fig.6 Trend in reactor pressure (Unit 1).

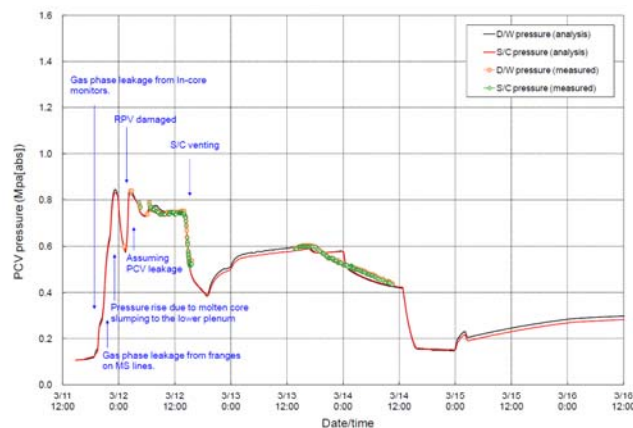
On the other hand, dry-well (D/W) pressure was confirmed as 600kPa [abs] for the first time around 00:00 on March 12. Considering the maximum operating pressure, 427kPa [gauge], this was excessive even in the situation of an accident (Fig.7). This could happen if there was a direct leak from RPV to PCV. So it is believed that the core damage caused a failure in the in-core instrumentation piping and the leakage from the flange sections of such parts at the safety relief valve (SRV) pipe beds. Thereby, it is presumed that reactor pressure fell before the RPV was damaged. Not long after, D/W pressure increased to 840kPa [abs], which means that RPV pressure and D/W pressure were equalized at the time.

Fig.7 Trend in PCV pressure (Unit 1).

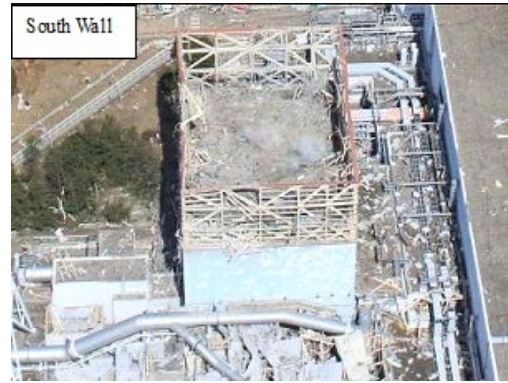
A hydrogen explosion occurred in the R/B topside at 15:36 on March 12. Although the cause of the explosion was not immediately determined, it is estimated that when the core fuel was damaged, hydrogen was generated as a result of zirconium-water reaction. This hydrogen then leaked out via the PCV to the R/B and finally the hydrogen exploded. In the explosion at Unit 1, all walls of the 5th floor were blown off and the ceiling collapsed onto the 5th floor of the R/B (Fig.9). Since the structure of the 5th floor walls of Unit 1 were of steel-frame construction and not reinforced concrete construction, it is presumed that the walls were damaged in the early stage of the explosion.

Another possibility is that the hydrogen might have escaped from the PCV vent line via the standby gas

Fig.9 Appearance of Unit 1 R/B after explosion.

treatment system (SGTS) line into the R/B. However, there was a flow control damper which could have prevented hydrogen back-flow and the entire R/B was severely contaminated, which would not be expected if the vent gas passed through the SGTS filter. Therefore the majority of hydrogen must have leaked directly from the PCV into the R/B. From the PCV design information, it is presumed that the main route which hydrogen in the PCV transferred to the R/B was via the seal of the PCV head flange.

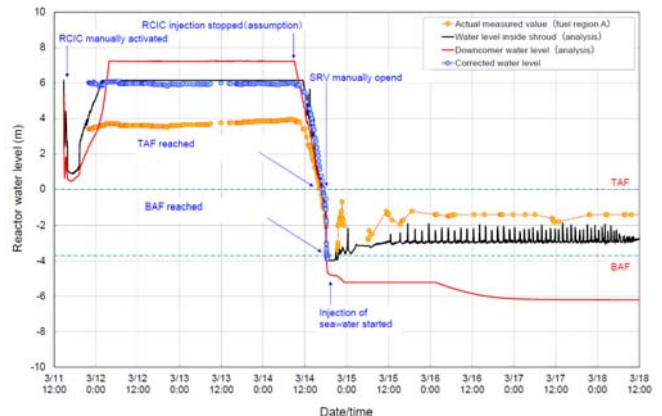
Fig.10 Trend in reactor water level (Unit 2).

of DC power supply. Until 02:55 on March 12, operators were unable to confirm the RCIC operation, however, the RCIC continued its operation without any operator control for about three days and the reactor water level was maintained (Fig.10).

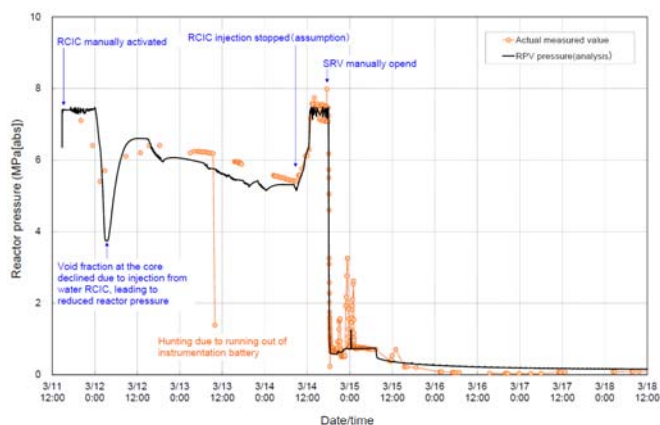
Under normal conditions, the RCIC stops upon receipt of a high reactor water level (Level 8) signal but in Unit 2 after the tsunami this signal never came because of the loss of all electrical power. This situation enabled continuous RCIC operation using a two phase flow turbine driven mechanism. In this situation, since high enthalpy coolant flowed out of the RPV, it could be explained that reactor pressure was maintained below SRV actuation set point (Fig.11).

Fig.11 Trend in reactor pressure (Unit 2).

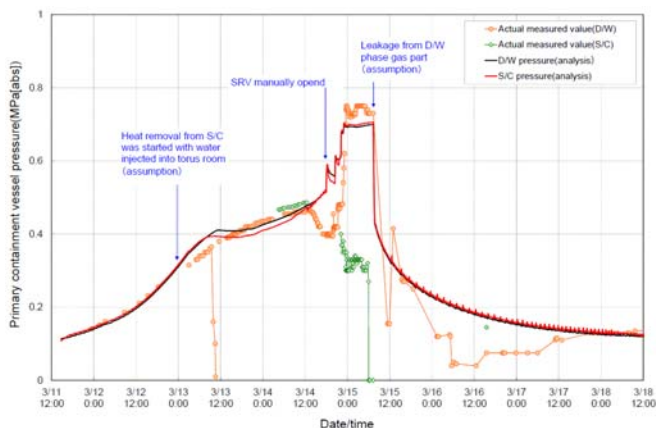
Moreover, measured D/W pressure was lower than that expected for this kind of accident. Since the tsunami water was confirmed to have entered the torus room of Unit 4 which is a similar plant to Unit 2, the assumption of water ingress to the torus room was applied in Unit 2 D/W pressure calculations. As a result, the behavior of measured D/W pressure has been reproduced by MAAP analysis (Fig.12).

Fig.12 Trend in PCV pressure (Unit 2).

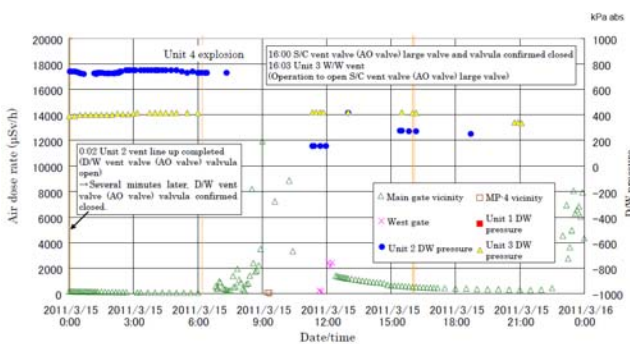
After 07:00 on March 15, Unit 2 D/W pressure dropped considerably while being out of operation, and monitoring data near the main gate increased sharply (Fig.14). Since winds blowing toward the north-northwest direction prevailed that day and the contaminated areas had rain on that day, it is possible that the contamination in high contamination zones was the result of the radioactive releases from Unit 2 R/B on March 15. Considering the design of the PCV, it is thought that the leak might have occurred at the seal of the PCV top head flange.

Fig.14 D/W pressure and monitoring data (March 15).

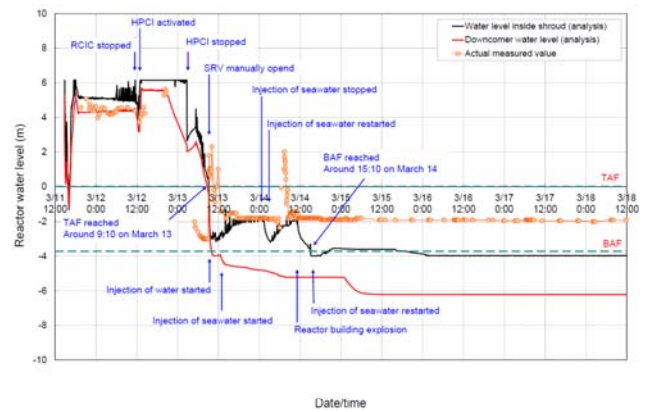
RCIC and HPCI (Fig.15). After the RCIC stopped, the HPCI started automatically due to a low reactor water level (level 2) signal, and the reactor depressurized to about 1 MPa [abs]. This phenomenon was the result of the operator’s action to ensure continuous operation of the HPCI in order to maintain a stable reactor water level. In this situation, continuous steam supply to the HPCI turbine enabled the reactor to depressurize (Fig.16).

Fig.15 Trend in reactor water level (Unit 3).

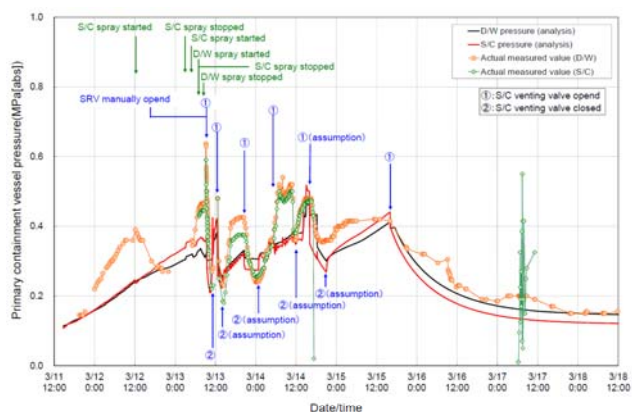
Since D/W pressure exceeded the maximum operating pressure, S/C vent was carried out several times to avoid PCV failure. The fact that D/W pressure responded consistently to vent operation, means that it is likely that PCV integrity was maintained or that damage was minor at that time (Fig.17).

Fig.17 Trend in PCV pressure (Unit 3).

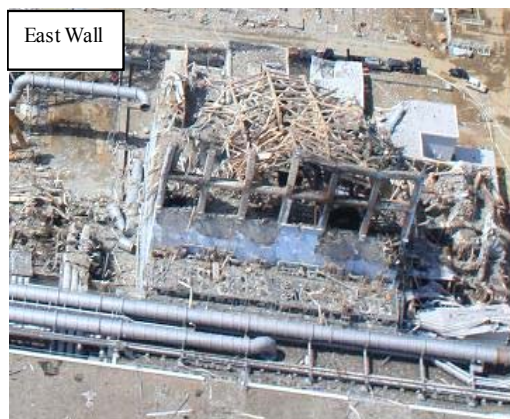
radiation area where there was a high risk of sparks causing an explosion. Regrettably, a hydrogen explosion occurred at 11:01 on March 14 (Fig.19).

Fig.19 Appearance of Unit 3 R/B after explosion.

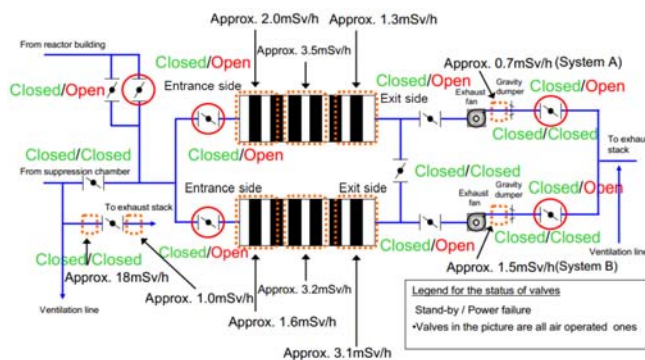
Similar to the Unit 1 explosion, hydrogen leakage via the PCV was judged to be the main route (Fig.20). This is supported by the results of investigations into Unit 3 SGTS filter radiation level, which is much lower than within the R/B. This means that the amount of vent gas that passed through the SGTS filter was limited if at all. From the PCV design information, direct leakage from the PCV to the R/B is expected to have occurred at the seal of the PCV head flange or equipment hatch.

Fig.20 Measurement of radiation dose of SGTS filters at Unit 3 (conducted on December 22, 2011).

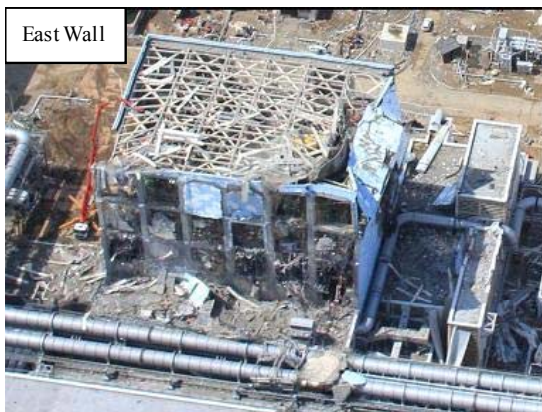
On March 15, a hydrogen explosion occurred in the Unit 4 R/B (Fig.21), which not only made cooling water injection into the SFP difficult but also prompted concern about the status of fuel stored in the Unit 4 SFP. On the next day, March 16, TEPCO employees flew over the Unit 4 SFP in a Self-Defense Force helicopter and confirmed that the water level was being maintained as expected. By subsequent analysis, it turned out that the water of the reactor well flowed into the SFP through the pool gate and the water level was maintained even higher than originally expected. Cooling water injection at Unit 4 using concrete pump trucks began on March 22. Furthermore, a nuclear species analysis of the pool provided no data that indicates fuel damage.

Fig.21 Appearance of Unit 4 R/B after explosion.

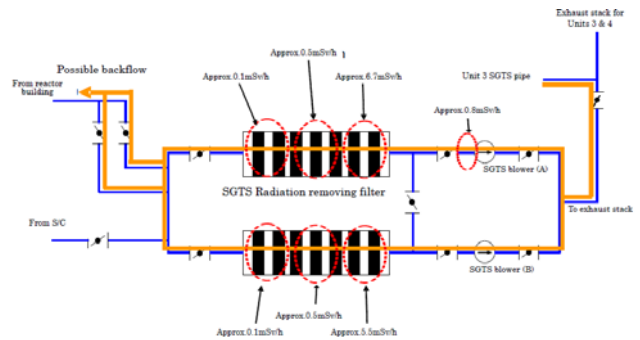
In Unit 4, although there was no possibility of hydrogen generation from the reactor and the SFP was not exposed, a hydrogen explosion occurred. From the radioactive dose measurement at Unit 4 SGTS filters, it was found that the radiation dose level of the downstream filter was higher than those of the upstream filters (Fig.22). So the PCV vent gas from Unit 3 was judged to have flowed into the Unit 4 R/B through the SGTS piping which was inter-connected at the bottom of the common exhaust stack. Different from other Units, the SGTS design of Unit 4 had no dampers which would close when AC power was lost. Furthermore, from the survey results below it is presumed that the explosion first occurred near the exhaust duct on the 4th floor of the R/B.

- the 5th floor of Unit 4 was pushed up
- the exhaust ducts are missing in the 4th floor

- many types of rubble on the 4th floor seems to be the wreckage of the ducts.

Fig.22 Measurement of radiation dose of SGTS filters at Unit 4 (conducted on August 25, 2011).
