# Lessons learned from the Fukushima Daiichi Nuclear Power Plant Accident

NARABAYASHI Tadashi<sup>1</sup>

**Abstract:** Many lessons can be learned from the Fukushima Daiichi Nuclear Power Plant accident. First, if an isolation condenser (IC) continues to operate, the accident would be terminated soon. A reactor core isolation cooling (RCIC) steam turbines also stopped due to loss of battery power in Units No.2 and No.3. suppression pool (S/P) temperature and pressure were so high that the accident management water injection took too long time. After the loss of ECCS and IC core cooling, Containment Vessel pressure increased. Hydrogen explosion occurred after venting. The analysis results show that the depressurization of the reactor pressure vessel (RPV) started before RPV bottom failure. It is hoped that the lessons learned from this accident will help to improve the safety of nuclear power plants worldwide.

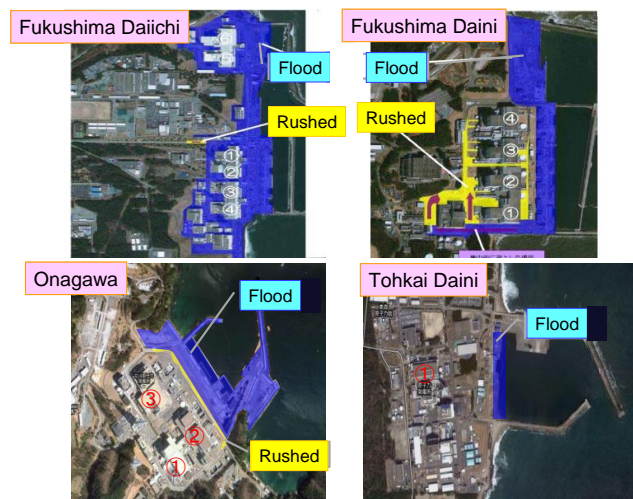
Fig. 1 Comparison of flooded area for each NPP<sup>[2]</sup>.

The Fukushima Daiichi NPP was hit by a tsunami caused by the Tohoku-Pacific Ocean Earthquake, resulting in nuclear accidents in Units No.1 to No.4. As shown in Fig. 1, although the other NPPs such as Fukushima Daini, Onagawa and Tokai Daini were also

hit by the tsunami, they all were able to terminate operation and safely, until cool down condition. The Fukushima Daini NPP succeeded in shutdown safely even though Unit No.1 was affected by water flooding through hatches and an emergency Diesel generator (EDG) air intake. The AC power was restored by changing the power cable and the seawater pump motors were replaced by bringing in new motors from the Toshiba Mie Works and Kashiwazaki-Kariwa NPP by helicopter. In the case of the Fukushima Daiichi NPP, Unit No.5 was brought under control by using EDG power from Unit No.6.

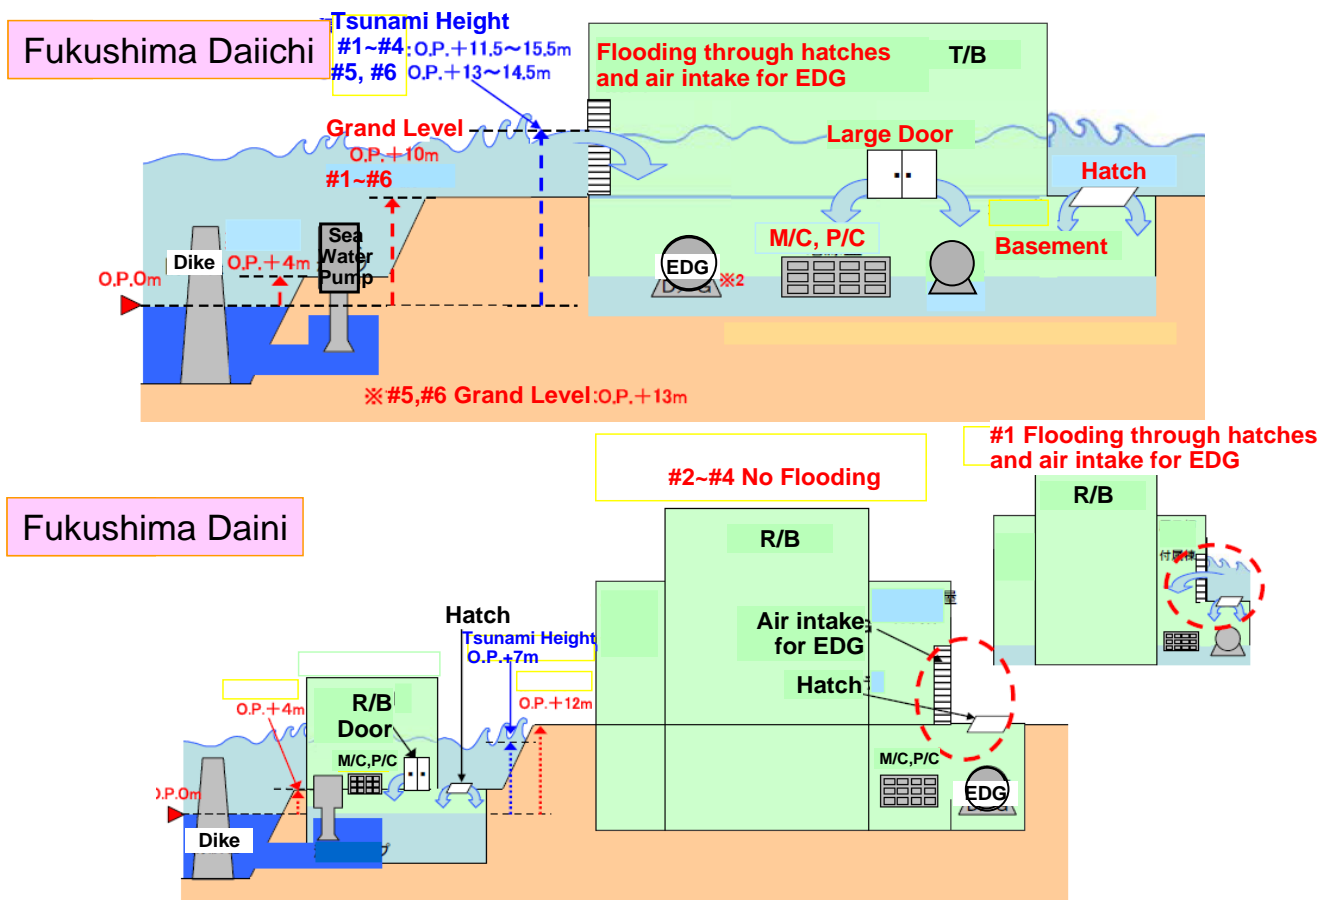
Fig. 2 Comparison of flood damage to emergency diesel generators for Fukushima Daiichi and Daini NPPs<sup>[2]</sup>.

Figure 2 shows a comparison of the flood damage to emergency diesel generators (EDGs). However, for Units No.1 to No.4, there was a complete loss of both AC power by the EDGs and DC power, and this was the main cause of the severe accidents that followed.

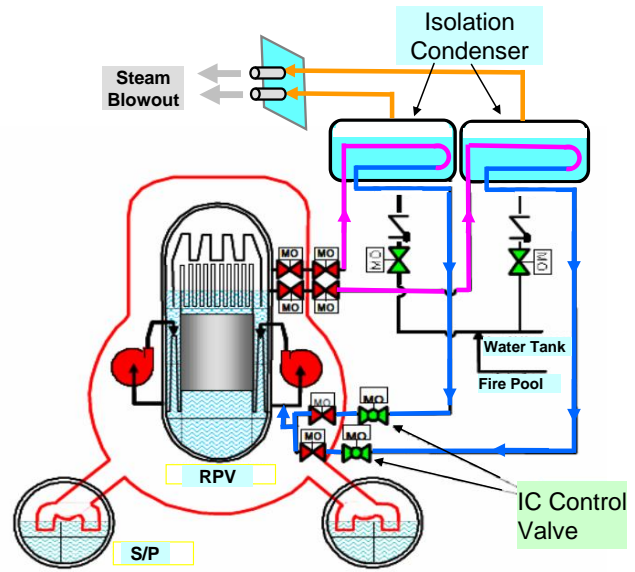
Fig. 3 Isolation condensers in Fukushima Daiichi Unit No.1.

In the case of Unit No.1, DC battery power was lost in the main control room. This caused the motor operated (MO) isolation valves to undergo fail-close action, thereby cutting off the isolation condenser (IC), as shown in Fig. 3. It was a fail-dangerous system. If the IC had continued to operate, the situation would have soon been brought under control.

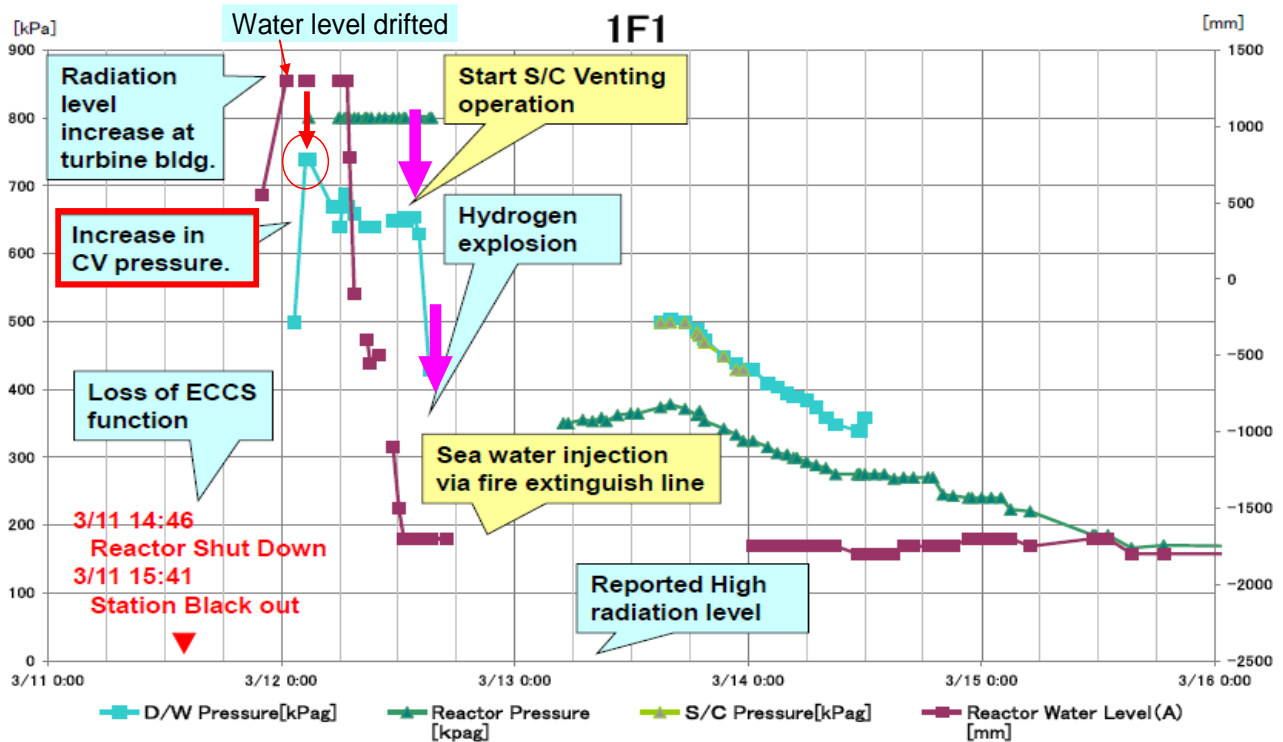
Fig. 4 Measured pressure in RPV and CV of Unit No.1, and water level in RPV [3].

After the loss of both the emergency core cooling system and the IC core cooling, the containment vessel (CV) pressure increased. The water level measurement drifted due to evaporation of water in the reference leg, as shown in Fig. 4. The radiation level increased at a turbine building (T/B). A hydrogen explosion occurred after suppression chamber (S/C) wet venting.

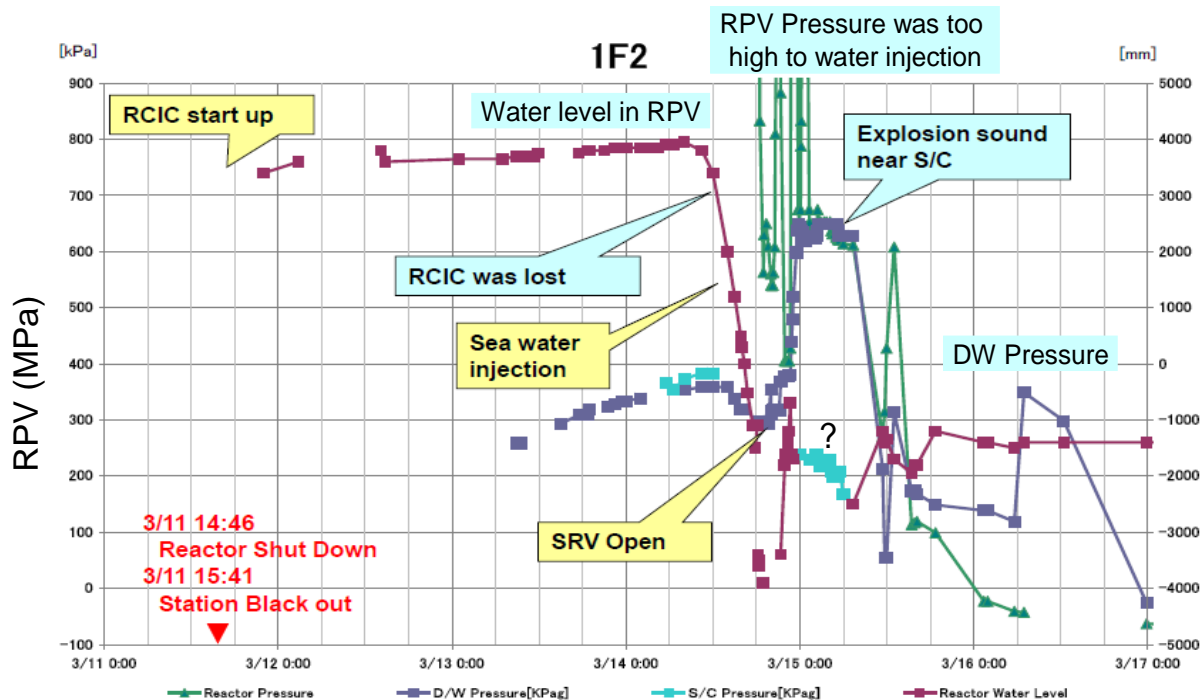
Fig. 6 Measured pressure in RPV and CV of Unit No.2, and water level in RPV [3].

It was reported that an explosion sound was also heard near the S/C of Unit 2. However, examination of the data showed that it was due to a hydrogen detonation in the reactor building (R/B) of Unit No.4. Soon after the detonation, the Unit No.2 DW pressure decreased, as seen in Fig. 6. Figure 9 shows the trend in monitored radiation levels for Fukushima Daiichi Units No.1, No.2, No.3 and No.4, which can be compared with the events as illustrated in Fig. 10.

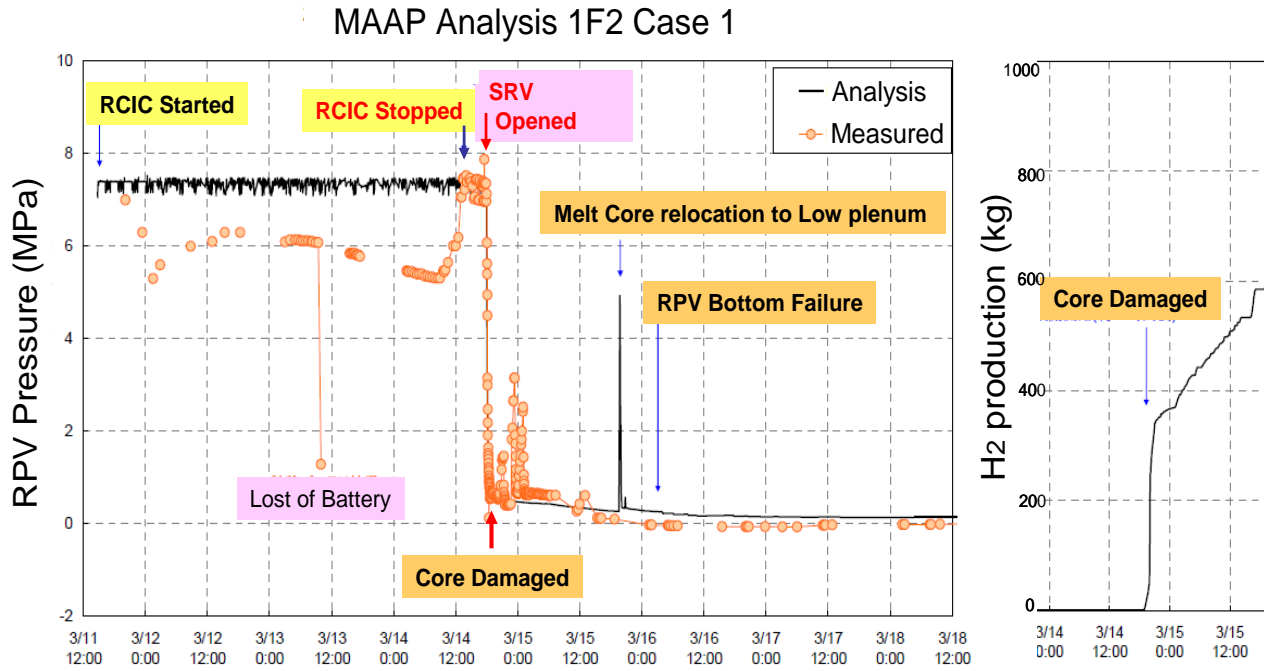
Fig.7 MAAP analysis results compared with actual plant data for Unit No.2 [2].

The RPV pressure was too high to allow water injection by using a fire engine pump. This failure to inject water soon after the stop of RCIC in Unit No.2 promptly lead to core damage and the generation of H<sub>2</sub> gas as shown in Fig. 7. A high-pressure discharge pump driven by a diesel engine or motor should have been used for the backup of RCIC trip.

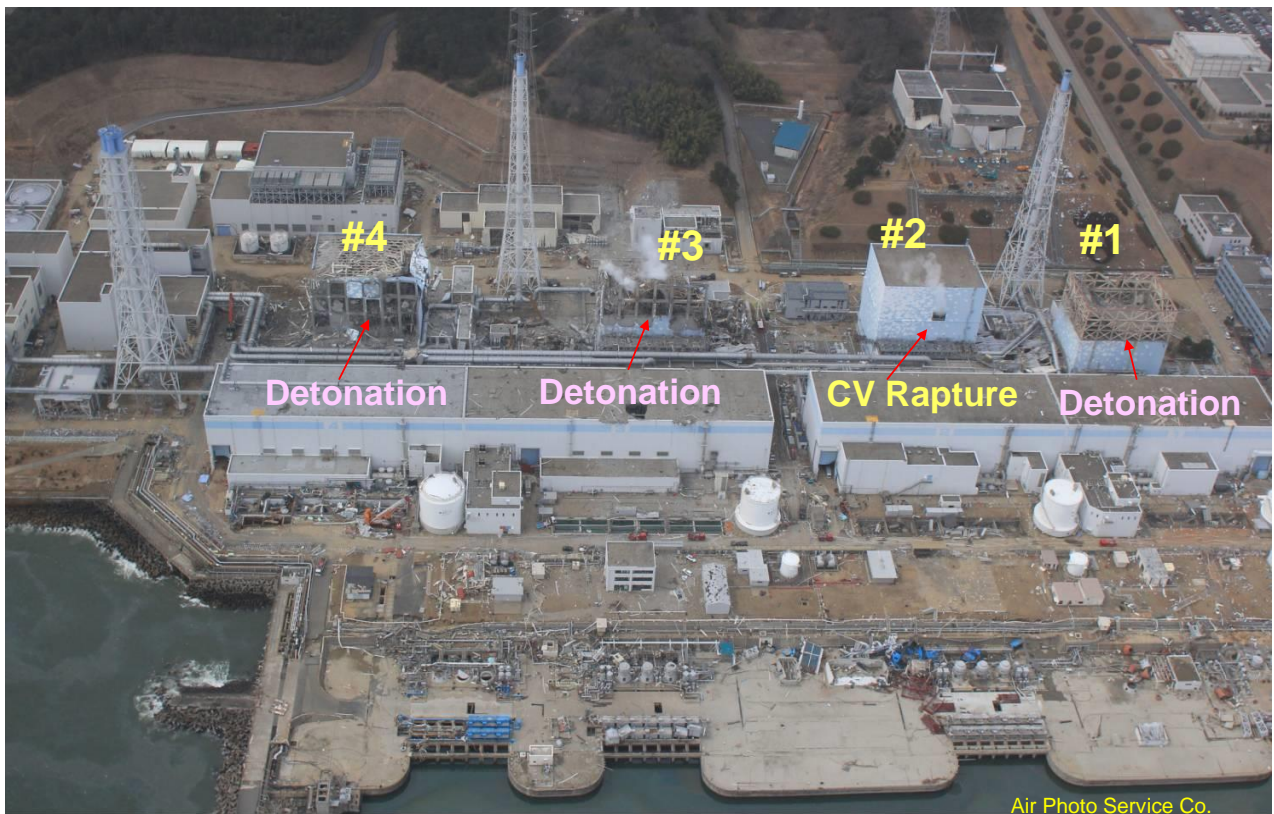
Fig. 8 H<sub>2</sub> detonations occurred after vent operations (Units No.1, No.3 and No.4).

As shown in Fig. 8, H<sub>2</sub> detonations occurred in Unit No.1, No.3 and No.4. When the Unit 1's detonation occurred the blowout panel of Unit No. 2 was opened. The hydrogen in Unit No.2 was released through the opened blowout panel and detonation didn't occurred in Unit 2.

It seemed that the detonation occurred after venting operations. The radiation level increased soon after the Unit No.2 CV rupture on March 15.

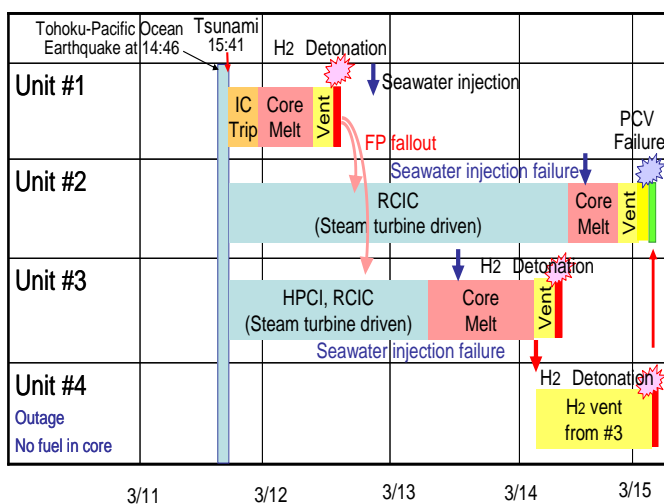
Fig. 10 Chain of major events in Units No.1 to No.4 to bring about severe accidents in the Fukushima Daiichi NPP.

A loss of core cooling occurred due to the IC trip in Unit No.1, and the RCIC steam turbine also tripped due to loss of battery power in Units No.2 and No.3. The suppression pool (S/P) temperature and pressure became so high that water injection actions for accident management took a long time.

This was the reason why the chain of severe accidents occurred in the four units of Fukushima Daiichi NPP, as shown in Fig. 10.

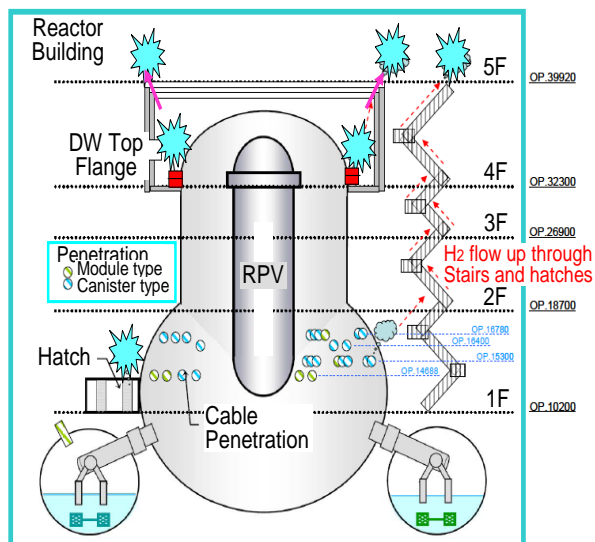
Fig. 11 H<sub>2</sub> leak path from drywell in Unit No.1 to No.3.

Figure 11 shows that the CV top flange and hatches might act as leakage pathways. Hydrogen and FP flow upwards by way of stairways and hatches.

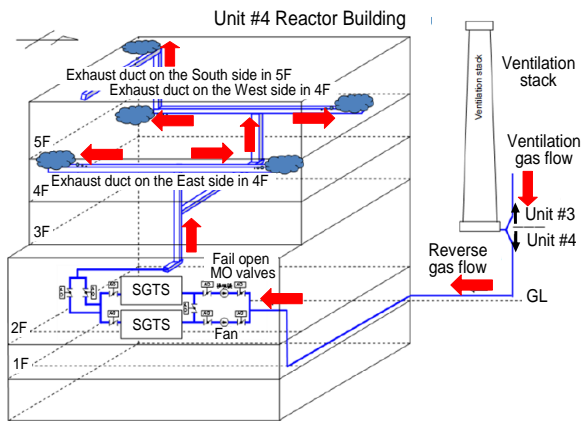
Fig. 12 H<sup>2</sup> gas flow into unit No.4 reactor building from unit No.3.

Although there was no nuclear fuels in the reactor core of Unit No.4, hydrogen flowed from Unit No.3 through the stack line into Unit No.4 and underwent reverse flow through the standby gas treatment system (SGTS) filters, as shown in Fig. 12.

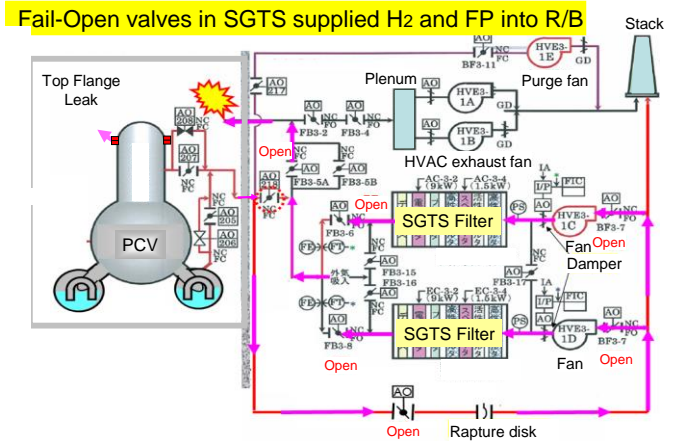
Fig. 14 Flow diagram of SGTS/HVAC and added hard vent system. [2]

The author pointed out to NISA that the added vent line might have acted as a means of hydrogen and fission products (FP) leaked through the SGTS and HVAC lines, as shown in Fig. 14. Because hydrogen and FP might flow back into each room through the exhaust gas ducts. The vent lines of each NPP should have been independent from the SGTS/ HVAC line. The NISA ordered to the licensees to make a new independent vent line for filtered vent system. This is the one of the point of lessons and learn. There were no accident reports about Fukushima-Daiichi which point out the vent system's fault and potential risk.

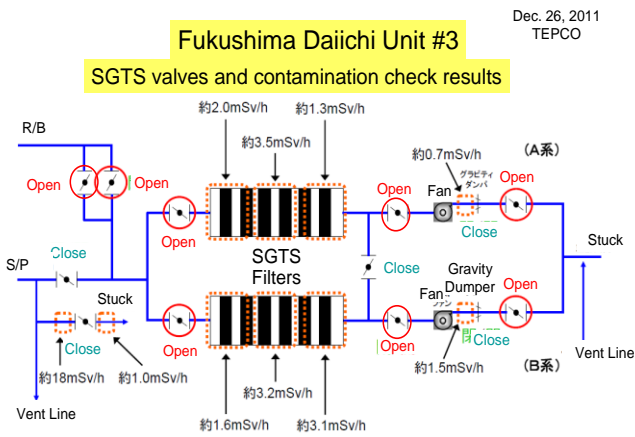
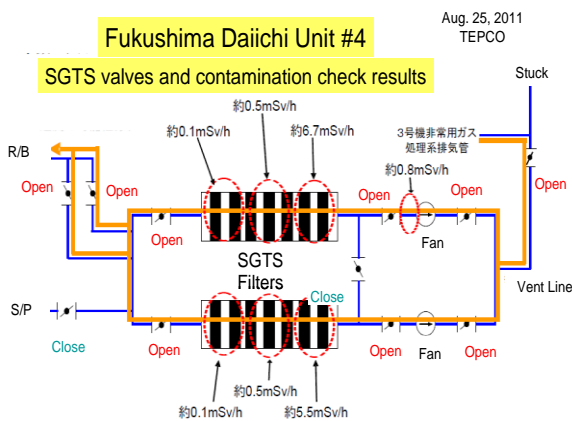
Fig. 13 Results of SGTS valves open/close check and SGTS filter contamination survey [2]

A strong hydrogen detonation occurred in the Unit No.4 reactor building on March 14. As shown in Fig. 13, it was confirmed that the SGTS filters were contaminated and all the MO valves were open due to the fail-open design in Units No.3 and No.4. This might be reason why hydrogen detonation in Unit 4, where these were no nuclear fuels in reactor core.
