Dry core degradation scenario and wet one in Fukushima Daiichi NPS core melt accident

TANABE Fumiya¹

Keyword: Fukushima accident, core melt, relocation into lower plenum, zirconium-steam reaction, hydrogen

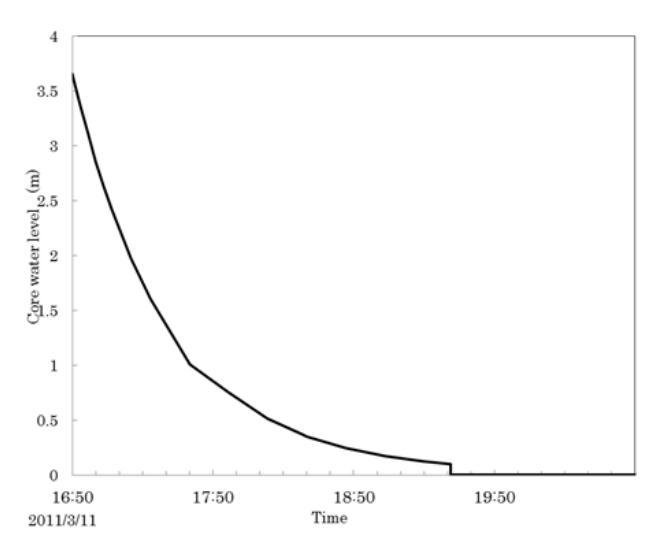
The top of the active core was assumed to begin exposed to steam at 16:50 on 2011/03/11. The calculated behavior of the water level is shown in Fig.1.

It is assumed for simplicity in the calculation that all of the exposed core material moves down together and interact with water at the termination of UO_2 melting (19:31). Then the water level is calculated to drop abruptly to zero at this time (Fig.1) and accumulated hydrogen mass is calculated to jump up to 453.5 kg at this time because all residual water in the core is assumed to react with high temperature zirconium relocating. It is expected in the actual course of the accident, on the contrary, that each metal and ceramic would have moved down on melting and froze with vaporizing water in the lower core. Therefore, the actual water level should have decrease faster than one in Fig.1 after Fe melting, and the actual accumulated hydrogen mass would have increased faster than the curve in Fig.3 with the same final value.

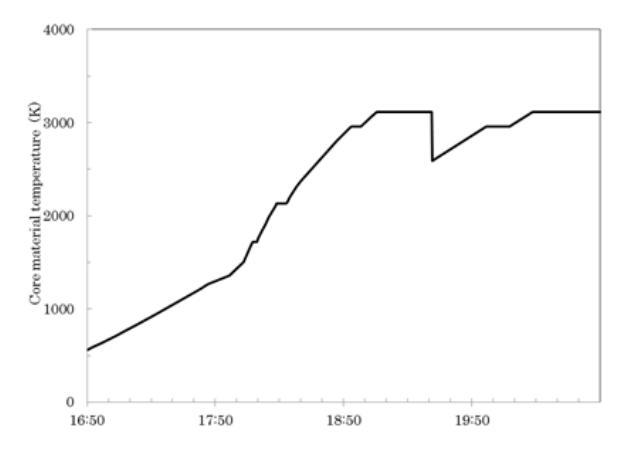
At 17:42 the average temperature of the exposed core material reaches 1200 K at which fuel rod cladding is expected to be ruptured due to inner pressure.

At 18:03 the temperature reaches 1500 K, when runaway zirconium-steam reaction starts on fuel rod cladding and channel box wall (fuel rod assembly canister), and it generates much heat and hydrogen.

Fig.2 Exposed core material temperature in the Unit 1 reactor calculated by the simple model.

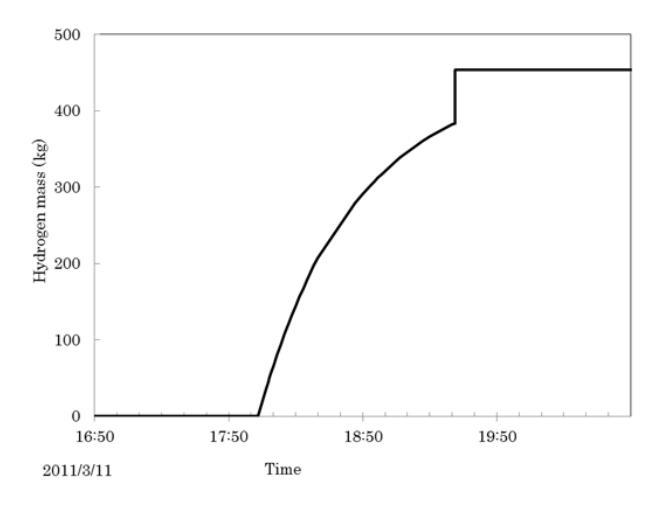
Fig.3 Accumulated hydrogen mass in the Unit 1 reactor calculated by the simple model.

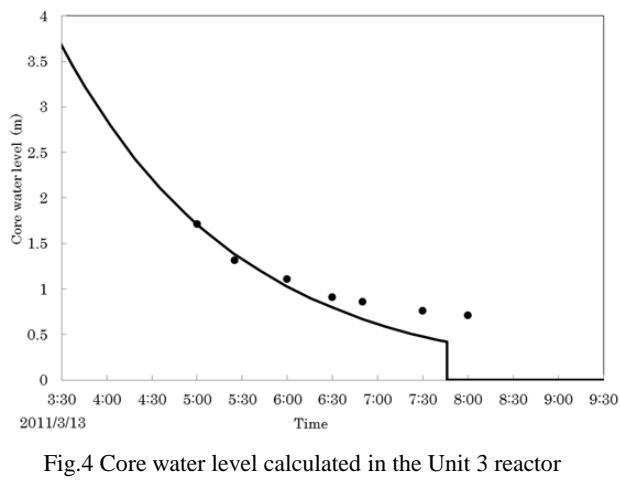
The top of the active core was estimated to begin exposed to steam at 3:29 on 2013/03/11. The calculated behavior of the water level is shown in Fig.4.

calculated by the simple model.

It is assumed for simplicity in the calculation that all of the exposed core material moves down together and interact with water at the termination of UO₂ melting (7:46). Then the water level is calculated to drop abruptly to zero at this time (Fig.4) and accumulated hydrogen mass is calculated to jump up to 1210 kg at this time because all residual water in the core is assumed to react with high temperature zirconium relocating. It is expected in the actual course of the accident, on the contrary, that each metal and ceramic would have moved down on melting and froze with vaporizing water in the lower core. Therefore, the actual water level should have decrease faster than one in Fig.4 after Fe melting, and the actual accumulated hydrogen mass increase faster than the curve in Fig.6 with the same final value.

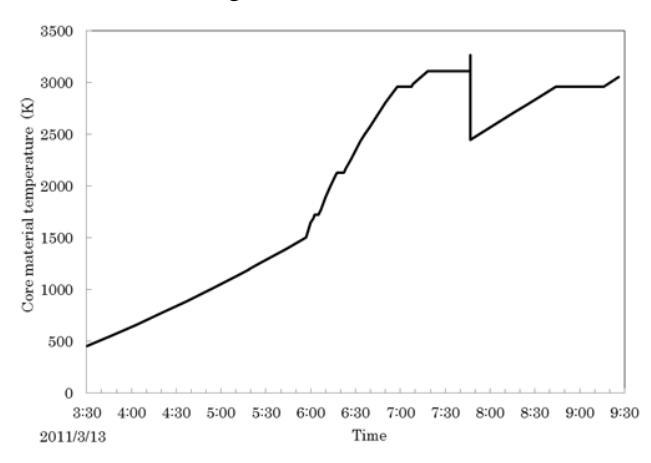
The calculated result of the average temperature of the exposed core material is shown in Figure 5. At 5:18 the average temperature of the exposed core material reaches 1200 K at which fuel rod cladding is expected to be ruptured due to inner pressure.

Fig.5 Exposed core material temperature in the Unit 3 reactor calculated by the simple model.

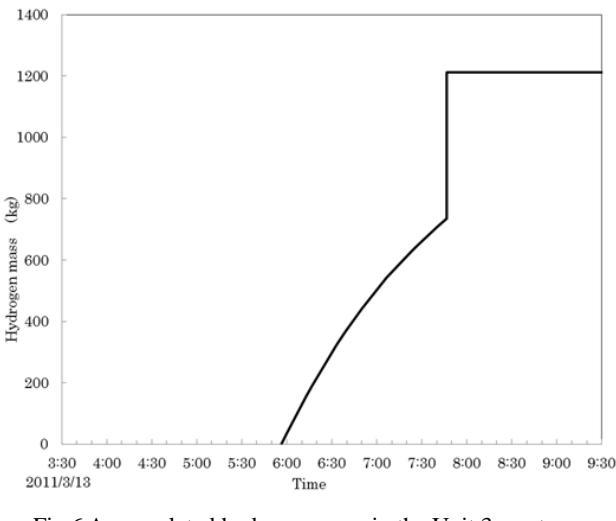
Fig.6 Accumulated hydrogen mass in the Unit 3 reactor calculated by the simple model.

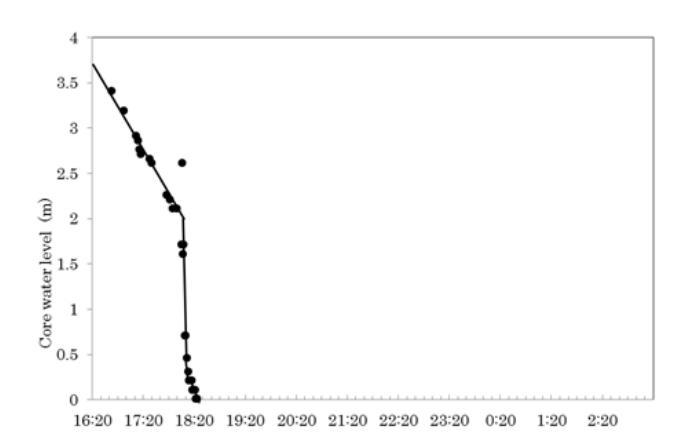
From the measurement the top of the active core was estimated to begin exposed to steam at 16:20 on 2011/03/14 and the core water level decreases gradually as shown in Fig.7. And then the bottom of the core was estimated to get completely dry out at 18.22 due to depressurization flashing. The estimated water level is well below the bottom of the core plate (namely in the lower plenum). The water level was assumed below the core plate hereafter because it was highly probable that the sea water injected using the fire pump on fire engine had not reached the reactor vessel due to high reactor pressure even after initiation of the injection at 19:54.

Fig.7 Core water level in the Unit 2 reactor interpolated with the measured values.

The core water level is shown in Figure 7, which is interpolation of the measured value.

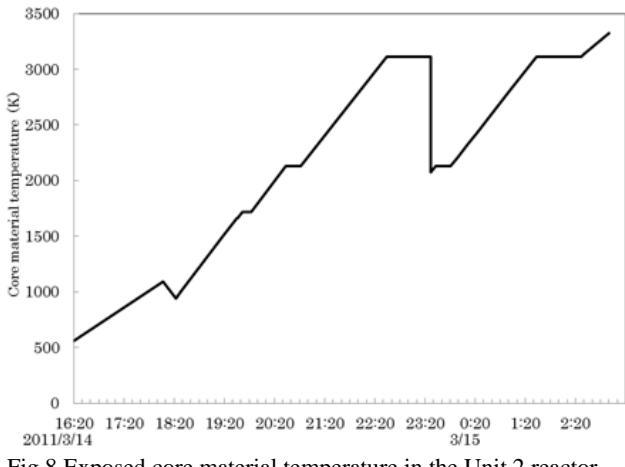
The calculated result of the average temperature of the exposed core material is shown in Figure 8. At 18:48 the average temperature of the exposed core material reaches 1200 K at which fuel rod cladding is expected to be ruptured due to inner pressure.

Fig.8 Exposed core material temperature in the Unit 2 reactor calculated by the simple model.

At 19:18 the temperature reaches 1500 K, when, if the water level was above the bottom of the active core, runaway zirconium-steam reaction should have started on fuel rod cladding and channel box wall (fuel rod assembly canister), and it should have generated much heat and hydrogen. Namely the completely dry core condition leads to no zirconium reaction because of absolute steam starvation.

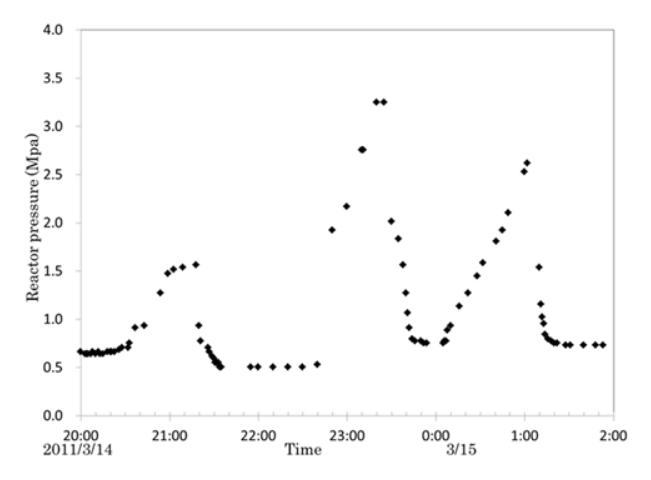
Hereafter, the metal liquid (Zr-Fe-B₄C) would have continuously drained into the lower plenum and interacting with water there to generate steam. The first distinguished but gradual pressure increase from 20:30 on March 14 in the observed reactor pressure as shown Fig.10 can be interpreted as due to this gradual relocation of the mixture metal liquid into the lower plenum.

metallic melt (Zr-U), ceramic (UO₂) melt and ceramic solid (UO₂) accumulate on the core plate. The core plate is heated by the molten mixture and stressed by the weight of the material, and finally abruptly gets failed. Then large amount of the very high temperature core material, most of which is fuel, would have fallen suddenly into the lower plenum. Then it interacts with water there and generates large amount of steam to result in abrupt reactor pressure increase. The second distinguished pressure peak increasing abruptly around 22:40 on March 14 in the observed reactor pressure (Fig.10) can be interpreted as due to this abrupt relocation of the fuel material (UO_2) . In the pressure increase, the recorded value is 0.428MPa (gage) at 22:40 and 1.823MPa at 22:50. Therefore the pressure should have increased in a shorter time, probably within several minutes, which resembles to the pressure spikes in the Unit-3 and the TMI-2.

Fig.10 Measured reactor pressure in the Unit 2.
