Failure and its mechanism of LWR and research reactor fuels

Abstract: A failure of LWR fuel under a normal operating condition up to the burn-up of 20MWd/kgU was PCI-SCC. A failure of LWR fuel under RIA occurred at 260cal/g • fuel for the fresh fuel and 118cal/g • fuel for pre-irradiated PWR fuel to 42MWd/kgU. The mechanism was the melt-brittle for the former and strong PCI combined with transient FGR for the latter. The silicide fuel failed by the through-plate cracking, where the tensile thermal stress governed by temperature drop (>94deg.C) and time to quench (<0.13s) is the principal mechanism.

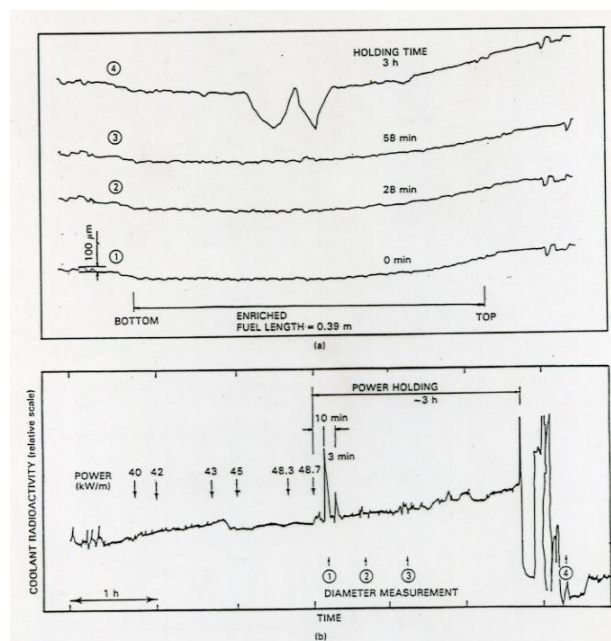
Fig.1 (a) Diameter profiles of failed rod 32 measures at the time, and (b) coolant radioactivity of the failed rod as a function of time, where rod power and time of diameter measurement are indicated.

Note that at that time diameter gauge and connected cable was degraded by the action of neutron, gamma heating and the immersed moisture from the coolant. The degradation was to weaken the signals from the core and to increase the noise level significantly. However, diameter profiles at the period could be obtained. The selected times and profiles obtained are shown in Fig.1a.

The profiles were only measured along a single generatrix (0 to 180 deg.). At the time of the first spurts ① and at subsequent periods ② and ③, corresponding profiles gave little change in shape. At the time of the second spurt ④, however, a large irregularity of cladding surface appeared.

Figure 3a shows a small crack located in the rod top section, and Fig.3b shows two marked cracks located in the rod middle section. The latter was on the path of diameter measurement. In addition, its location coincided well with information that was observed from the diameter profile of the failed rod (Fig.1a,

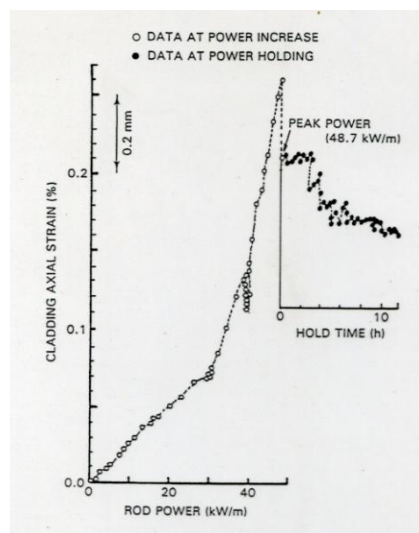
Fig.2 Cladding axial strain of the failed rod as a function of rod averaged power and holding time.

form of axial strain, as a function of power and time, is shown in Fig. 2.

As can be seen from the figure, a sudden drop of axial strain immediately after reaching maximum power occurred. In the subsequent periods, however, a few change occurred. The sudden drop of the cladding strain coincided well with the first spurts of coolant radioactivity. Although a sign of failure in the diameter profile is not observed, the PCI failure

(cracking) should be initiated from that time. The marked change of cladding surface coincided well with the second spurt of coolant radioactivity. At that time, significant cracks developed in the rod surface along a path of diameter measurement. Opened cracks released a large amount of FP gas into the coolant.

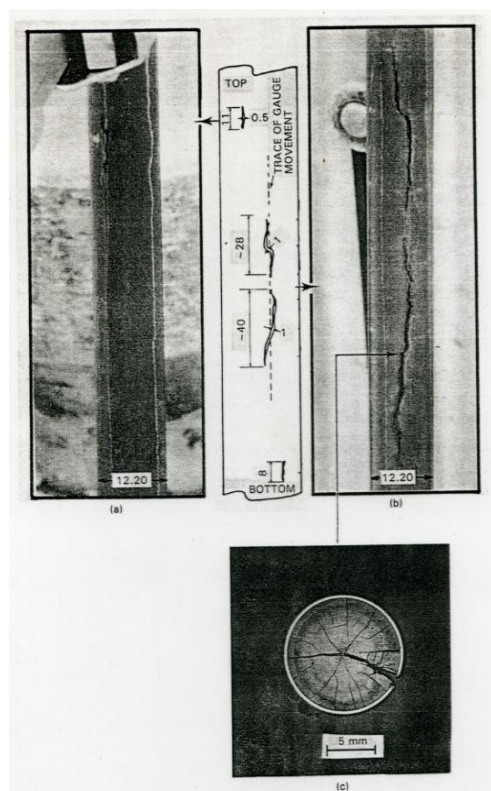
Fig.3 An over view of the failed rod taken immediately after unloading from HBWR core: (a) a crack in the rod top, (b) two marked cracks in the rod middle, and (c) a metallographic cross section taken from (b), Units are in millimeters.

The failed rod was retained in the reactor a week longer with the power at 40kW/m and then unloaded. After unloading from the reactor, the rod was given visual inspection and post-irradiation examination (PIE). Figure.3 gives the rod outer view taken from the visual inspection and reveals that four apparent cracks existed. The locations are indicated in the photo.

④). The cracks observed in the visual inspection stage seem to be more extended than during in-core failure stage due to hydriding. The cross sectional photograph taken from one of the marked cracks is shown in Fig.3c. A very large radial crack starting from the failure position is seen. A more detailed observation showed that many hydridings existed around cracked locations. Not mentioned in detail here but the author detected the propagation of PCI crack by the eddy current on power measurement. Usually the measurement is known to be very difficult because the crack was initiated from the inner surface of the cladding.

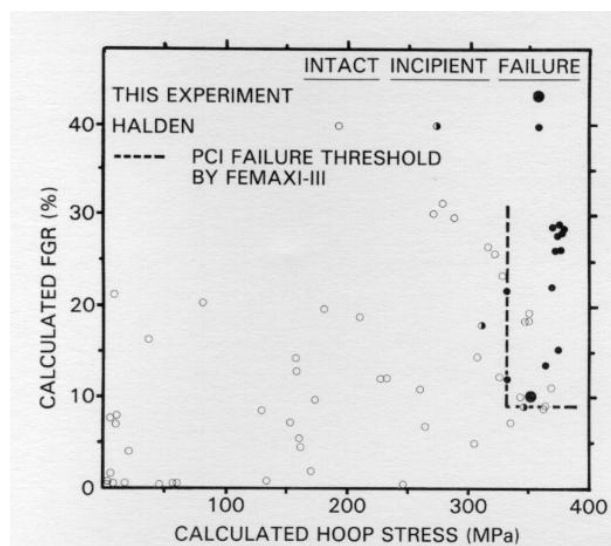
Fig.4 Failure threshold of the HBWR fuel rods (dashed line) and rod 32 used in the present study

Note: THIS EXPERIMENT means the IFA-508 experiment done by the author. Meanwhile HALDEN means that all data were from the Halden OVERPOWER tests carried out by the Halden Project. The author collected the necessary data from them as the input of FEMAXI-III code and plotted the calculated results here.

Obtained in-core data were used for the verification of FEMAXI-III code. In the verification stage, more than 60 power ramped rods under HBWR conditions were also included. PCI failed or no failed rods were plotted together as a function of calculated maximum hoop stress and FGR. The result is shown in Fig. 4.

The dotted line gives estimated PCI failure boundary for HBWR rods, where the failed rod in this experiment was within the boundary. The calculated hoop stress and FGR of the rod 32 are 350MPa and 10%, respectively.

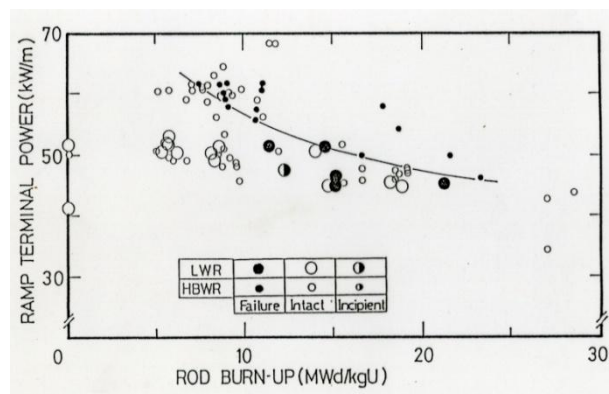
Fig. 5 PCI failure threshold for HBWR rods and LWR ones ramped in the LWR loop installed in the HBWR core.

As shown in Fig.5, the PCI failure threshold for LWR (PWR and BWR) is slightly lower than that of HBWR. Note that a standard PWR fuel at 18MWd/kgU was subjected to power cycling (power range 30 to 45kW/m with period 20-25min) to 620 times without failure. A standard BWR fuel at 15MWd/kgU was also subjected to power cycling (power range 30 to 45kW/m with period 20-25min) to 826 times without failure. It was monitored that the FGR rate during the power cycling was the diffusion and dependent on the square root of the holding time at the power. This fact was also observed in the PWR fuel.

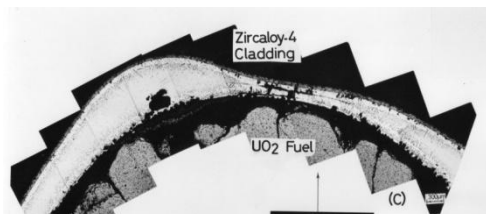
Fig.6 A failure of NSRR standard fuel by the melt-brittle mechanism, where the circumferential crack would occur during the quench and the fuel rod was broken into a few pieces.

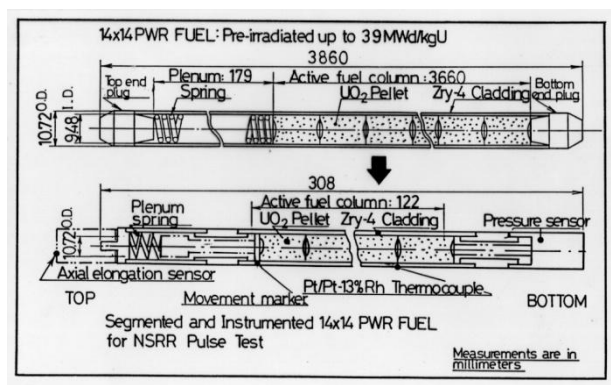
Fig.7 (Top) OTFR; (Bottom) STFR having an active column length by 0.122m.

With respect to the pre-irradiated LWR fuel, the author would like to focus on the PWR fuel in this report. The PWR fuel was used in the commercial power reactor for the electricity generation about 3 years. Attained burn-up during the reactor usage was about 39-42MWd/kgU. As shown in Fig.7, an original test fuel rod (OTFR) was then transported to the JAERI Hot Laboratory to shorten the size as long as about 0.122m. The author defined it as the segmented

test fuel rod (STFR). The STFR was transported again to the NSRR to attach the axial elongation sensor, the pressure transducer and the T/C. The main experimental parameter was so called the deposited energy E_g (cal/g/fuel), which was estimated from the integral value of reactor power P (MW · s) measured

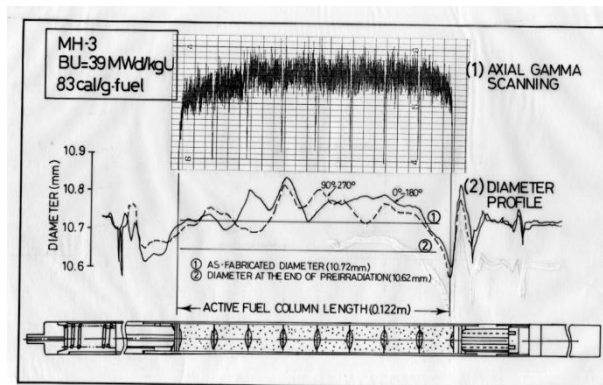
Fig.8 (1) Axial gamma scanning and (2) diameter profiles at two generatrices, observed in the PIE of MH-3 PWR rod pulsed at 83 cal/g · fuel.

Up to now, several pulse irradiations were performed by the use of STFR-PWR (STFR in PWR type). During the PIE it was revealed that a strong PCMI would occur. Figure.8 shows an axial gamma scanning and diameter profiles obtained from the pulse irradiated PWR fuels. Residual ridges occurred at the pellet-to-pellet interfaces with a magnitude of about $50 \mu\text{m}$, which was about ten times the normal, namely a normal residual ridge height is up to $10 \mu\text{m}$ for a fresh fuel and 2-3 μm for pre-irradiated fuel.

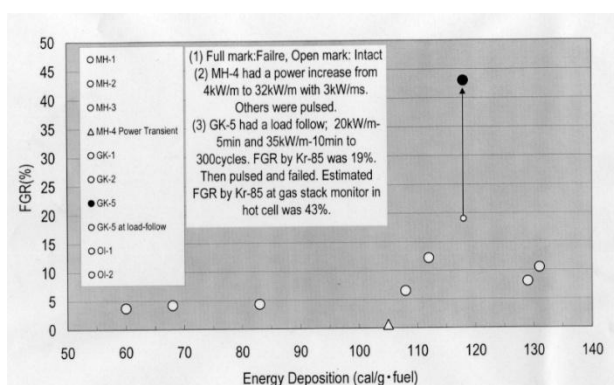
Fig. 9 Transient FGR of STFR-PWR. Open circle is intact and full circle is in failure.

As shown in Fig.9, a transient FGR during the pulse was increased with an increase of deposited energy except for the triangle data which had the slow ramp. A maximum was around 12% and seems to be not increased more. The transient FGR seemed to be not followed the diffusion mechanism because the time at the elevated temperature was too short. The author considered that the principal mechanism might be the

As shown in Fig.9, one STFR GK-5 was in failure. As STFR GK-5 and STFR GK-1 were the sister rod; they were segmented from the same OTFR at the Large Hot Laboratory. As for GK-5, it was loaded into the Pressurized Capsule (POCA) at the JMTR to perform a load follow operation under PWR conditions. The load follow was carried out between the high power level of 35kW/m for 10-min and the low power level of 20kW/m for 5-min time interval. The total cycles were 300. It should be noted that the OTFR had an average linear power of 18kW/m and FGR by 0.42% at the end of life (EOL). During the load follow operation, an FGR occurred additionally to the magnitude of 19%. and caused an increase of the rod internal pressure from 0.28MPa to 1.2MPa. This was the estimation from the non-destructive activity counting by Kr-85 at the fuel plenum [9]. After load follow, GK-5 was inspected at the JMTR Hot Cell and confirmed the non failure. Accumulated

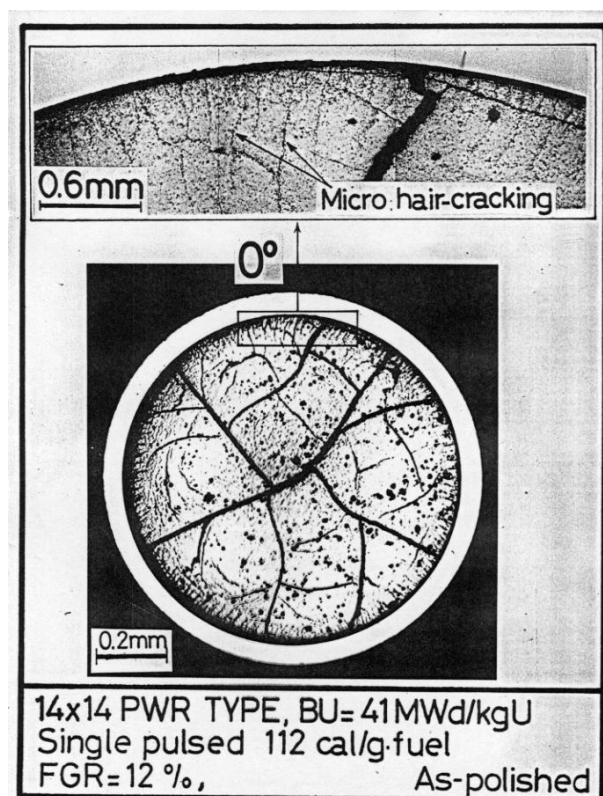
Fig.10 A fuel microstructure to show the occurrence of the transient FGR, which was caused by a fuel micro hair-crack at deposited energy of 112 cal/g · fuel.

micro hair-crack occurred at the fuel periphery, where much fission product gases were retained. As expected, during PIE, the author revealed the evidence. As shown in Fig. 10, the fuel had lots of micro hair-cracks at the periphery. The author modeled the micro hair-cracking into the computer code FPRETAIN and predicted the transient FGR. As shown in Fig.11, the predicted value coincided well with that of experiment.

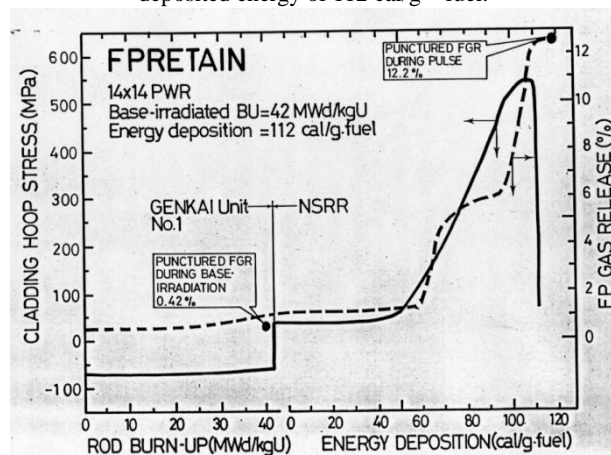
Fig.11 Transient FGR predicted by FPRETAIN and experimental data obtained from the PIE.

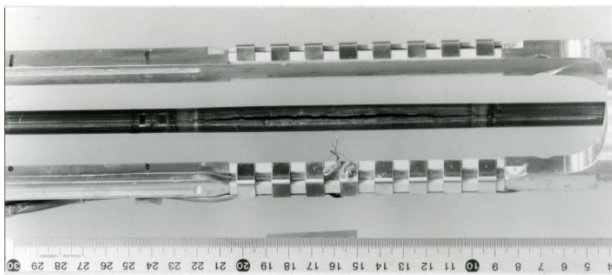
Fig.12 Overview of the STFR-GK-5, failed at the energy deposition of 118cal/g · fuel.

GK-1. The small magnitude in the former might be due to the failure. As shown in Fig.12, GK-5 was split along one generatrix, where the crack propagated from the end to the top of active column region (0.123m). Estimated FGR by Kr-85 activity counting at the gas stack monitor inside the hot cell was about 43%. The failure mechanism is not revealed yet because it is a significantly difficult to separate the damage occurred in NSRR from that occurred in load follow in JMTR. Accumulated thermal effect such as the fuel cracking during the load follow is also not clarified to date.

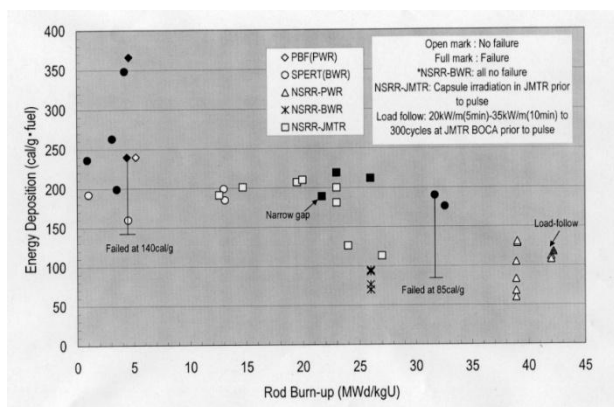
Fig.13 Energy deposition of the STFR-PWR as a function of rod averaged burn-up.

Preliminary failure threshold of the STFR-PWR at the present stage is given by Fig. 13. Note that data points from the STFR-BWR, the NSRR standard fuel irradiated by the capsule in the JMTR^[10], and the U. S.^[11, 12] were included as the references. Failure threshold of PBF and STFR-PWR seems to be decreased with increasing burn-up. This implies that the magnitude of PCMI as well as the transient FGR (that is also the indication of rod internal pressure) at the pulse irradiation might be the key factor.

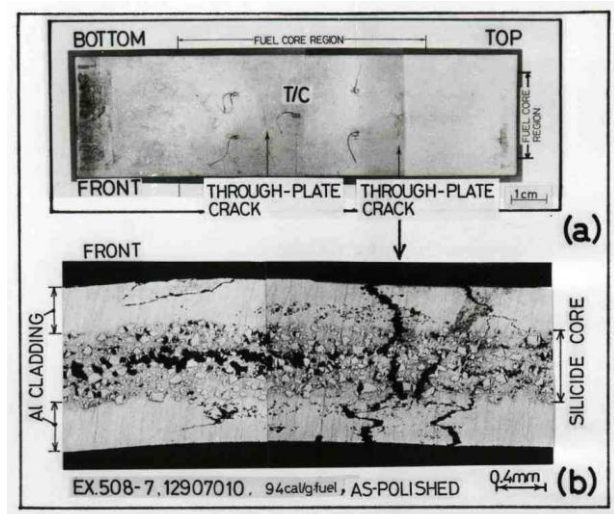
Fig.14 (Top) overview of the tested fuel plate at 94cal/g · fuel plate (B&W), where the PCST was 237deg.C. Two through-plate cracks occurred locally. (Bottom) as-polished longitudinal section cut from the location of the through-plate crack at the plate top.

In almost research reactors in Japan now used the 4.8g/cc silicide fuel. The failure threshold for the silicide was studied in the NSRR. In the series of test denoted as Ex-508, a total of 17 tests were conducted, in which 5 data points were in failure as typically shown in Fig.14.

It was clear that the failure took the form of through-plate cracking, occurred at the peak cladding surface temperature (PCST) above the DNB (182 ± 15 deg.C) point. As shown in Fig.15, the 4.8g/cc silicide fuels had the failure points with the energy deposition >94 cal/g · fuel. Of course, if PCST exceeds 640deg.C, the silicide shall fail by the melt mechanism.

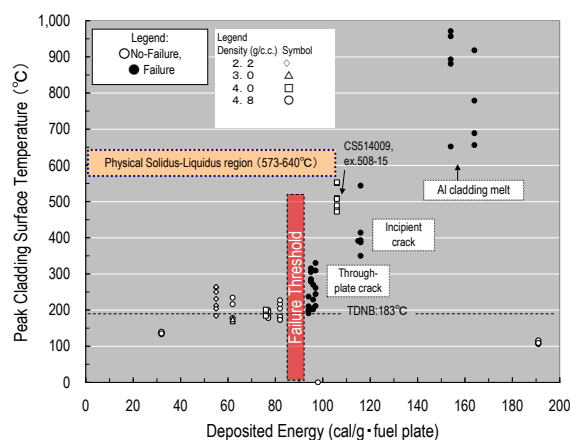
Fig.15 PCST as a function of deposited energy.

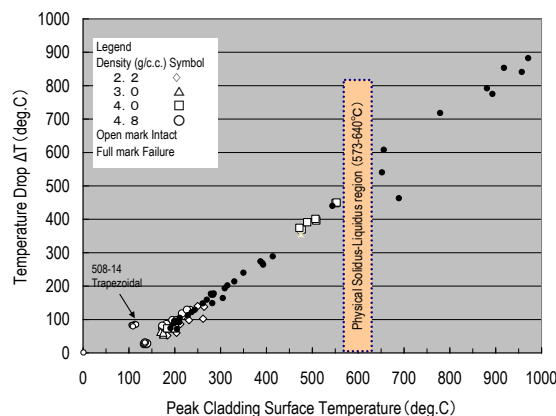
Fig.16 Temperature drop ΔT as a function of PCST.

The temperature drop should occur during the fuel quench. The author considered that the temperature drop ΔT or simply ΔT here was one of the important factors related to the fuel failure mechanism, because the thermal stress arisen during the quench is given by $\alpha \times E \times \Delta T$, where α is the thermal expansion coefficient and E is the Young's modulus. In which the value ΔT is defined by PCST- T_p (quench temperature). As shown in Fig. 16, ΔT is revealed to have a linear relationship to the PCST because T_p is almost constant, 112 ± 12 deg. C. This is one of the main reasons why the author used PCST as the index of the failure threshold (Fig.15). However, PCST is not sufficient to consider the failure mechanism of

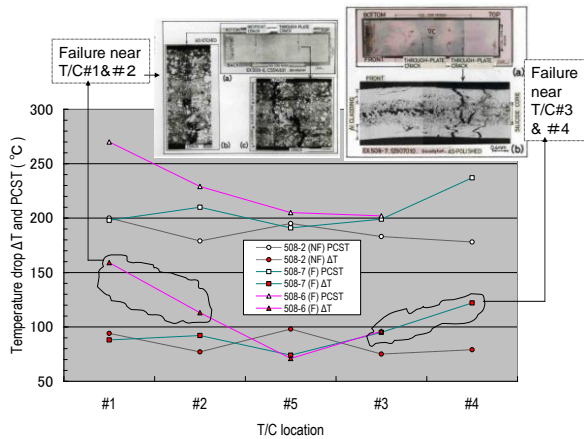
Fig.17 Temperature drop ΔT at each T/C location.

The author considered that the failure mechanism was attributed to an uneven ΔT , which caused an ill-balanced quench front during the quench of the fuel plate. To explain this, three data from Ex. 508-6 (96cal/g, failure), Ex. 508-7 (94cal/g, failure) and Ex. 508-2 (77cal/g, no failure) were prepared. PCST and ΔT at each T/C location are plotted together as shown in Fig.17. The data curve of the PCST of any fuels resembled to that of ΔT , but not constant. Here, the author focused on ΔT (triangle data) from the failed fuel. In-core data showed that the Al-3wtMg cladding at T/C#1 was heated from 22deg. C to 270 deg. C through the DNB (174deg. C for this case), and quenched to 111deg. C. As a result, ΔT was 159deg. C and t_q was 0.055s. PIE revealed that the incipient crack occurred around T/C#1-T/C#2 and the through-plate crack occurred around T/C#3-T/C#4 (see the picture at the top-left side of Fig.17).

With respect to ΔT (rectangular data) from the failed fuel, Al-3wt%Mg cladding at T/C#4 was heated from 24deg. C to 237 deg. C through the DNB (179deg. C for this case), and quenched to 115deg. C. As a result, ΔT was 122deg. C and t_q was 0.052s. PIE revealed that the incipient cracks occurred around T/C #1-T/C #2 and through-plate cracks occurred around T/C #3-T/C#4 (see the picture at the top right side of Fig.17).

With respect to ΔT (circle data) from the intact fuel, a magnitude of the ΔT was $85 \pm 11 \text{ deg.C}$ ($n=5$) and tq was $0.06 \pm 0.01 \text{ s}$. PIE revealed no abnormality at all.

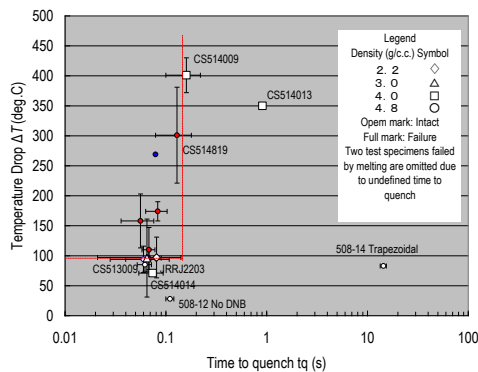
Fig.18 Temperature drop ΔT as a function of the time to quench.

Obtained values for ΔT and tq , except for the fuel melting cases were plotted in Fig.18. This plot implies that there exists a failure threshold at ΔT 94deg.C and tq 0.13s. If a silicide fuel had a high ΔT ($>94 \text{ deg.C}$) together with a low tq ($<0.13 \text{ s}$), the risk of the fuel failure should be high and vice versa.
