Fukushima Daiichi Accident: Why it happened, What happened and the Challenge of nuclear safety in Japan

Hidekazu Yoshikawa, HEU

HEU-TAMU Summer School on Nuclear
Reactor System Engineering

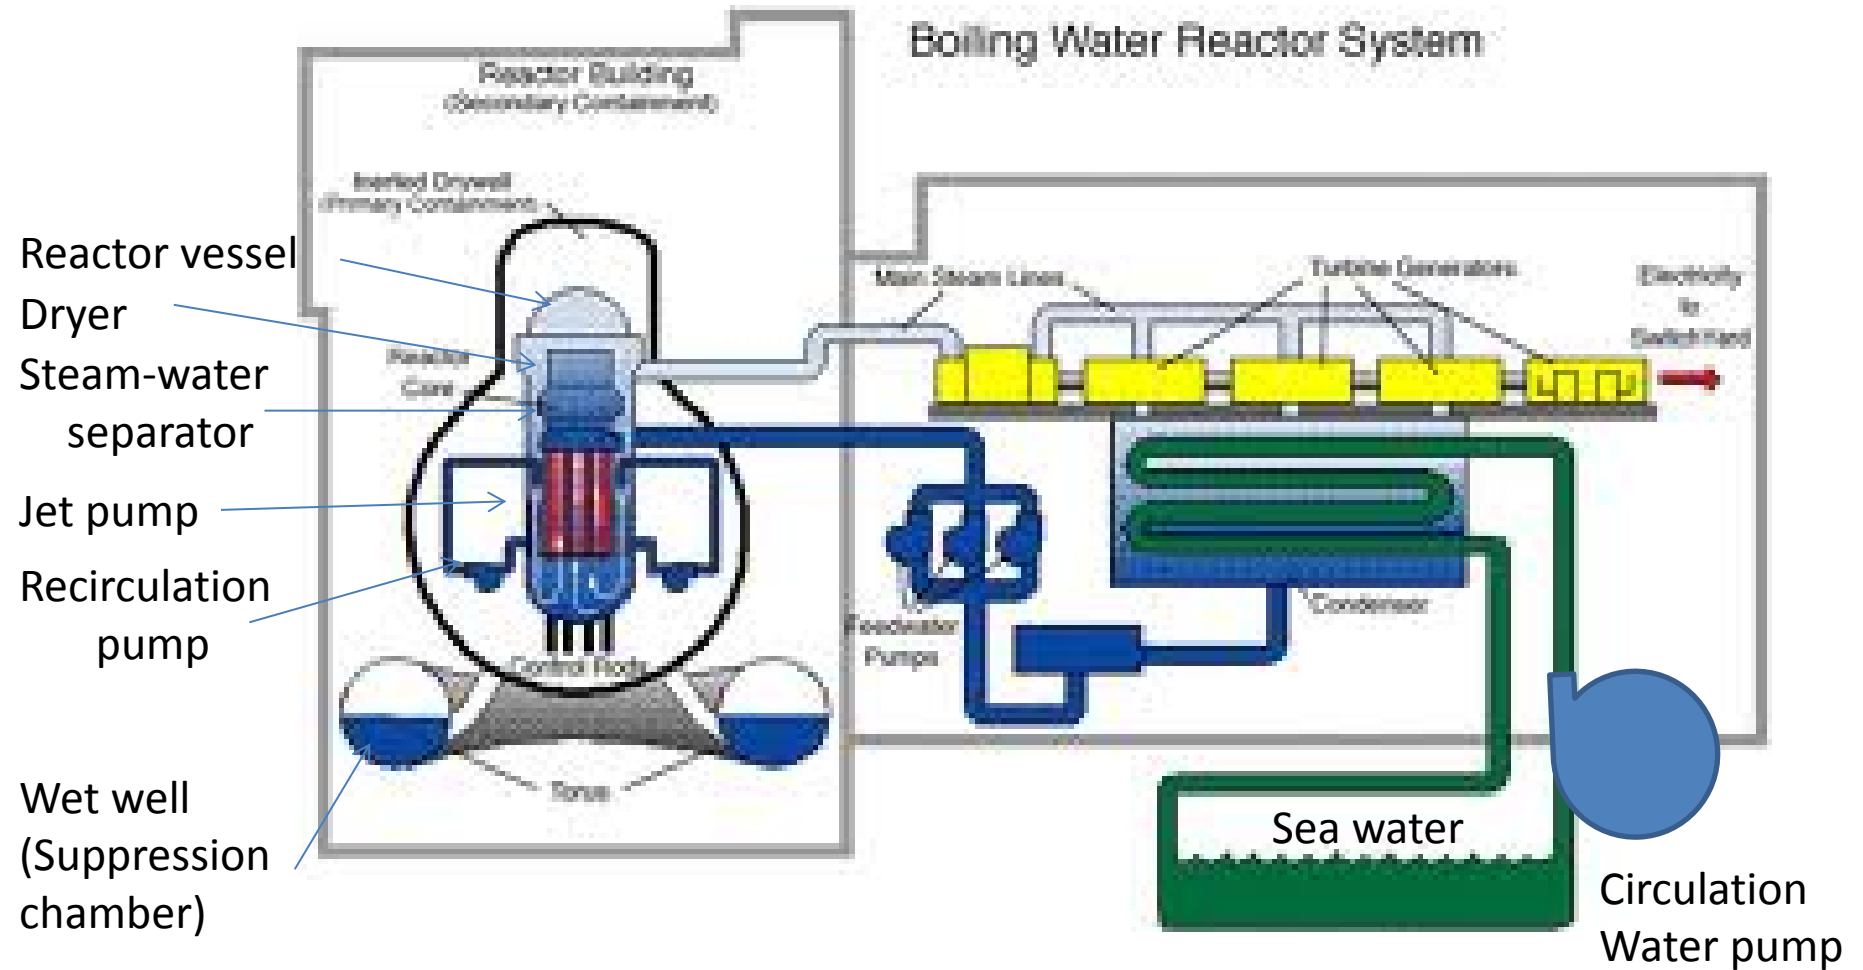
Mark 1 Containment

Blow-out panel
Opened in Unit 2

Location of explosions
In Units 1 and 3
Location of fires
In Unit 4

Explosion of Unit 2
Somewhere in the
Reactor building
near the suppression
Chamber?

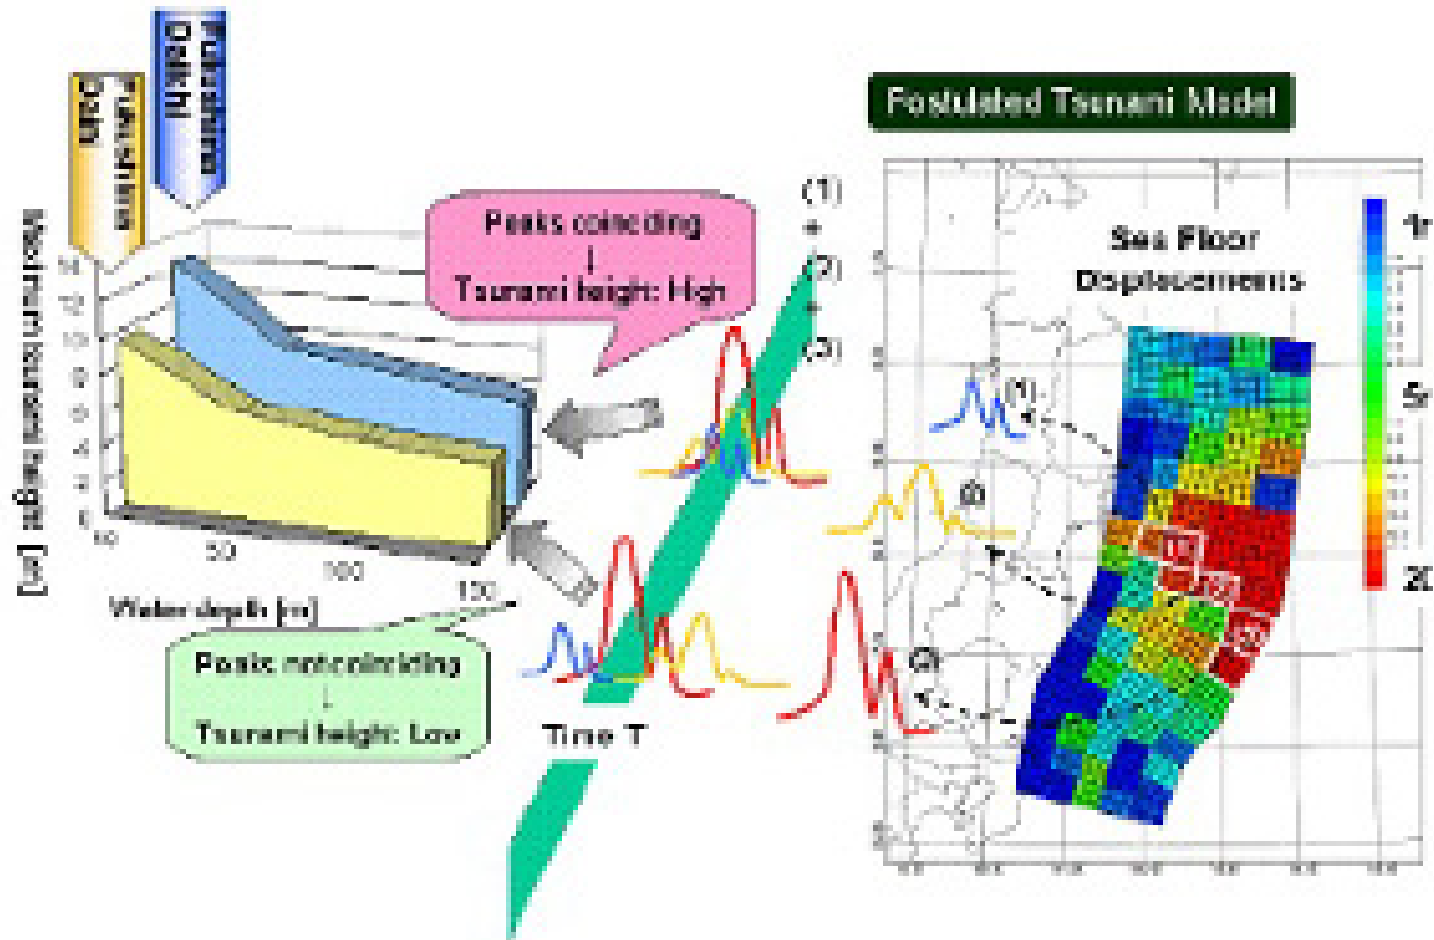
- Analysis has shown that the difference in the tsunami heights at Fukushima Daiichi NPS and Fukushima Daini NPS was caused by the degree of superposition of tsunami waves occurring in different epicentral areas.

The superposition analysis results of tsunami (image).

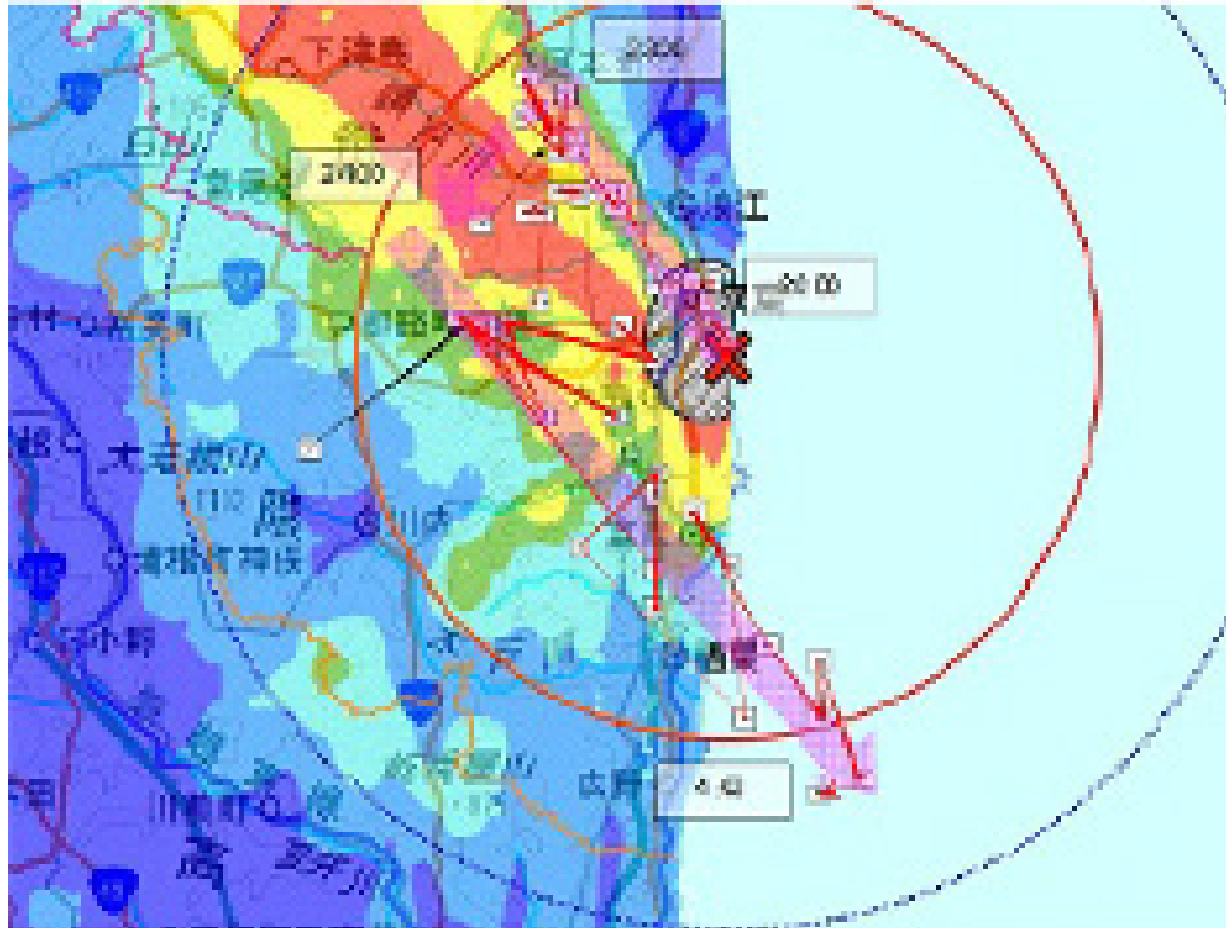
Path of plume released from Unit 2 after 20:00 on March 15.

- Radioactive release from the R/B of Unit 2 on March 15 in conjunction with winds to the north-northwest (the next figure) and rain fall (the second next figure) had a major impact on the environmental contamination.
- The reason for this amount of release is that the emissions from Unit 2 bypassed the suppression pool and there was therefore no scrubbing effect. (According to TEPCO's estimation, major FP release path is through failed flange seal of PCV head.)
- The reason why no hydrogen explosion in Unit2 R/B was that the blow-out panel was already blown-out by the time of Unit 1 R/B explosion.
- As a matter of fact, FPs released on March 15 reached as far as 40 km from Fukushima Daiichi NPS. This far-reaching FP release let citizen in evacuation be thrown into heavy confusion at the time.
