# Lessons learned from the Fukushima Daiichi Nuclear Power Plant Accident

NARABAYASHI Tadashi<sup>1</sup>

1. Division of Energy and Environmental Systems, Hokkaido University  
Kita 13, Nishi 8, Kita-ku, Sapporo 060-8628, Japan. (E-mail: [tnaraba@eng.hokudai.ac.jp](mailto:tnaraba@eng.hokudai.ac.jp))

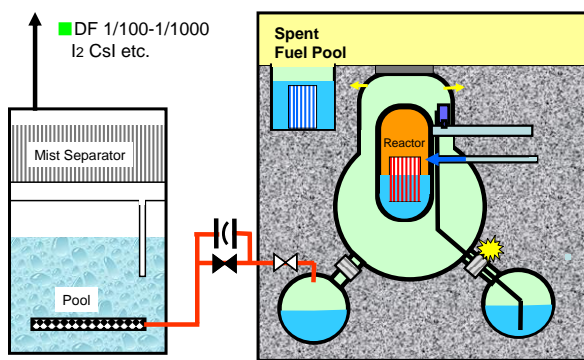
Fig.15 Filtered containment venting system

As shown in Fig. 15, after the Chernobyl NPP accident, countries such as France, Germany, Switzerland, Finland and Sweden decided to install a filtered containment venting system (FCVS) to protect against radioactive material exhaust, as shown in Figs. 16 and 17. Figure 18 shows a schematic diagram of the FCVS installed in the Leibstadt NPP. A venting process is automatically carried out when the CV pressure reaches the set pressure for the rupture disk. An operator who wishes to vent early can easily open the vent valve using a hand wheel driven shaft.

In the case of the Fukushima Daiichi NPP accidents, operators should have closed a large number of valves in the SGTS system and then opened the vent valve using an air compressor and connecting tubes, because of the station blackout condition. If a FCVS had already been installed in the Fukushima Daiichi NPP, environmental contamination by FP would be having been avoided. The decontamination factor is about 1000 for aerosols and about 100 for  $I_2$ .

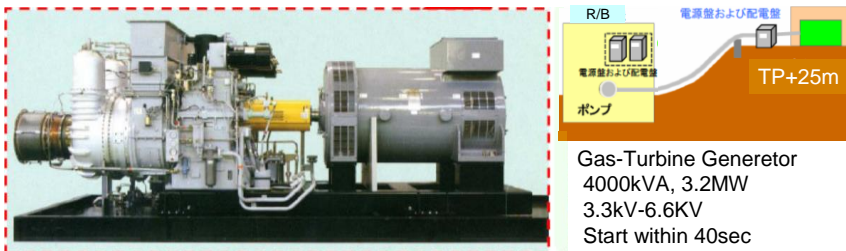
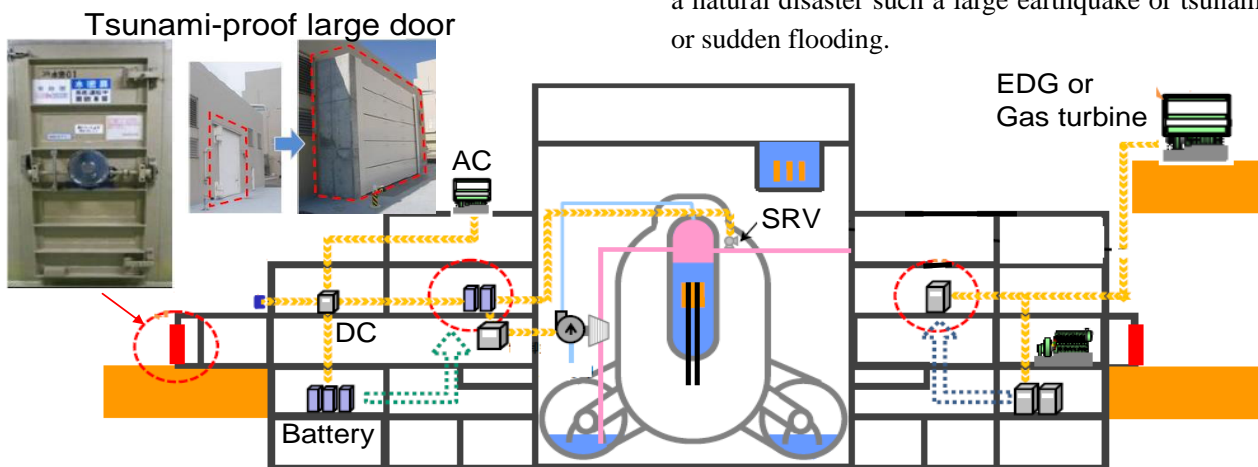
Fig. 21 Tsunami protection example at Tomari NPP (Hepco) and Hamaoka NPP (Chubu Electric)<sup>[7]</sup>.

(b) 3.2 MW Gas-turbine generator to be installed at 25 m height(Chubu Electric).

(c) Tsunami-proof doors and hatches (BWR Utilities in Japan)

Figure 21 shows several tsunami protection examples, such as a large mobile gas-turbine generator and an

electricity receiver/transmitter device on top of a hill (85 m high). Tsunami-proof doors and hatches have been installed in both PWR and BWR plants in Japan, as shown in Fig. 21(c).

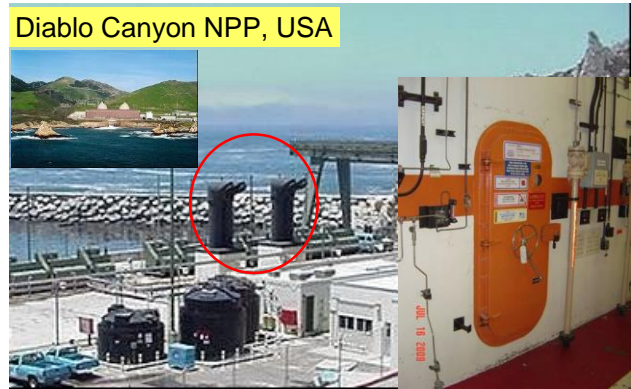
Fig.20 Tsunami protection at Diablo Canyon NPP,USA<sup>[6]</sup>.

changing the power cable and new seawater pump motors were installed. Therefore, it is very important to prevent the flow of water into important areas. As shown in Fig. 20, at the Diablo Canyon NPP in Florida, the seawater pump motors are equipped with waterproof hatch-type doors and snorkel piping.
