# Evaluation of plant behavior during the accident at Fukushima Daiichi Nuclear Power Station

MIYATA Koichi<sup>1</sup>, and NISHINO Shoichiro<sup>2</sup>

1. Tokyo Electric Power Company, Chiyoda, Tokyo, 100-8560 Japan (Miyata.Koichi@tepcoco.jp)

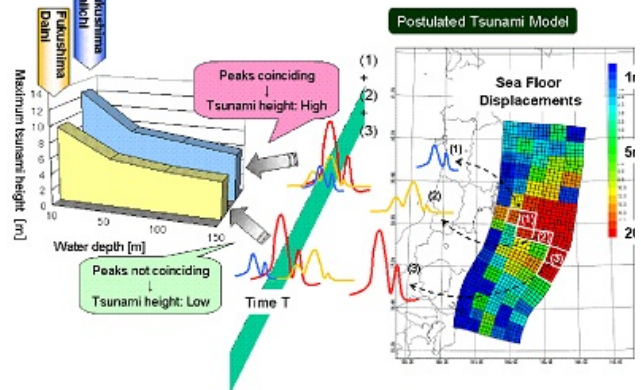
Fig.4 The superposition analysis results of tsunami (image).

Analysis has shown that the difference in the tsunami heights at Fukushima Daiichi NPS and Fukushima Daini NPS was caused by the degree of superposition of tsunami waves occurring in different epicentral areas (Fig. 4).

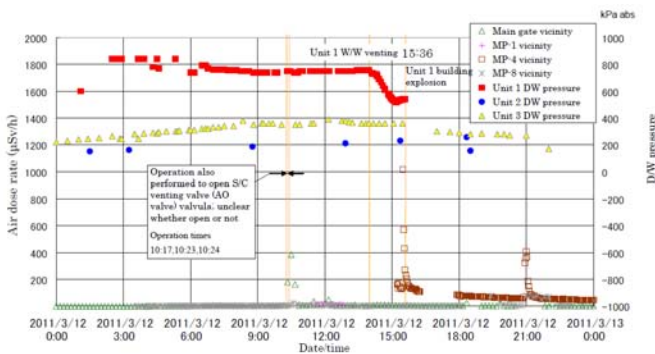
Fig.8 D/W pressure and monitoring data (March 12).

molten core concrete interaction (MCCI). Concrete erosion depth estimated by MAAP analysis was about 70 cm. After confirmation of D/W pressure, preparation for S/C vent operation was initiated. Because all the power supplies had been lost, field operation was necessitated and there were many difficulties in conducting the operation. After checking the completion of local resident evacuation, the air operated (AO) bypass valve along with the hardened vent line was opened after 10:00 on March 12 and the radiation dose rate near the main gate increased temporarily (Fig.8). After 14:00 on March 12, the S/C vent valve was opened and D/W pressure was decreased, however the radiation dose rate near the main gate did not increase. So, it is estimated that vent at Unit 1 did not release a large amount of radioactive materials that could have contributed to the contamination.

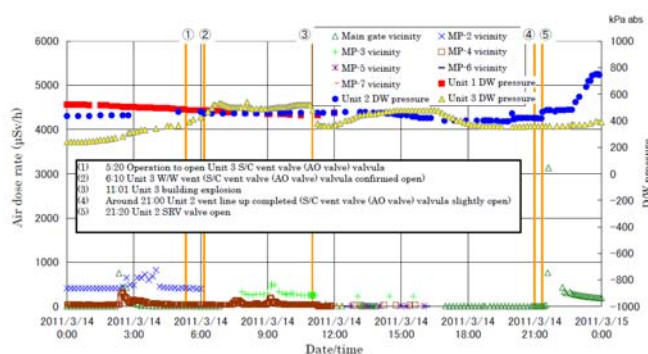
Fig.13 D/W pressure and monitoring data (March 14).

After 21:00 on March 14, the AO bypass valve along with the hardened vent line was opened and the radiation dose rate near the main gate increased temporarily (Fig.13). However, it is unknown whether the rupture disk, which was installed along with the vent line, was opened in this operation.

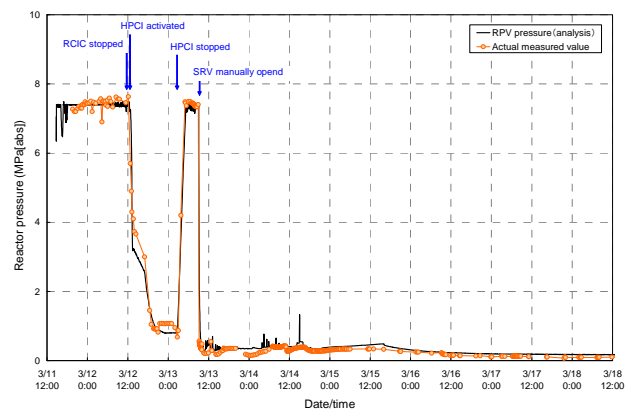
Fig.16 Trend in reactor pressure (Unit 3).

RCIC and HPCI (Fig.15). After the RCIC stopped, the HPCI started automatically due to a low reactor water level (level 2) signal, and the reactor depressurized to about 1 MPa [abs]. This phenomenon was the result of the operator’s action to ensure continuous operation of the HPCI in order to maintain a stable reactor water level. In this situation, continuous steam supply to the HPCI turbine enabled the reactor to depressurize (Fig.16).

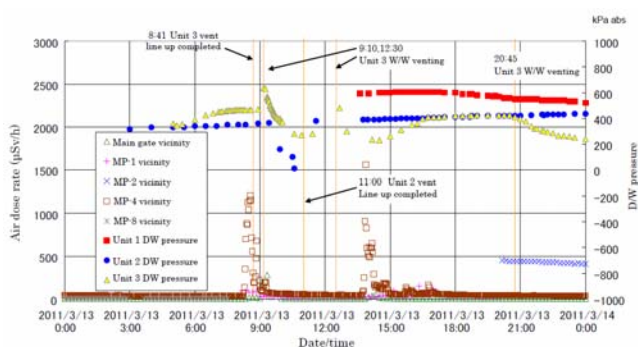
Fig.18 D/W pressure and monitoring data (March 13).

In addition, although monitoring data near the main gate increased temporarily from the direct radiation of the radioactive plume at the time of the first vent, a significant increase of monitoring data was not confirmed for the later vents (Fig.18). So, it is assumed that the vent did not release a large amount of radioactive materials that could have contributed to the contamination.

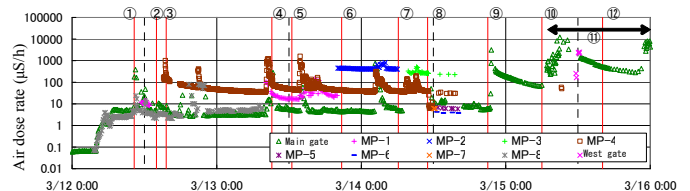
Fig.23 Monitoring data.

Evaluation of major events when radioactive materials were released into the atmosphere (Fig.23, Table 4) and the causes of high level contamination areas to the northwest of Fukushima Daiichi NPS are as follows:

- As shown in Fig.23, dose rates taken on March 15 show a rapid increase from several hundred to tens of thousands  $\mu\text{Sv/h}$  near the main gate over several hours after 07:00 and then a decrease to approximately  $1,000\mu\text{Sv/h}$  at noon on the same day. The dose rate measured at 23:00 increased to close to  $10,000\mu\text{Sv/h}$  again. Considering the wind patterns on the day, it is believed that a large amount of radioactive materials were released continuously throughout this time period.
- Since Unit 2 PCV pressure decreased substantially between 07:00 and 11:00 on the same day and white smoke was seen coming from Unit 2 R/B (Fig.24), it is highly likely that Unit 2 was the source of the release.
- Radioactive release from the R/B of Unit 2 on March 15 in conjunction with winds to the north-northwest (Fig.25) and rain fall (Fig.26)
