# Lessons learned from the Fukushima Daiichi Nuclear Power Plant Accident

NARABAYASHI Tadashi<sup>1</sup>

**Abstract:** Many lessons can be learned from the Fukushima Daiichi Nuclear Power Plant accident. First, if an isolation condenser (IC) continues to operate, the accident would be terminated soon. A reactor core isolation cooling (RCIC) steam turbines also stopped due to loss of battery power in Units No.2 and No.3. suppression pool (S/P) temperature and pressure were so high that the accident management water injection took too long time. After the loss of ECCS and IC core cooling, Containment Vessel pressure increased. Hydrogen explosion occurred after venting. The analysis results show that the depressurization of the reactor pressure vessel (RPV) started before RPV bottom failure. It is hoped that the lessons learned from this accident will help to improve the safety of nuclear power plants worldwide.

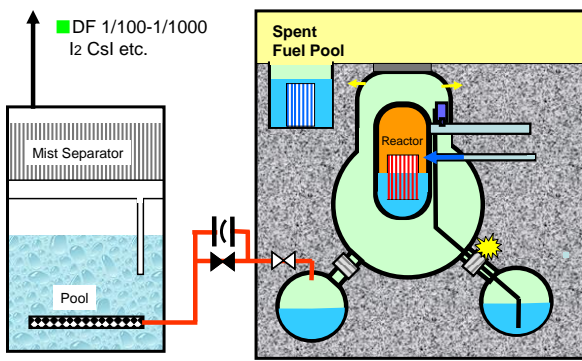
Fig.15 Filtered containment venting system

As shown in Fig. 15, after the Chernobyl NPP accident, countries such as France, Germany, Switzerland, Finland and Sweden decided to install a filtered containment venting system (FCVS) to protect against radioactive material exhaust, as shown in Figs. 16 and 17. Figure 18 shows a schematic diagram of the FCVS installed in the Leibstadt NPP. A venting process is automatically carried out when the CV pressure reaches the set pressure for the rupture disk. An operator who wishes to vent early can easily open the vent valve using a hand wheel driven shaft.

In the case of the Fukushima Daiichi NPP accidents, operators should have closed a large number of valves in the SGTS system and then opened the vent valve using an air compressor and connecting tubes, because of the station blackout condition. If a FCVS had already been installed in the Fukushima Daiichi NPP, environmental contamination by FP would be having been avoided. The decontamination factor is about 1000 for aerosols and about 100 for  $I_2$ .

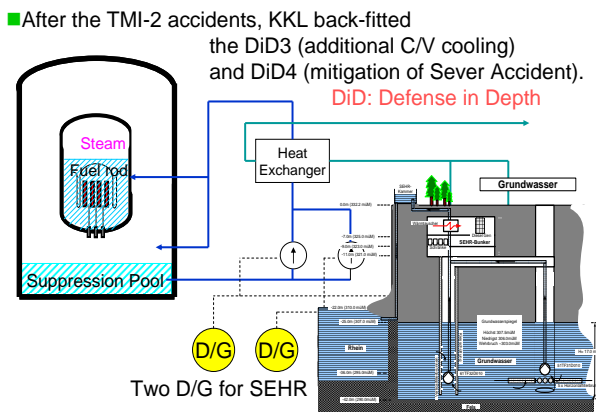
Fig.19 SEHR (Special Emergency Heat Removal) System<sup>[6]</sup>.

After the TMI-2 accident in 1979, Kernkraftwerk Leibstadt (KKL) back-fitted the Leibstadt NPP with additional CV cooling (Defense in Depth 3) and a mitigation system for severe accidents (Defense in Depth 4). The back-fitted system was named the special emergency heat removal (SEHR) system. The SEHR system was required by ENSI/ HSK in the late 70s, shortly after the start of the project planning, so it was the first back-fitting in the present design of KKL. Due to space limitations, only a single heat exchanger was installed for two SEHR trains and the heat removal power is a minimum of 36.3 MW (1% of the nominal power: decay heat). The system has two special EDGs and an underground well water heat sink. The system is able to cool both the core and the CV using the heat exchanger.

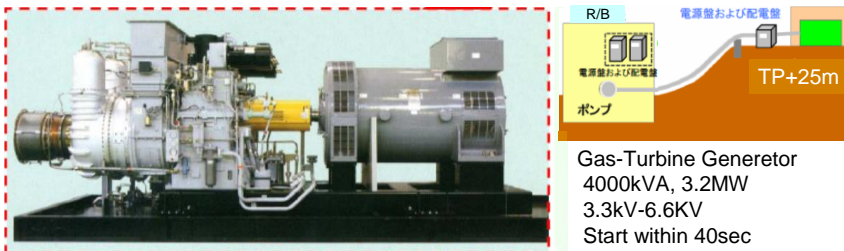
(b) 3.2 MW Gas-turbine generator to be installed at 25 m height(Chubu Electric).

Figure 21 shows several tsunami protection examples, such as a large mobile gas-turbine generator and an electricity receiver/transmitter device on top of a hill (85 m high). Tsunami-proof doors and hatches have been installed in both PWR and BWR plants in Japan, as shown in Fig. 21(c).

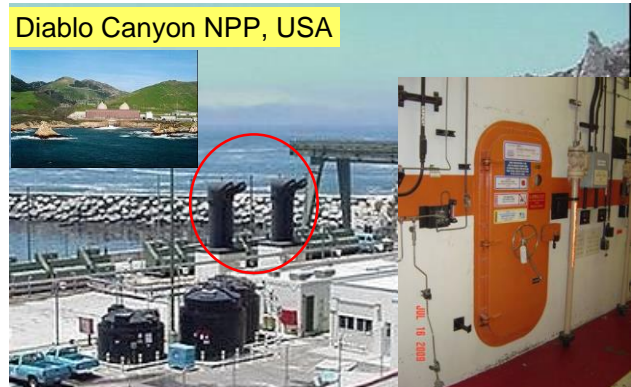
Fig.20 Tsunami protection at Diablo Canyon NPP,USA<sup>[6]</sup>.

changing the power cable and new seawater pump motors were installed. Therefore, it is very important to prevent the flow of water into important areas. As shown in Fig. 20, at the Diablo Canyon NPP in Florida, the seawater pump motors are equipped with waterproof hatch-type doors and snorkel piping.

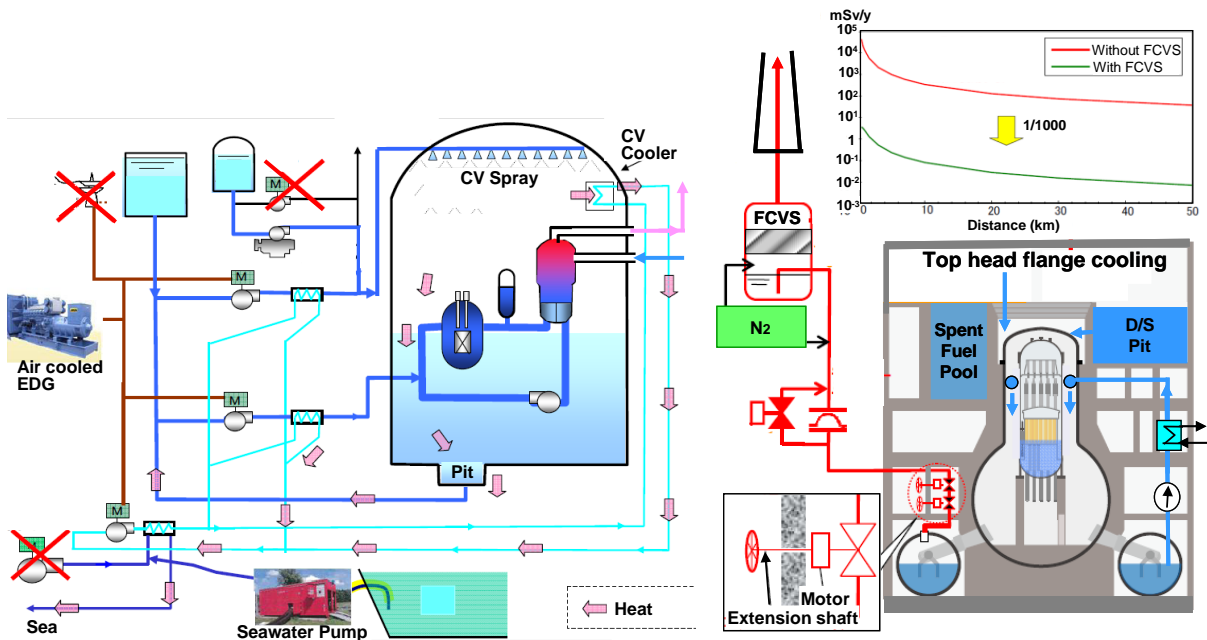
Fig. 22 Decay heat removal system and CV spray cooling system with FCVS<sup>[7]</sup>.

As shown in Fig. 22, decay heat removal and CV spray cooling with FCVS can be carried out using mobile generators and heat exchangers to maintain a permanent heat sink even in a natural disaster such a large earthquake or tsunami, or sudden flooding.

- 1) Enhance aseismic electric device to prevent loss of external power by earthquake, SF<sub>6</sub> gas insulated switchgear (GIS) and flexible insulators should be installed for transmission line.
- 2) Station blackout (SBO) occurred by wetting emergency diesel generator (EDG), power center (P/C), DC Battery, I&C and cell phone. Therefore, water proof door or hatches and mobile power should be installed on hill.
- 3) To prevent the core meltdown by loss of water injection, diversity of water injection and heat sink is very important.
- 4) To prevent the loss of containment function by over heat damage, containment vessel cooling and filtered containment vent system (FCVS) should be installed independently from hard vent system.
