# Addenda to the update of the Fukushima Daiichi Nuclear Power Station accident (March 11 through May 31, 2011)

**Abstract:** These addenda provide the figures and tables for helping readers to understand the article titled “the update of the Fukushima Daiichi Nuclear Power Station (NPS) accident” by SHIBUTANI Yu. These figures and tables are mainly referred from “Report of the Japanese Government to the IAEA Ministerial Conference on Nuclear Safety- The Accident at TEPCO’s Fukushima Nuclear Power Stations - June 2011 Nuclear Emergency Response Headquarters Government of Japan”

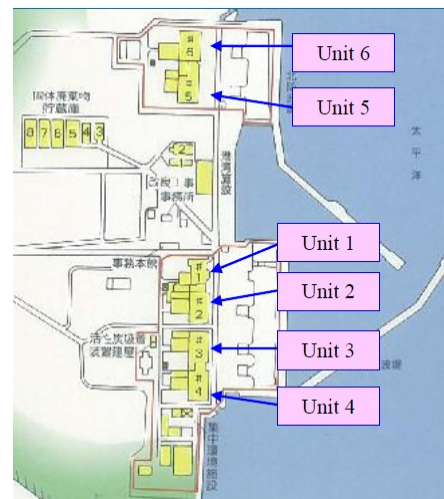
Fig. 2 Plant layout of Fukushima Daiichi NPS.

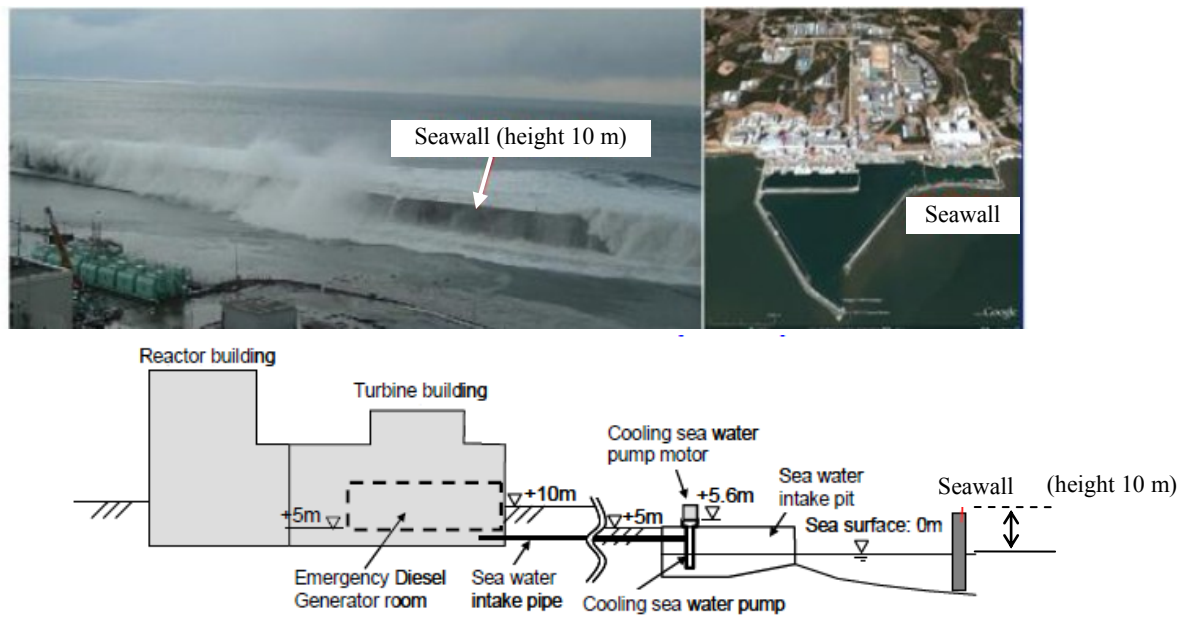
Fig.3 Snap shot of the tsunami just getting over seawall (top left), birds eye view of seawall layout (top right), and cross-sectional layout of Fukushima Daiichi NPS. Modified by IJNS editor

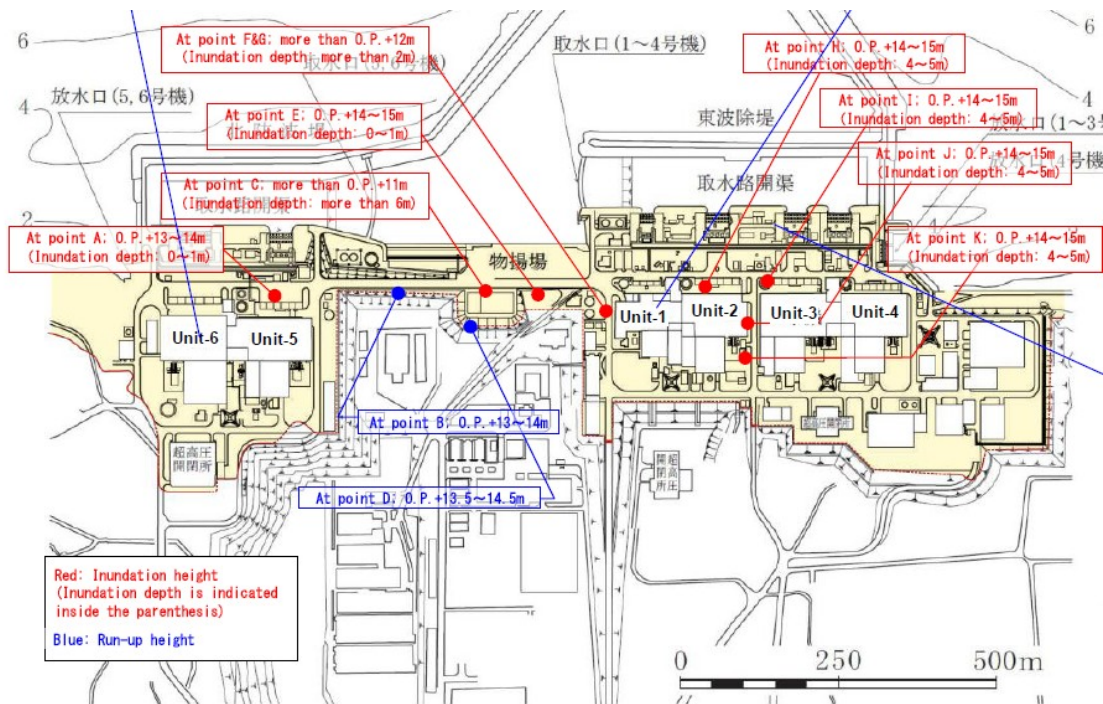
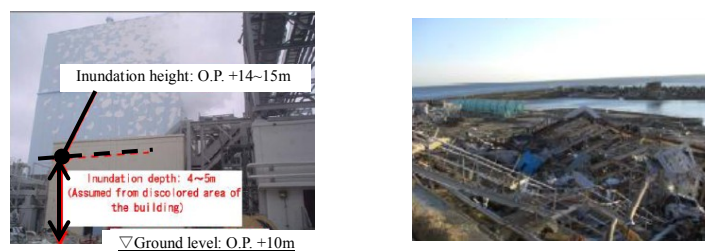
Fig.4 Inundation area (yellow part) of Fukushima Daiichi NPS due to the tsunami (top). Photos showing inundation height (bottom left), and wrecked intake pump area (bottom left). Modified by IJNS editor

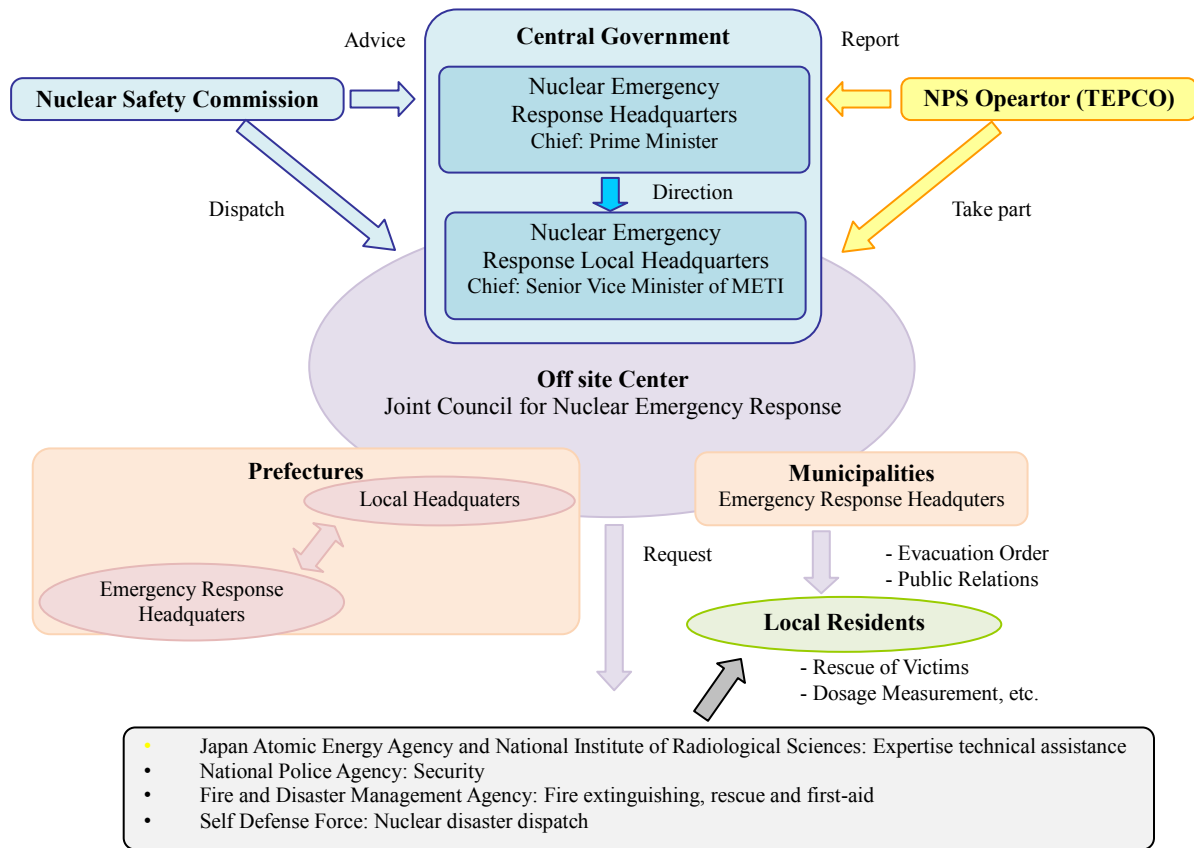
Fig.5 Formal relation of various organizations involving nuclear emergency response described in Japan's Act on Special Measures Concerning Nuclear Emergency Preparedness.

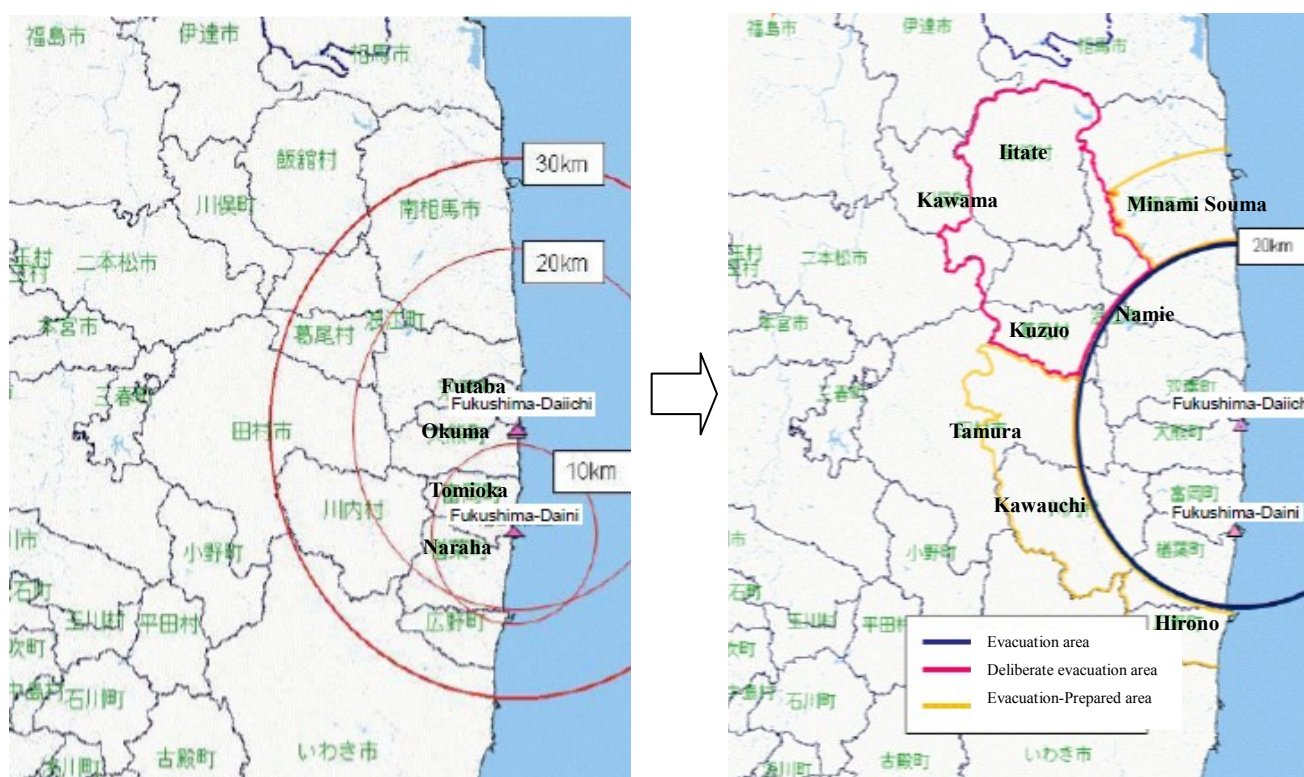
Fig.6 Establishment of restricted area on April 21.

The Restricted Area is intended to limit access to the area in order to prevent residents and others from radiological risk by entering the evacuation area. The evacuation area (within 20 km from Fukushima Daiichi and 10 km from Fukushima Daini) and the stay in-house area instructed before April 21 (left). The stay in-house area was lifted, and the evacuation area (black line; within 20 km from Fukushima Daiichi), the deliberate evacuation area (red line) and evacuation-prepared area (yellow line) in case of emergency were established after April 22 (right)

18:25	Instruction of evacuation to the residents living within a radius of 20 km from the NPS was issued.
March 15	11:00	Instruction of stay in-house to the residents living within a radius of 20 to 30 km from the NPS was issued.
April 21	11:00	Instruction to designate the evacuation area as the restricted area in accordance with the Basic Law on Natural Disasters was issued.
April 22	09:44	The stay in-house instructions were lifted and the Deliberate Evacuation Area and Evacuation-Prepared Area in Case of Emergency were established. (see Fig. 6 )

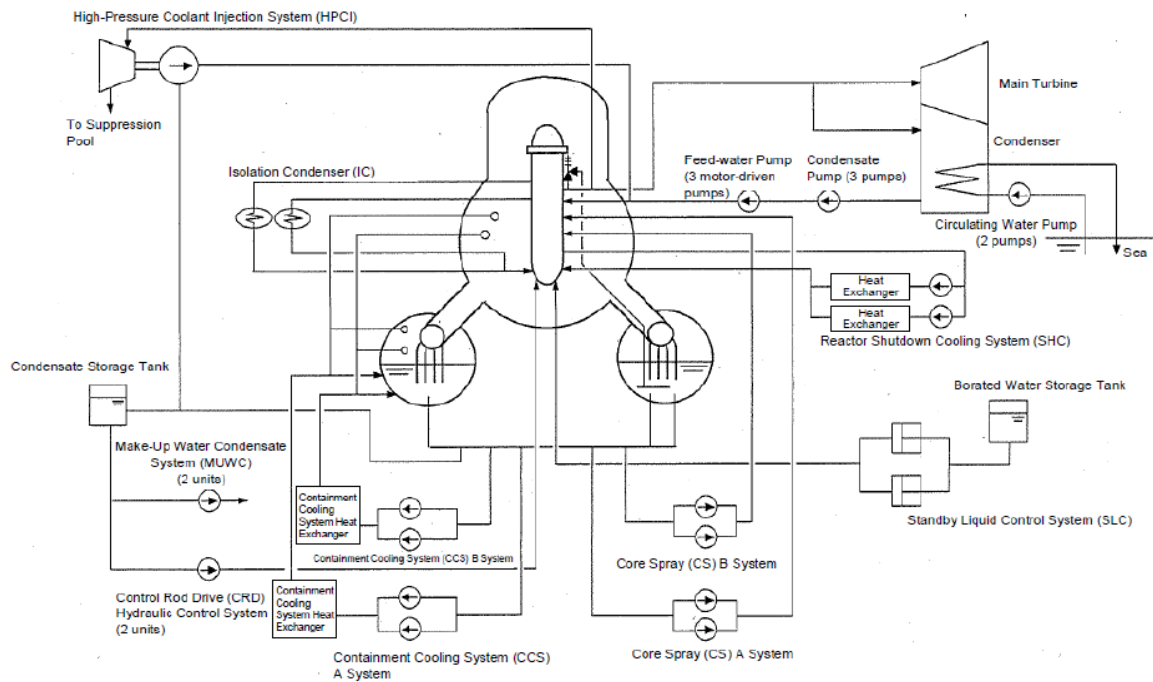
Fig.7 Normal configuration of Emergency Core Cooling System of the Fukushima Daiichi NPS (Unit 1).

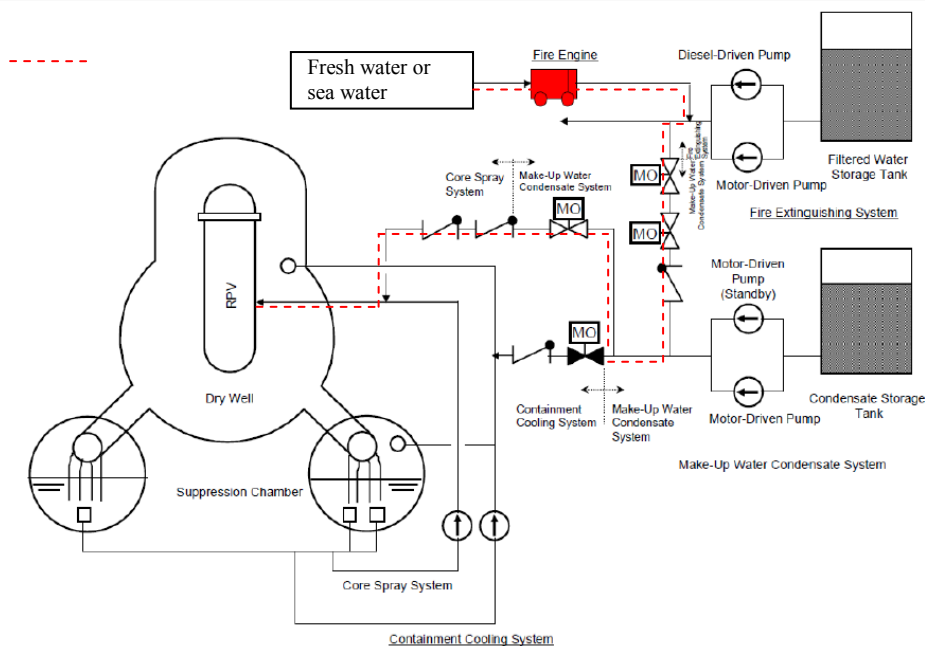
Fig.8 Makeshift water injection method employed by the tsunami-struck Fukushima Daiichi NPS (Unit 1).

Borated water has been injected into RPV by way of dotted line from Fire Engine, after the water both in Filtered Water Storage Tank and Condensate Storage Tank were exhausted. The water to be pumped by Fire Engine was switched to sea water when all the sources of fresh water were exhausted.

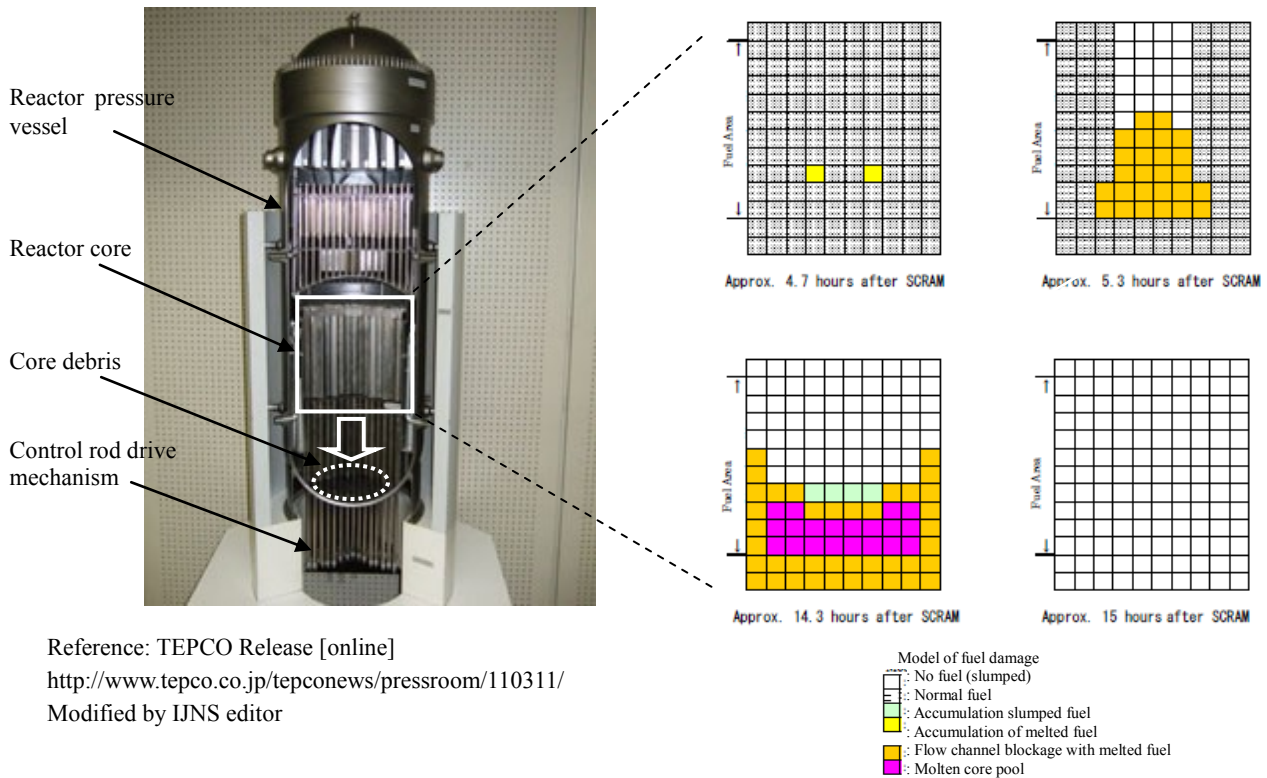
Fig.9 Meltdown of the Fukushima Daiichi NPS (Unit 1) due to insufficient core cooling.

Progression of fuel melting of the reactor core in the reactor vessel was analyzed by MAAP code as shown in the four figures in the right-hand side. In 15 hours after the reactor scram, the core debris would drop down to the bottom of reactor vessel (see left-hand side figure).

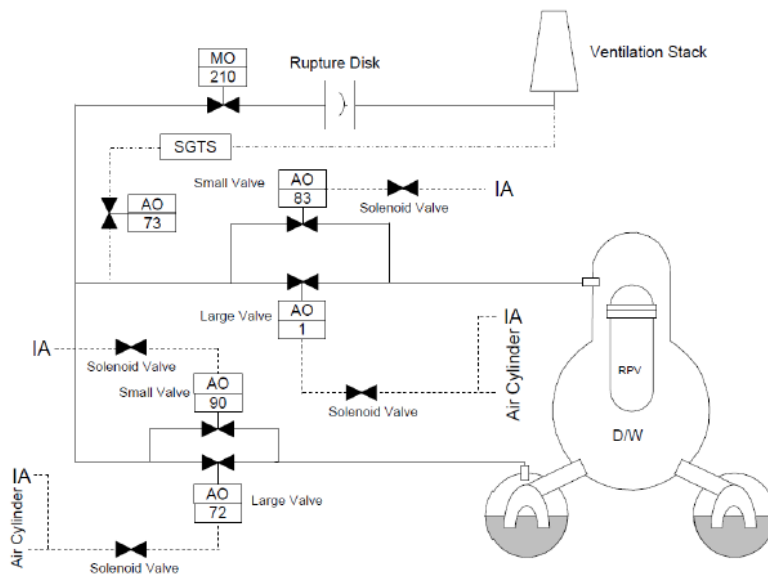
Fig.10 PCV Venting Facility of the Fukushima Daiichi NPS (Unit 1) installed as a countermeasure for severe accident management. This is to bypass the SGTS line (dotted line in the figure) to cope with high pressure situation of dry well.

AO: Air operated valve  
 MO: Motor operated valve  
 SGTS: Standby gas treatment system  
 DW: Dry well

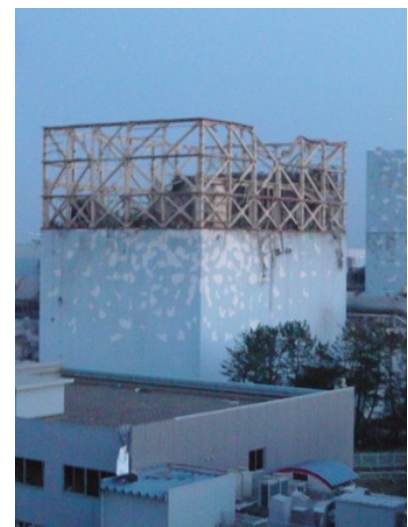
Fig.11 Photo showing exterior view of reactor building of the Fukushima Daiichi NPS (Unit 1) after hydrogen explosion.  
 Reference: TEPCO Release [online] <http://www.tepco.co.jp/tepconews/pressroom/110311/>

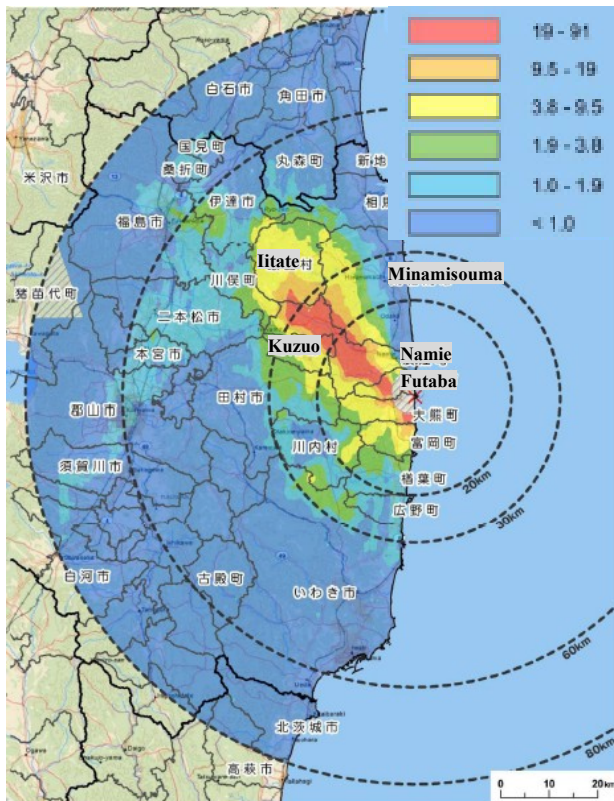
Fig.12 Air dose rate of one meter above ground level ( $\mu\text{Sv/hr}$ ) as of April 29. The value was synthesized from the two results of airborne monitoring, one by the Ministry of Education, Culture, Sports, Science & Technology (MEXT) and the other, United States Department of Energy (DOE).

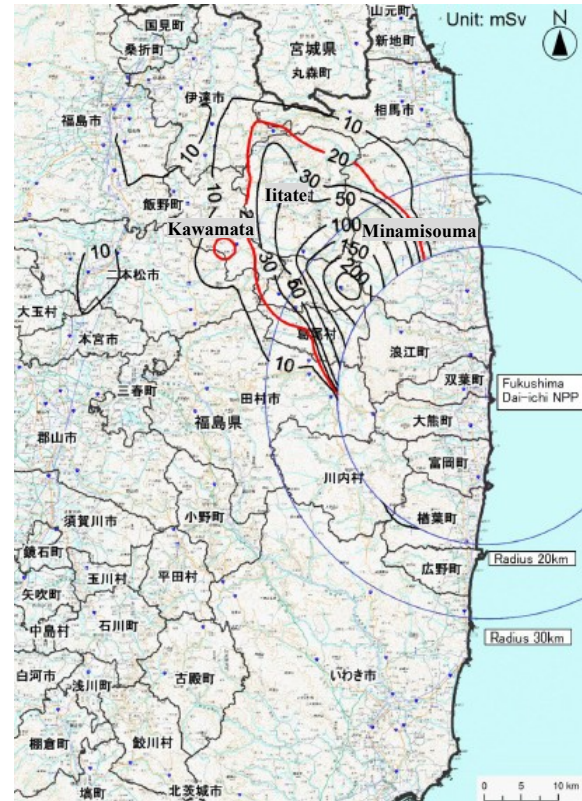
Fig.13 Estimated contour map of integrated dose (Until May 11, 2012) showing discharge of radioactive material by hydrogen explosion toward north west direction from Fukushima Daiichi NPS.

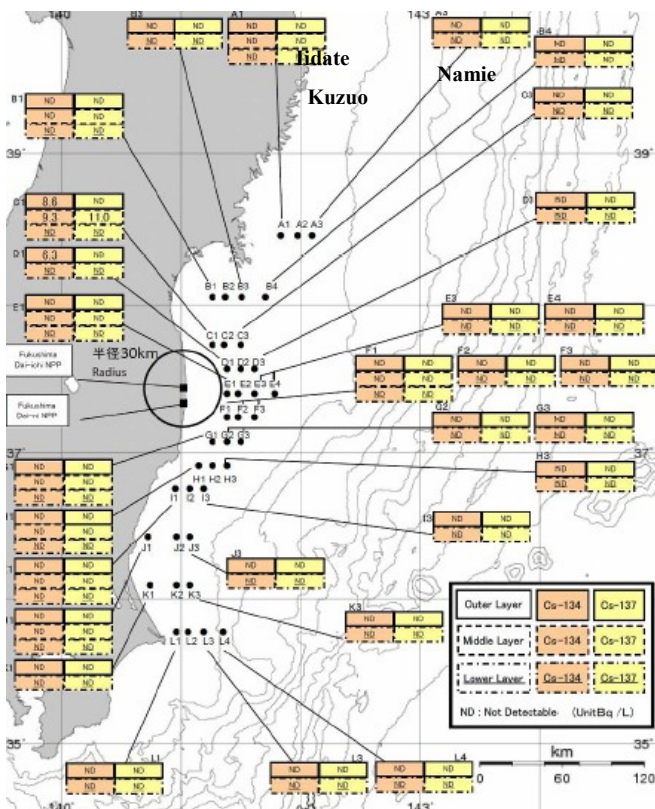
Fig.14 Readings of sea area monitoring showing detection of isotopes Cs-134 and Cs-137 in three layers from sea surface at various sampling posts along the coastal line from the prefectures of Miyagi, Fukushima, Ibaraki to Chiba. Only the both sampling post C1 and D1 just exterior of 30 km radius from the Fukushima Daiichi and Daini NPS still exhibited radioactivity. (May 9 -14, 2011)

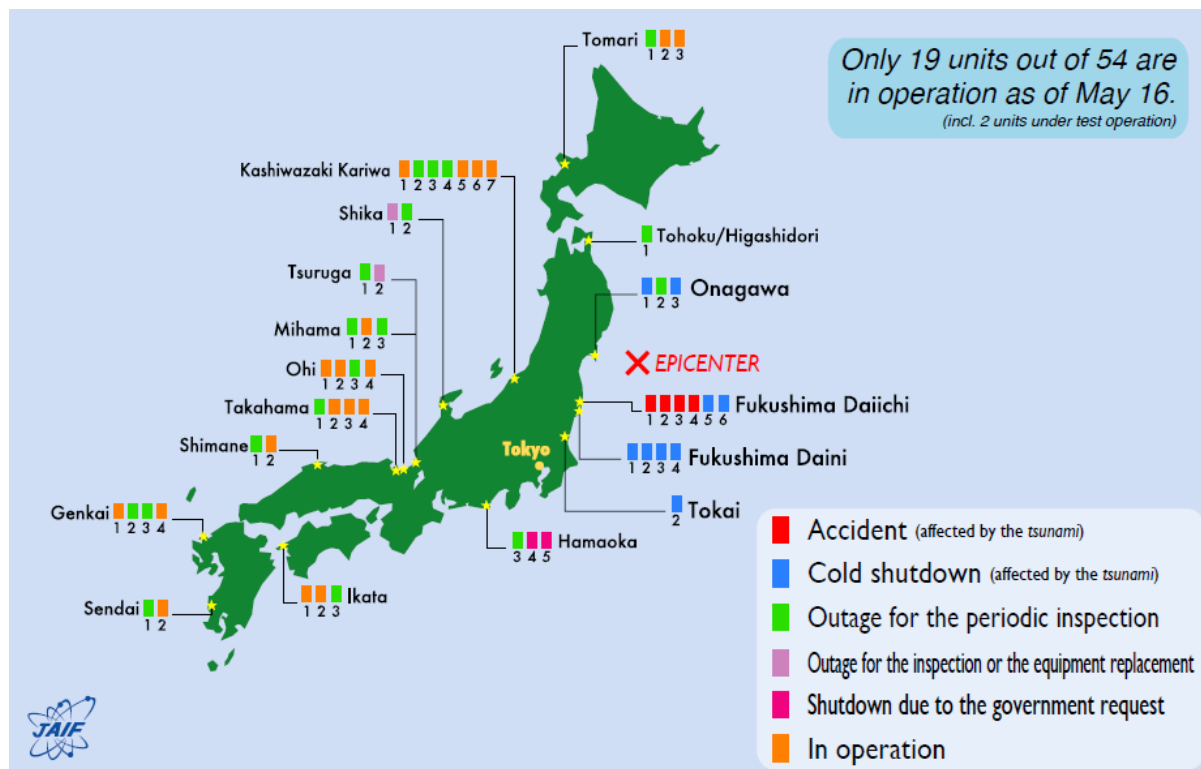
Fig.15 Current status of all the 54 nuclear power plants in Japan as of May 16, 2011
